VICTORIA RICE AND FLOURING MILLS

1824 STORE STREET, VICTORIA, BC

CONSERVATION PLAN
JANUARY 2022

A condition assessment of 1824 Store Street was undertaken in June and July of 2021 by Geoff Purdon of NorthStar General Contracting Ltd. The assessment reviewed the exterior and interior of the building. Conditions were observed and photographed and at no time were materials or elements removed or damaged.

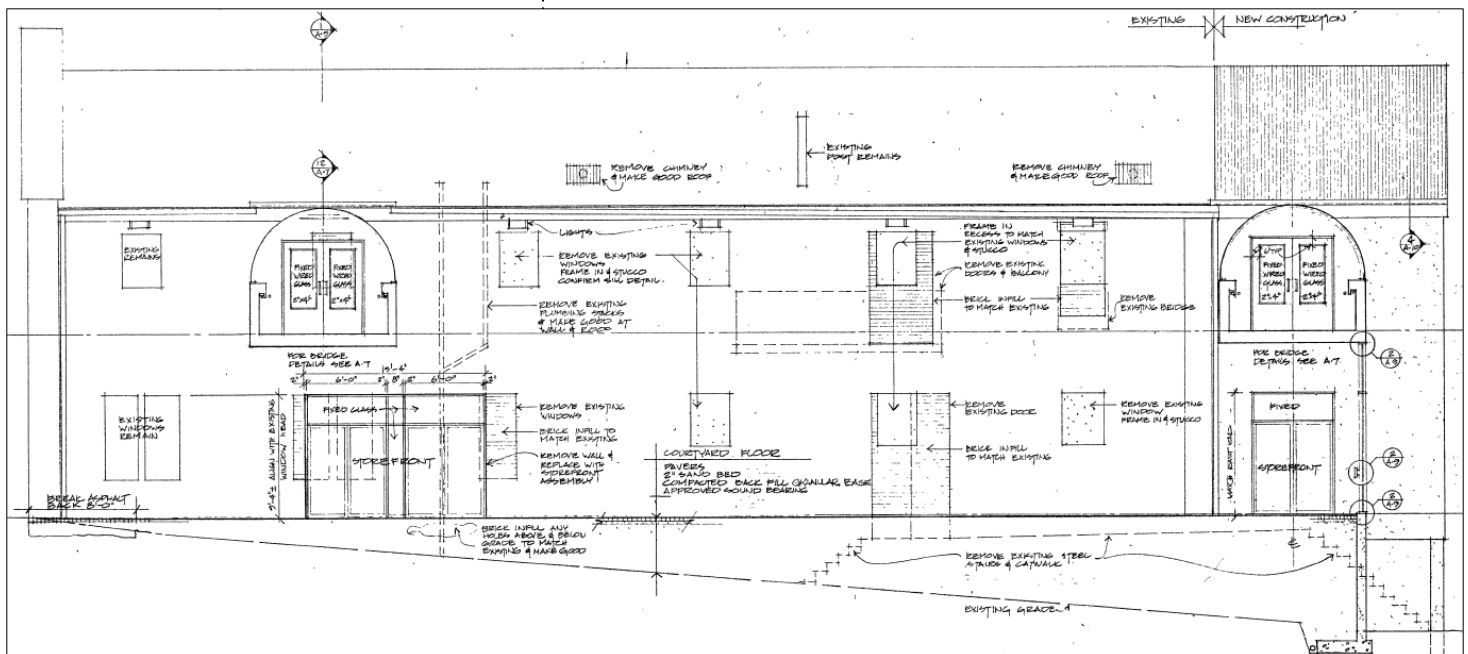
North side elevation showing two pedestrian bridges, windows either filled in or removed, two doors removed and filled in, and the west extension. Note that only one of the pedestrian bridges impact the original structure. Drawing is part of North Elevation plans by Claude Maurice, Architect, in January 1986. Source: City of Victoria.

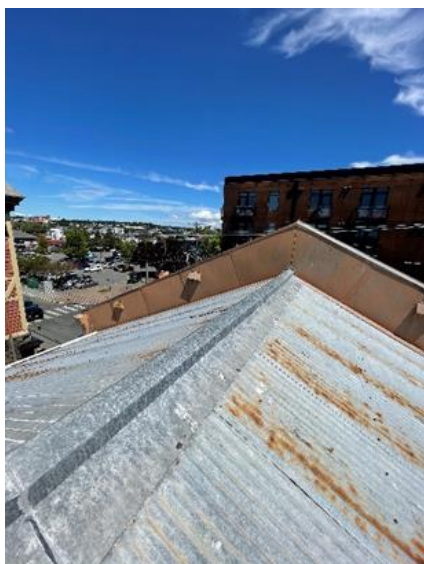
The existing roof is a medium-gabled corrugated sheet metal roof with typical attic vents, ridge cap, and gas vents. The fascia board and trim

above the metal flashing of the non-original cupola appears to be original and the condition is unmaintained and deteriorating. Gutter and downspouts are present. Parapet flashing is intact, has been previously painted, and is currently in need of paint/maintenance. The south flat-roofed addition has rooftop air handler units and vents. Drain vents appear to be clear of debris other than seagull feathers. Seagull nests should be removed and water pooling on roof addressed.

1	Retain the original roof assembly and repair by using a minimal intervention approach. Such repairs might include limited replacement in-kind, or replacement with an appropriate substitute material, of the roof covering, flashing, gutters and downspouts, attachments and penetrations.
2	Preserve the wood-framed decorative pedimented gable, cornice and dentils on the front façade, and the decorated upper gable of the west façade. If repairs are necessary, they should follow a minimal intervention approach and include replacement in-kind based on documentary or physical evidence.
3	Comply with energy efficiency objectives in upgrades to the roof assembly in a manner that respects the character-defining elements and heritage value of the historic building.
