# SPRATT BUILDING

1910 STORE STREET, VICTORIA, BC

## CONSERVATION PLAN

JANUARY 2022

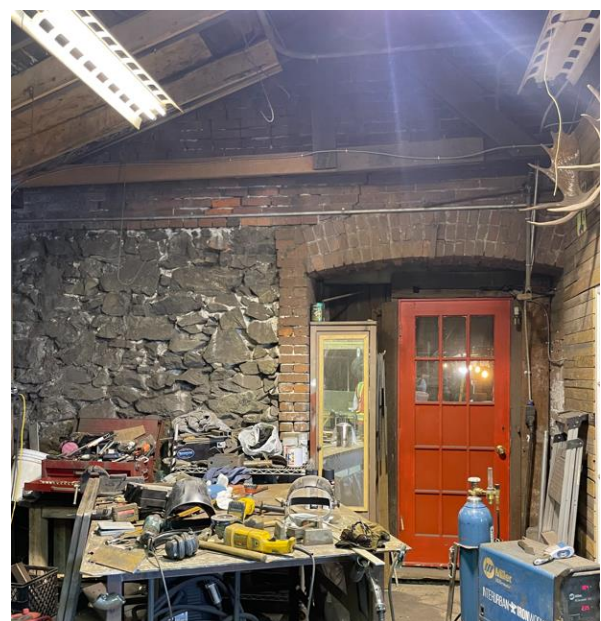
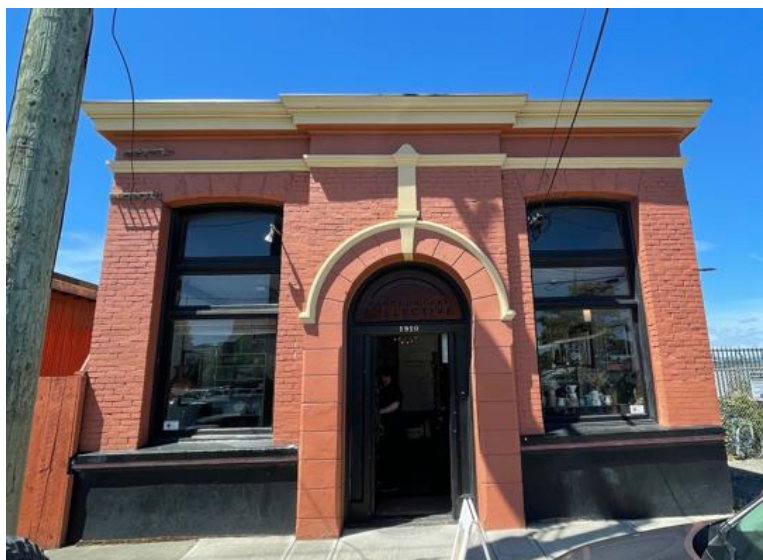
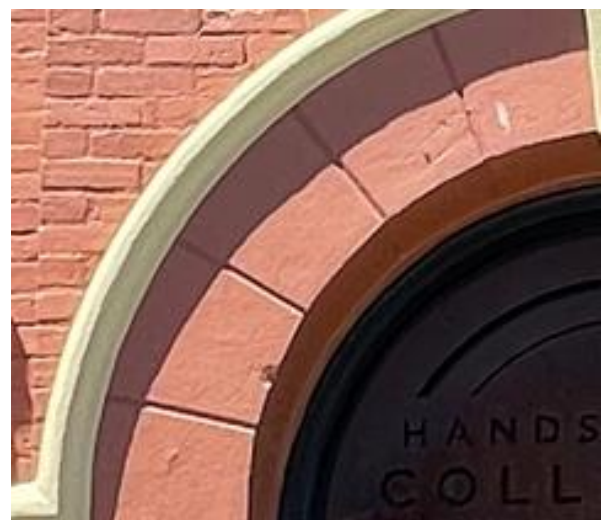
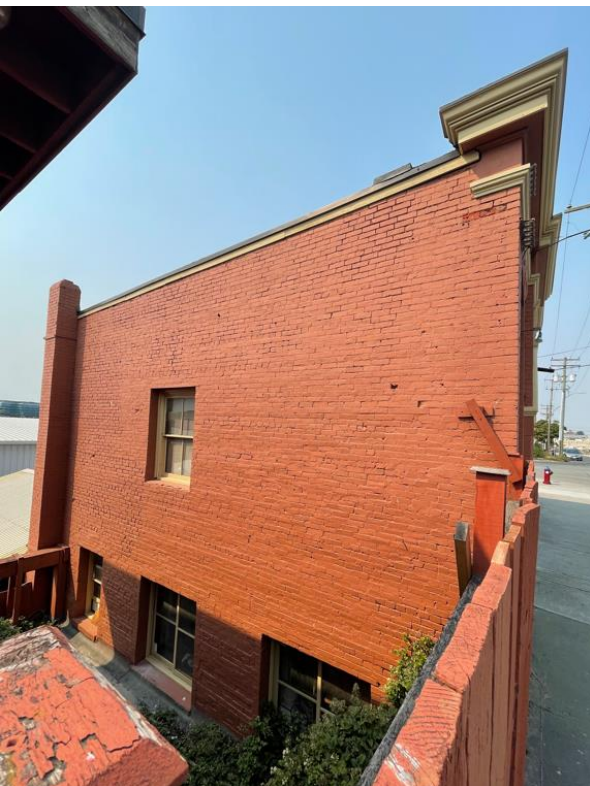
The south and north brick walls and pointing appear to be in good condition. There is evidence on the south wall of some brick deterioration in the upper right corner that will require brick replacement, repointing and repainting to match existing. Other signs of penetration into the brick

will require repair or in-kind replacement. The anchoring of wood bracing evident near the south corner of the front façade should also be investigated, removed if redundant, and the brick repaired and repainted. Overall, some signs of maintenance are required within the next couple of years as evident in the photographs to the left.

- 1 Complete a comprehensive survey of all masonry surfaces to further document noticeable deterioration, areas requiring immediate protection and repair, and areas that may require monitoring.

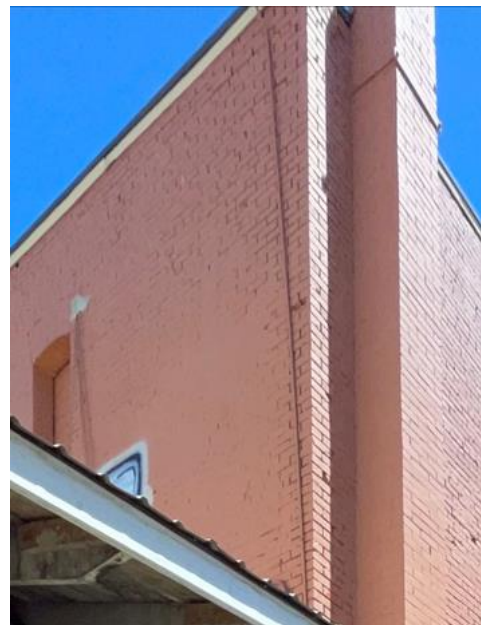
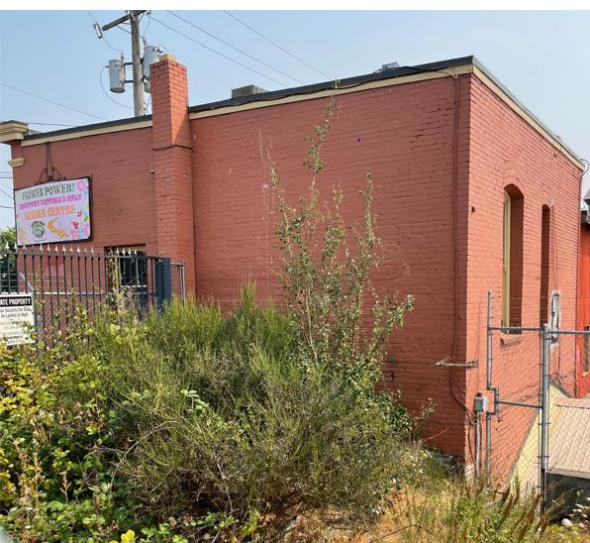
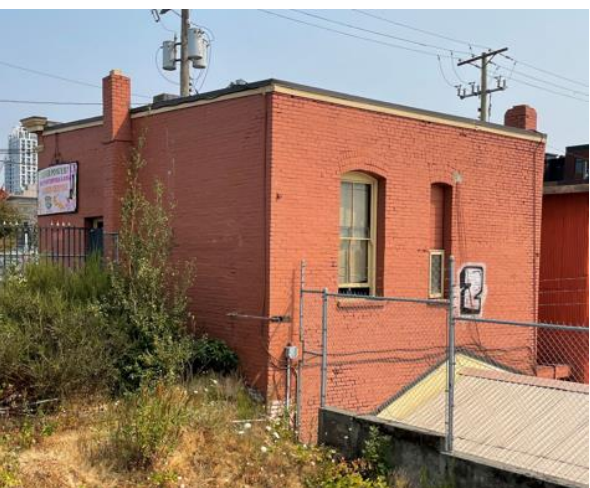
The west wall shows evidence of parging over the brick at some point as well as the west side of the south chimney, as shown in the photograph to the right.

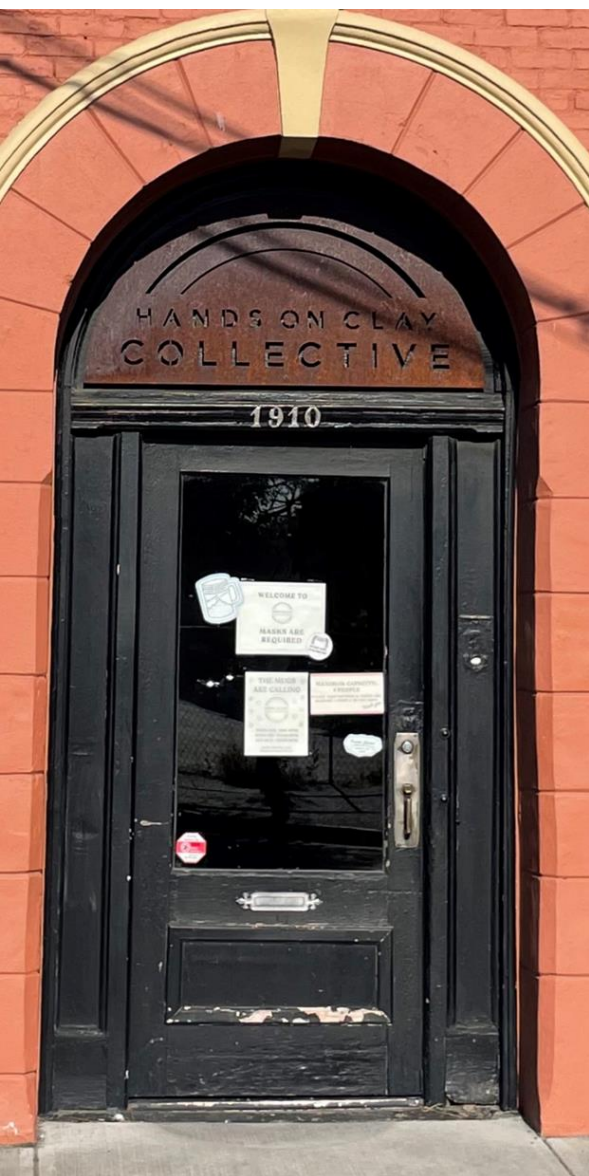
All existing 1892 windows appear to be the original wood windows. The east façade has fixed windows with a fully operable central inward-opening hopper window and appear to be in good condition. The central entrance has a multi-paneled wood and glass door with solid wood side panels, original hardware and mail slot, original metal 1910 address numbers, as well as the single lite shaped transom above the door that is currently obscured by the Hands On Clay Collective metal sign.

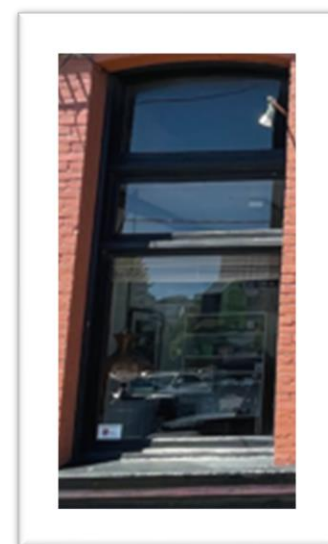
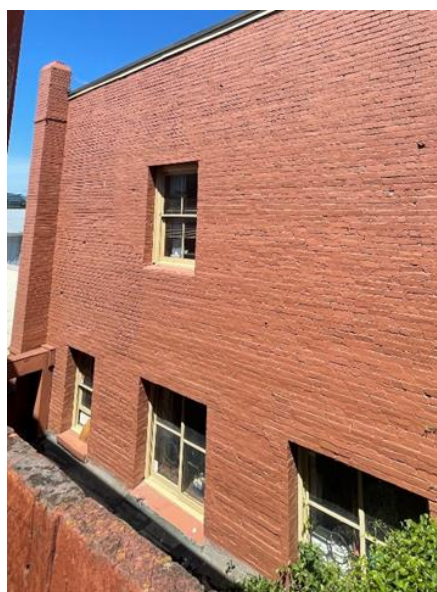
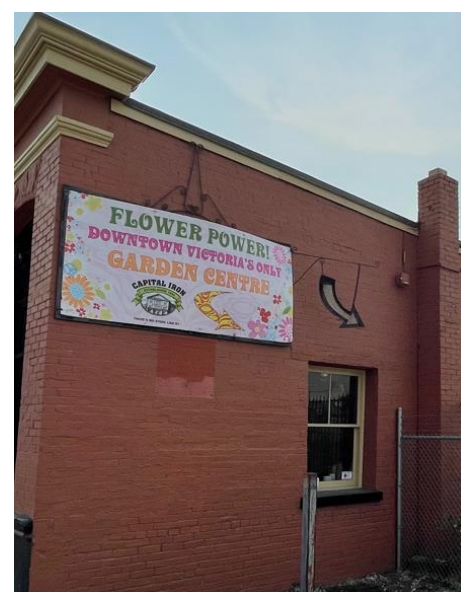
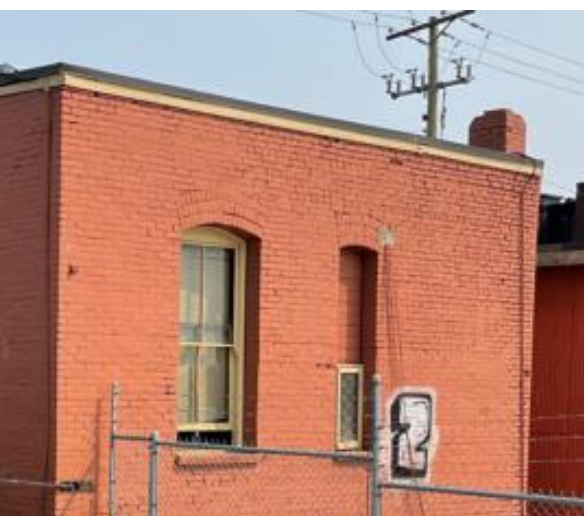
The south elevation has two two-over-two wood sliding windows and two two-over-two single-hung windows all in good condition. The north elevation contains one two-over-one wood window and is in good condition.

The west elevation shown on the left has a single-hung two-over-two window and a second fenestration opening that appears to be filled in. It is visibly unclear as to whether the fill material is wood panelling or brick.
