BRITISH COLUMBIA POWER COMMISSION BUILDING

780 BLANSHARD STREET, VICTORIA, BC

CONSERVATION PLAN
REVISED OCTOBER 2022

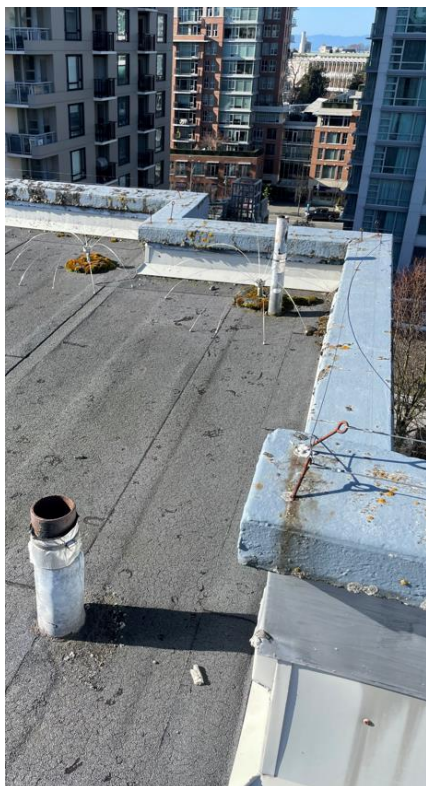
View of raised parapet, bird wire, vent stacks, stained surfaces, crazing, membrane deterioration, nesting materials,

years. The roof system consists of a low-sloped modified bitumen roof system that is presumably installed atop a layer of rigid insulation, supported by wood knee walls atop a concrete roof deck. The presence of a vapour barrier nor the thickness of the insulation could be confirmed as it would have required destructive testing. Roof drainage diverts water to internal roof drains which release to the municipal stormwater system. Roof penetrations consist of plumbing vents, roof drains, and a skylight above the stairwell at the northeast corner. The roof drains are in poor condition but there appears to be no active leaking, although the condition assessment noted evidence of moisture infiltration on ceilings within the building. There are also signs of crazing, membrane deterioration, nesting materials and debris.

| 1 | Preserve the original flat roof assembly beyond the footprint of the tower and rehabilitate for adaptive re-use as part of the rooftop landscaping and site planting for hotel and residential use. Rehabilitation will also address roof drainage, flashing replacement. Repairs may also include limited replacement in-kind, or replacement with an appropriate substitute material, of the roof covering, attachments, and penetrations. |

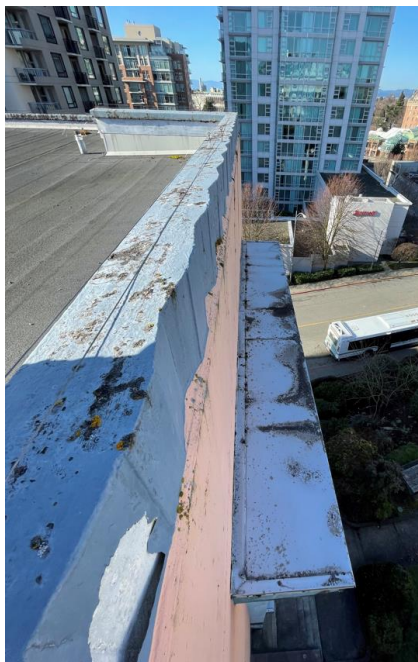
View of fluted parapet defining west entrance, and top of horizontal canopy on parapet. Note droppings, organic growth, and staining.

The raised flat parapet shows signs of deterioration and bird wire needs replacement. Small, unsealed openings on the parapet cap may be from the removal of metal ties used to hold bird wire in place.

| 2 | Preserve the parapet around the perimeter of the roof and the fluted parapets emphasizing the north, south, and west entrances. Repair where necessary following a minimal intervention approach and include replacement in-kind based on documentary or physical evidence to ensure the repair matches the existing as closely as possible, physically, and visually. Consider protecting the flat horizontal surface of the parapet with a water-based waterproof sealant. Metal cap flashing could potentially cause future rust stains on the vertical face of the building. |

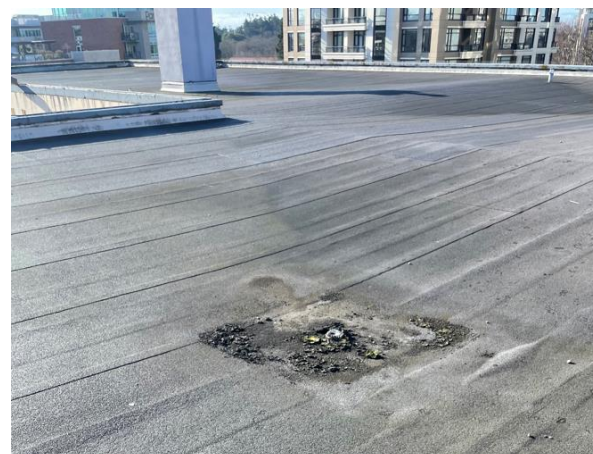
The condition assessment determined the roof assembly is approximately 11,550 ft² and in excess of 25 years old. It is a torched-on roof system and roof drains are in poor condition and need replacement. Some patching has been done but the roof will likely need to be replaced in four to five

View of one of the roof drains in poor condition.

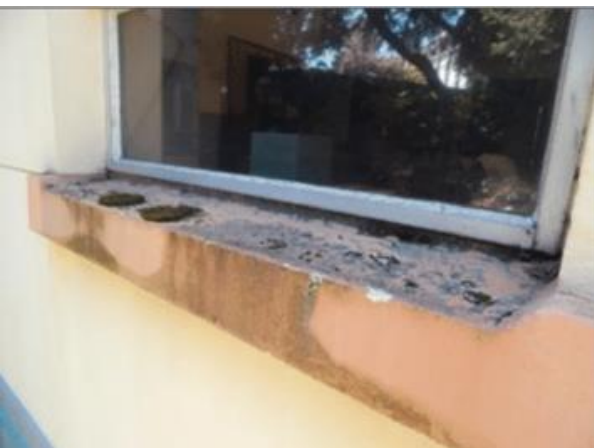
Organic accumulation and stains on window sills.

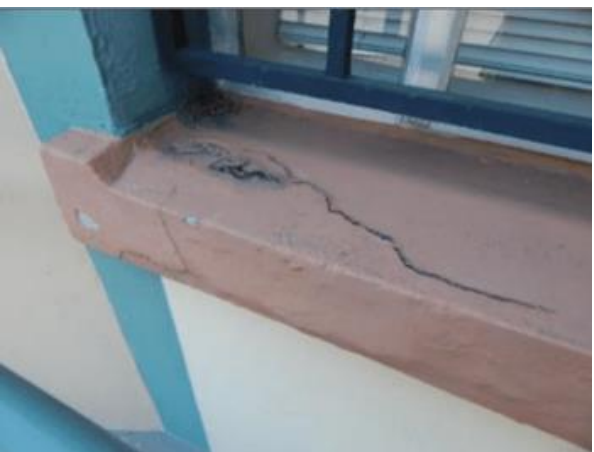
Cracks evident on window sill areas.

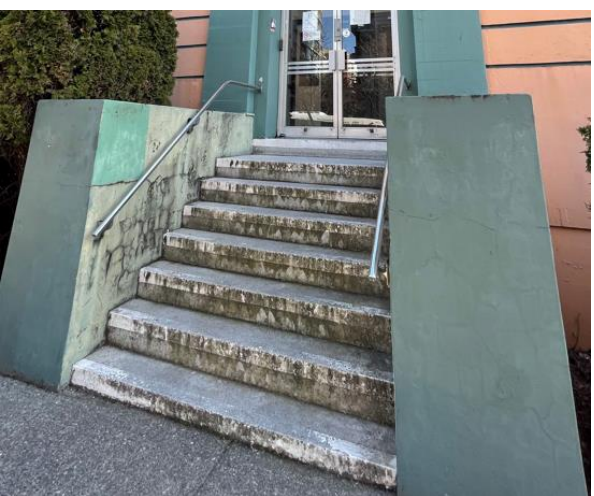
Cracks in closed stair retaining wall, as well as badly stained exterior stairs.

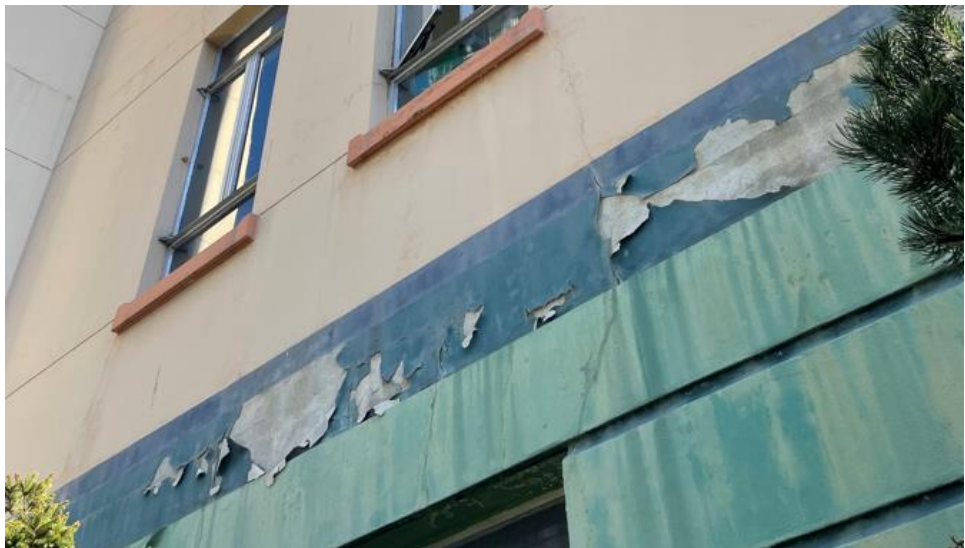
Peeling paint and staining on exterior wall surfaces.

The condition assessment of the exterior walls was limited to ground-level observations. Generally, the exterior wall surfaces are in good condition and there appears to be some localized paint maintenance and repair. However, there is evidence of paint peeling, spalled concrete, cracks in the stucco, and staining. The concrete metal-clad canopies on the west elevation show signs of corrosion, efflorescence, deteriorating and loose concrete, and the soffits above the entrance doors are in disrepair. Paint finishes on the south elevation appear to be peeling and bubbling at various locations. Horizontal cracks in the concrete wall were also evident at various locations and are potentially indicative of significant movement. The northwest corner of the building is experiencing delamination of concrete with areas of exposed reinforcing steel and exterior base ledges and window sills have organic accumulation, stains, and cracking in some areas. Concrete retaining walls are located along north sections of the site and also bookend the south and west entrance stairs.

1	Complete a comprehensive survey of all concrete and metal surfaces to further document noticeable deterioration, areas requiring immediate protection and repair, and areas that may require monitoring.
2	Preserve all surviving original poured concrete and stucco surfaces that are sound or deteriorated but can be repaired, especially the Art Deco geometrics and chevron detailing. Restore elements that may be too deteriorated with in-kind masonry.
3	Protect masonry and stucco surfaces by cleaning and repairing any damaged areas and checking for moisture penetration and infestation. Take corrective action as soon as possible. Clean exterior masonry using the gentlest means possible, such as: water-based methods of soaking; low-pressure water washing;

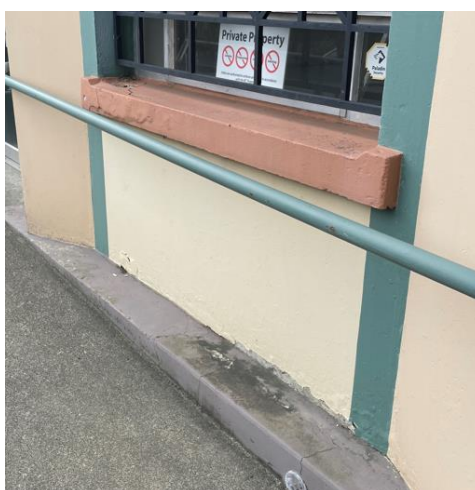
Organic accumulation and stains on base ledge.

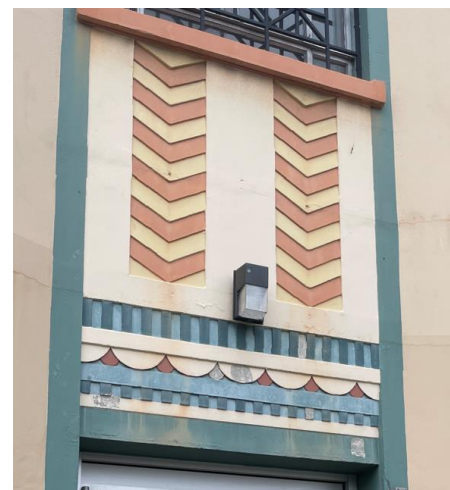
Multi-coloured staining of chevron panels and geometric details.

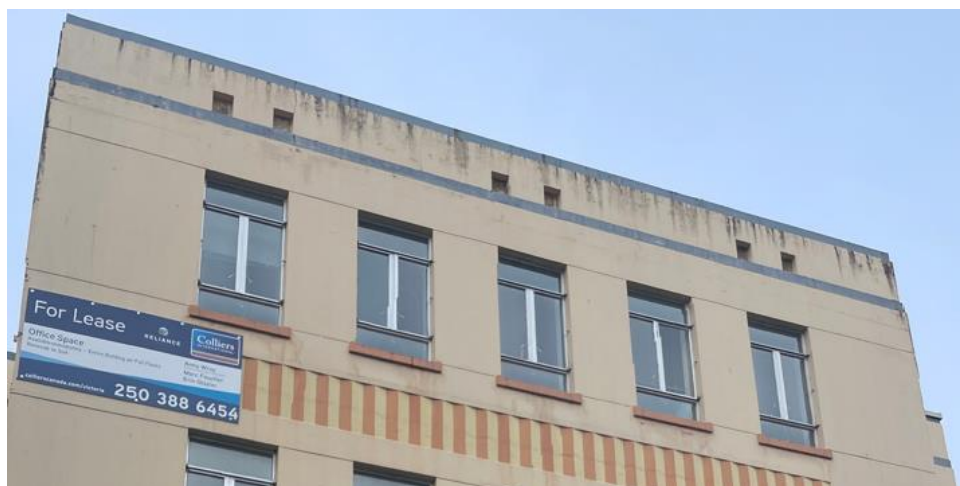
Stained wall surfaces clearly evident from the multi-colour palette applied in 1994.

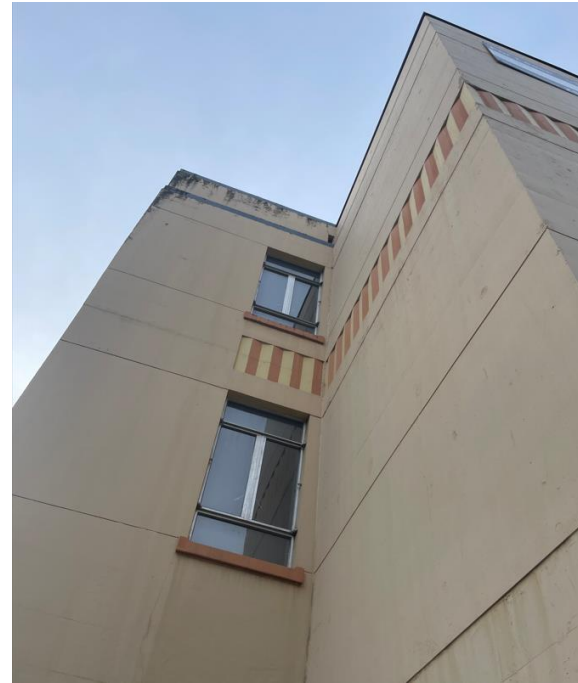
Multi-coloured stains on the exterior wall surface.

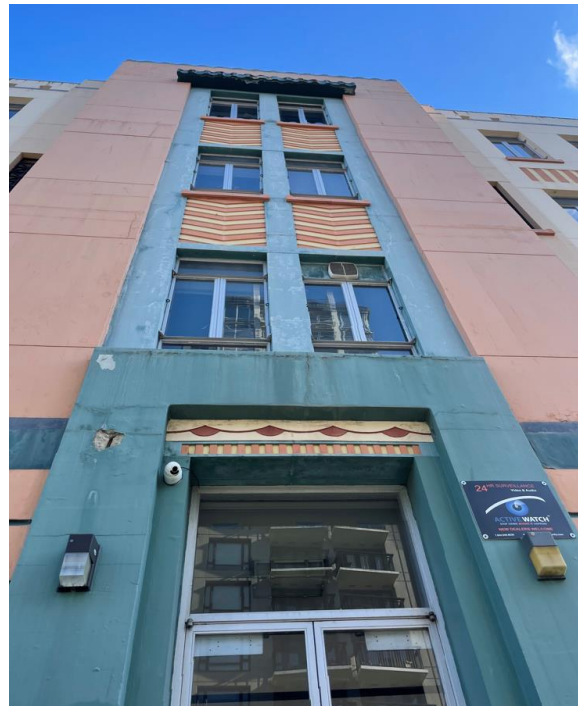
Stained and faded painted exterior wall surfaces.

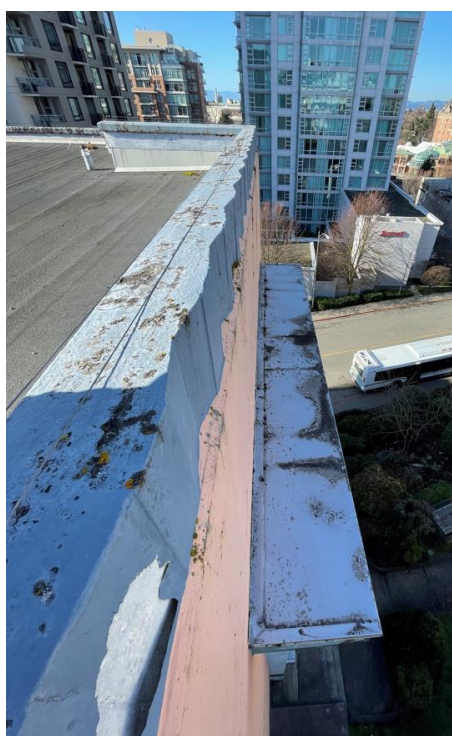
Image shows the upper projecting concrete canopy above the west entrance with metal cladding on the upper horizontal surface. Considerable staining and biological growth are evident.

conservation. Repairs should follow a minimal intervention approach. If canopies require replacement due to safety hazards to the public, they should be replaced with a compatible substitute material that matches as closely as possible to the physical and visual properties of the existing canopies.
12	Repaint the exterior walls and Art Deco detailing by restoring the original colour palette identified and recommended in the Paint Analysis study completed in August 2020.
13	The heritage consultant should always be consulted regarding paint colours to be applied to existing painted surfaces of the historic building.

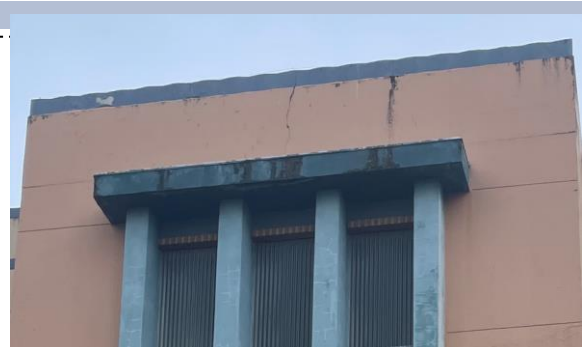
The upper projecting concrete canopy does not appear to be metal-clad along its fascia and overall deterioration of the canopy is not as severe as the lower canopy.

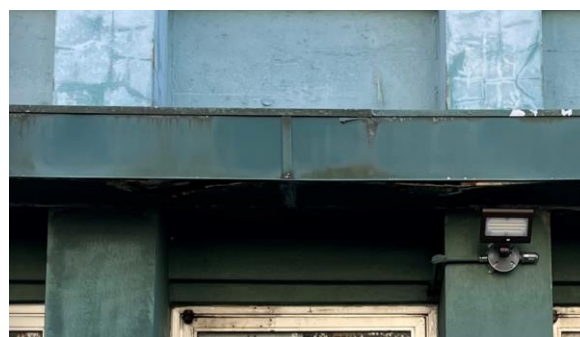
The lower projecting concrete canopy is metal-clad and appears far more deteriorated than the upper canopy, with corrosion, efflorescence on the concrete, loss of cladding material, and water ingress.

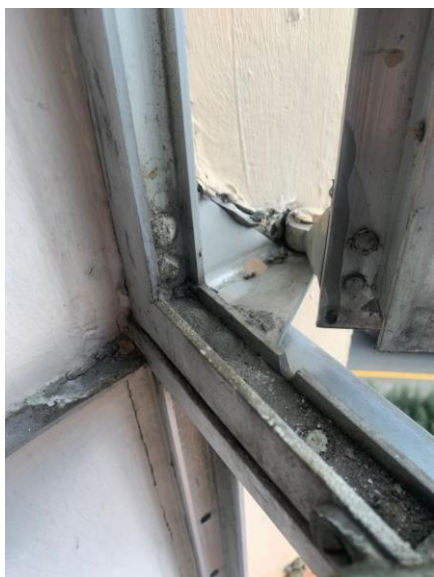
Deterioration of metal sections of the window frame.

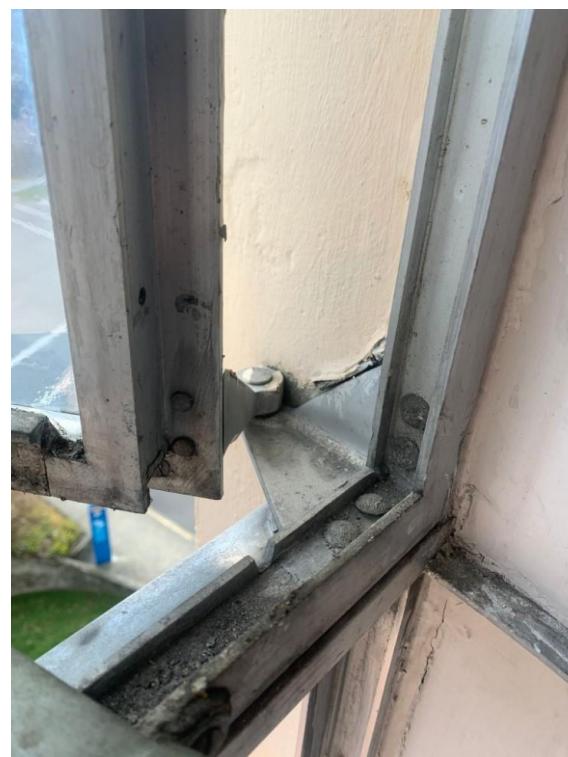
Deterioration of metal sections of the window frame.

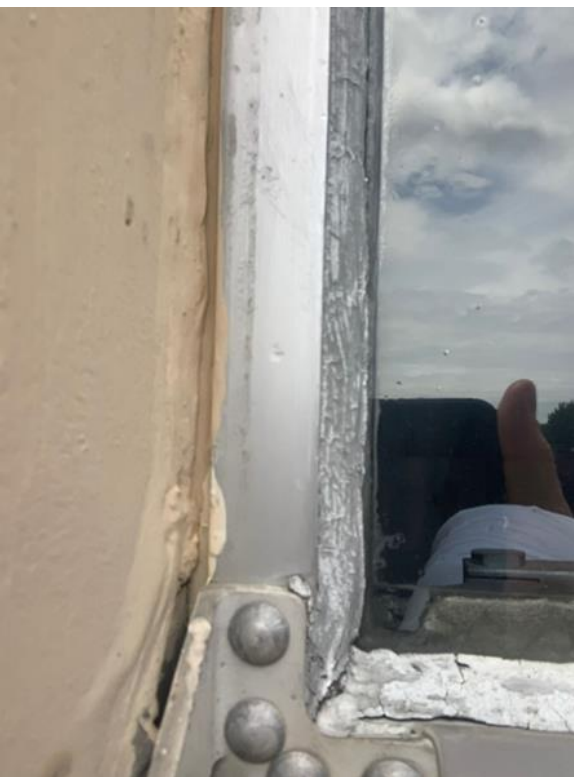
Deterioration of glazing compounds and lack of exterior perimeter caulking.

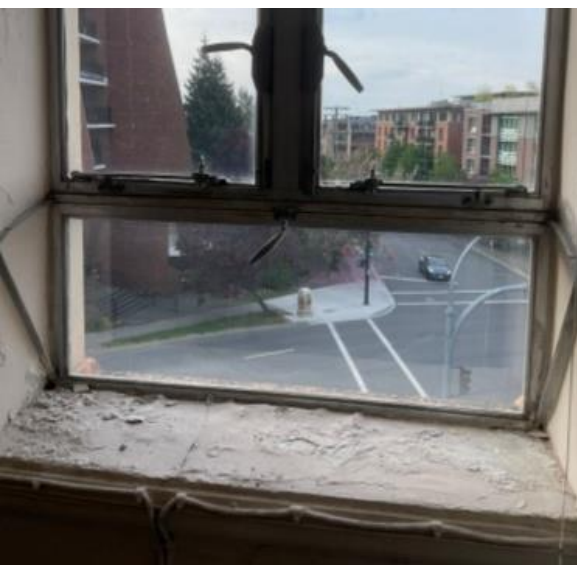
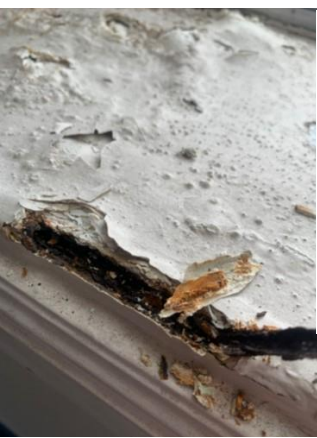
Deteriorated concrete sills, no evidence of waterproofing, and spalling paint a clear sign of moisture.

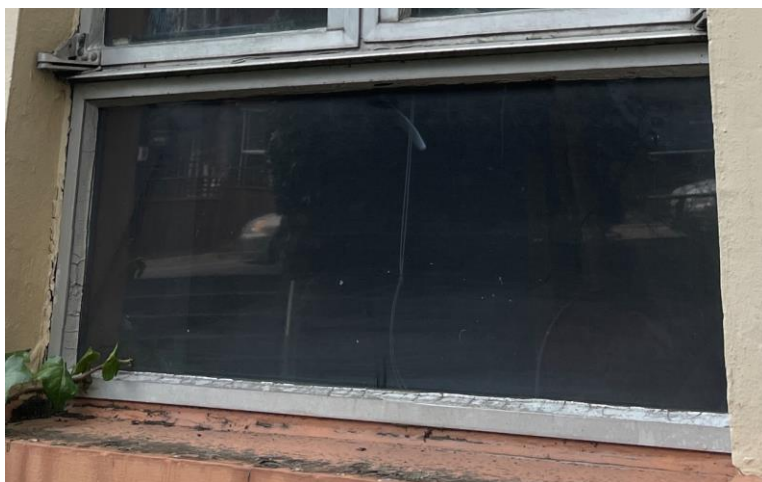
Deterioration of glazing compounds.

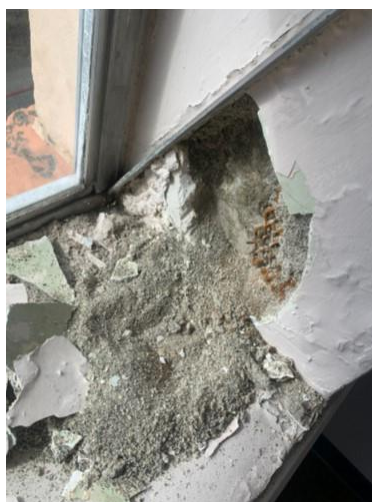
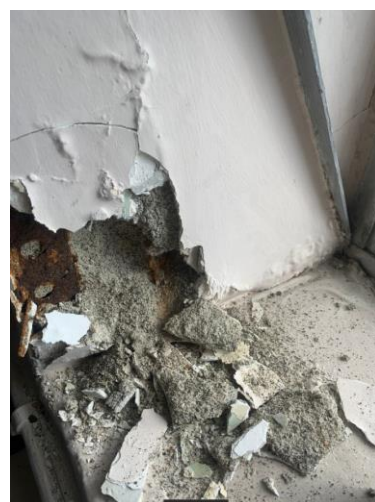
interior concrete surround causing severe rust of steel mesh and extensive deterioration of the concrete and interior sills. It is unknown whether internal corrosion exists within the metal sections, and the as-built condition of the fasteners which secure the concrete wall sections, and

Deterioration of concrete, rusted metal mesh, and lack of a waterproof membrane at the sill and concrete surround.

Rehabilitation appears beyond routine maintenance, repair, and weatherization. Repair of the structural conditions would require the removal of all retained windows to enable the concrete surrounds to be

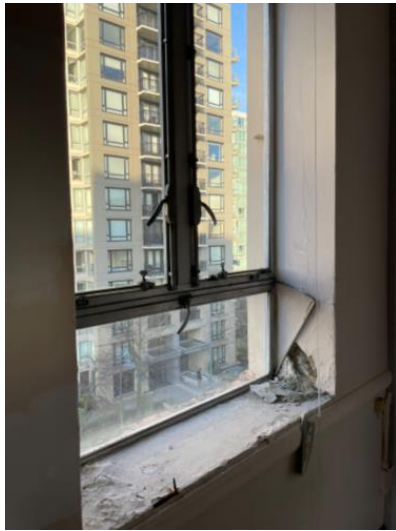
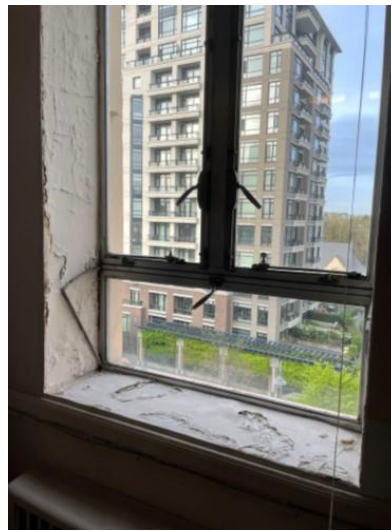
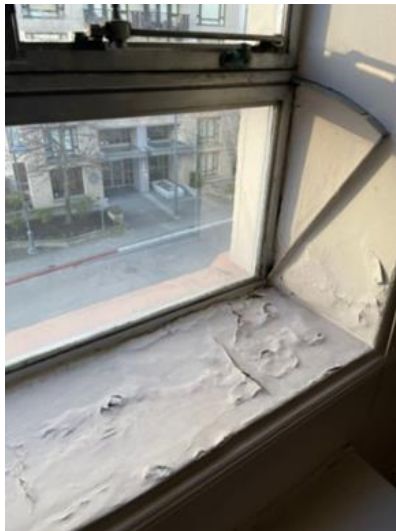
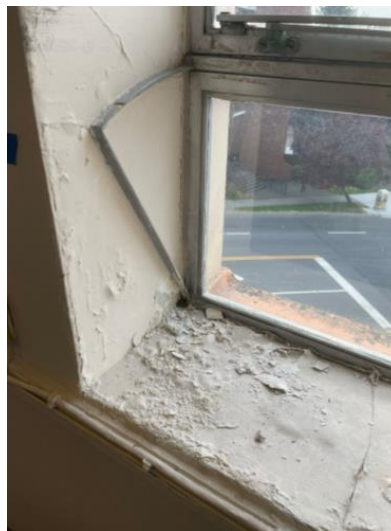
Deterioration of concrete sills and concrete surround throughout the building.

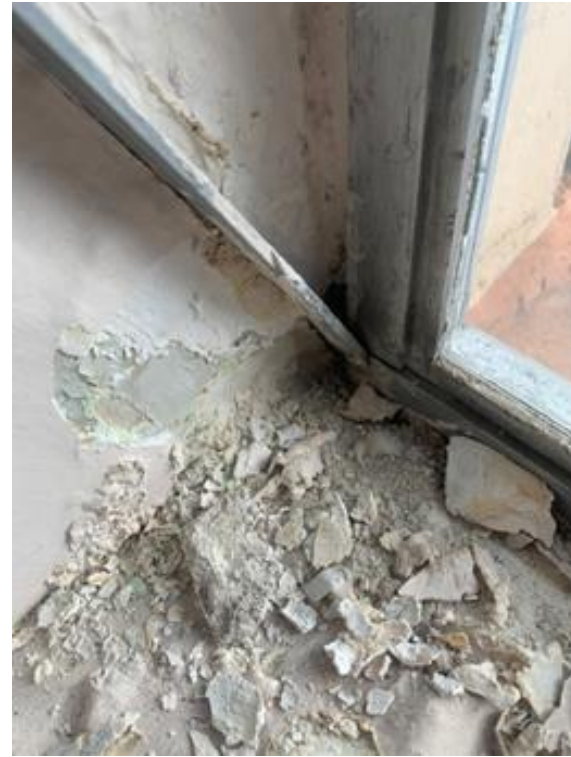
Loss of substrate integrity at several locations.
