# CAIRE & GRANCINI WAREHOUSE

1314 WHARF STREET, BC

## CONSERVATION PLAN

MAY 2017

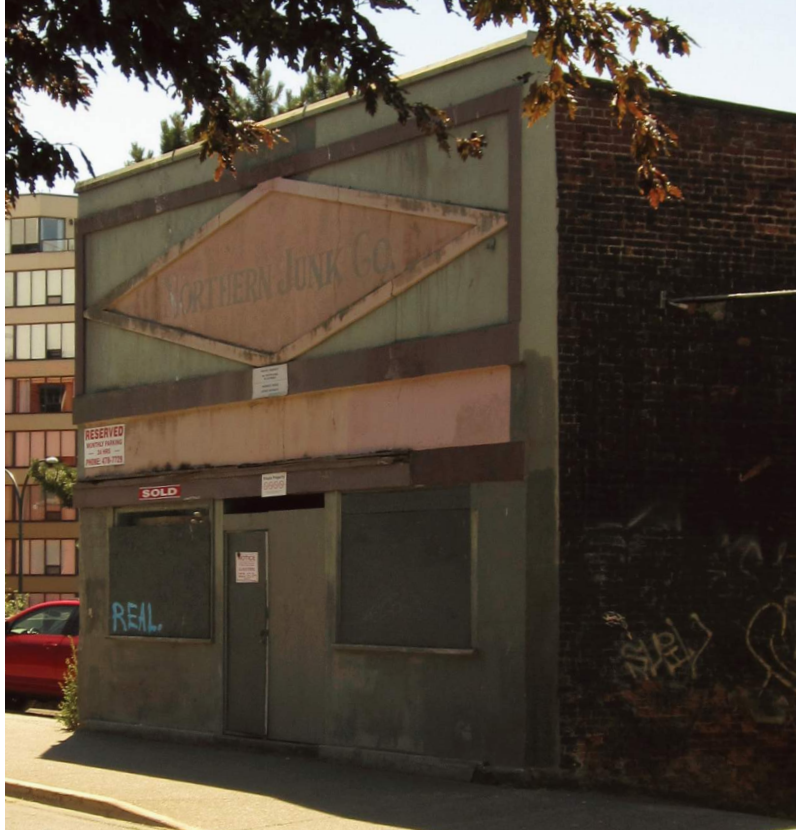
*Current Front Elevation of the Caire and Grancini Warehouse*

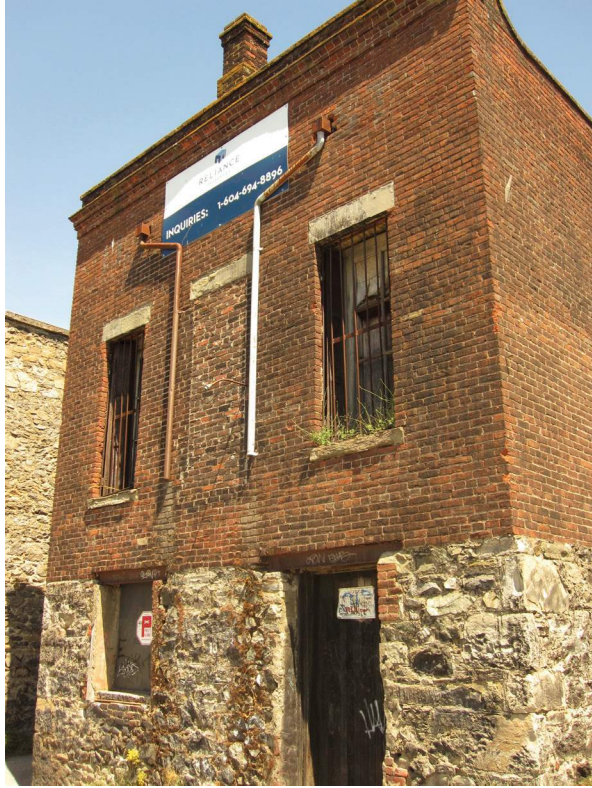
*Current Rear Elevation of the Caire and Grancini Warehouse*

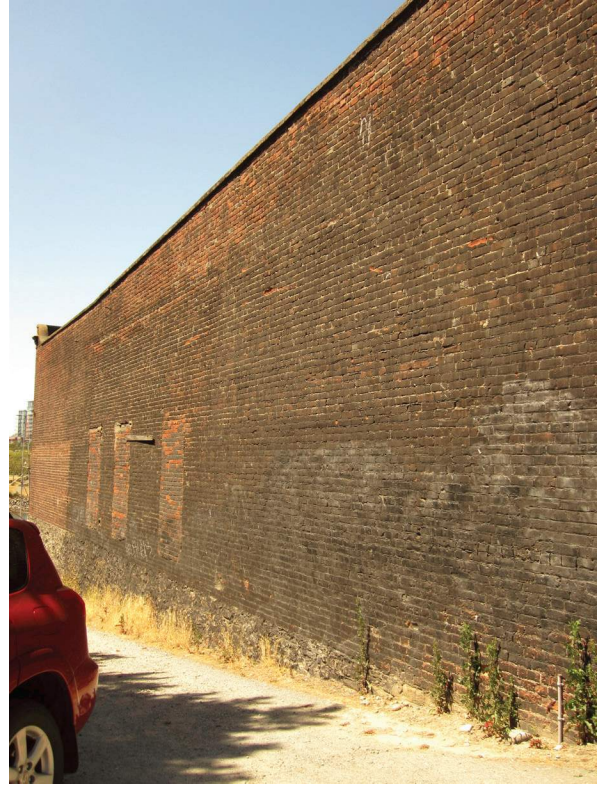
*Current South Elevation of the Caire and Grancini Warehouse*

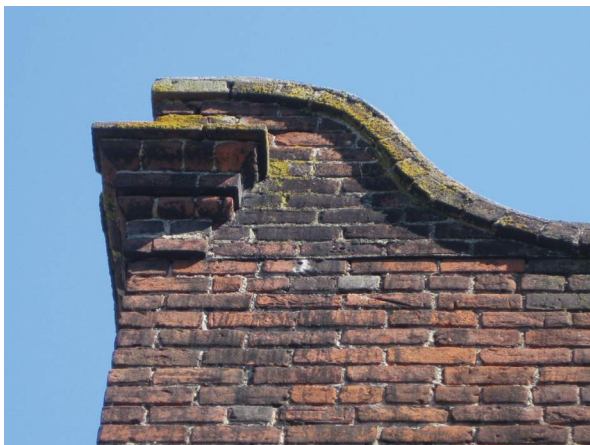
The cap flashings on the Caire & Grancini Warehouse are limited and only visible on the front façade. Other parapet locations, and chimney do not indicate that flashing have been installed to shed water and protect the masonry façade or interface with the roof assembly. The existing cap flashings on the front elevation are oversized, are not sympathetic to the existing building, and are in a significant state of decay and should be replaced. In locations where the flashings are absent, new flashings should be installed to protect the brickwork, prevent water ingress into the interior of the building, and be in compliance with conservation requirements and guidelines.

*Parapet at Rear of Building - No Cap Flashing Noted*

- Evaluate the overall condition of the parapet cap flashing to determine whether more protection is required, or replacement in kind is required.
- Repair or replace deteriorated flashing, as required. Repairs should be physically and visually compatible.
- If new flashings are installed, ensure that the colour is compatible with the overall colour scheme.
