# DICKSON, CAMPBELL & CO. BUILDING

1900 STORE STREET, VICTORIA, BC

## CONSERVATION PLAN

JANUARY 2022

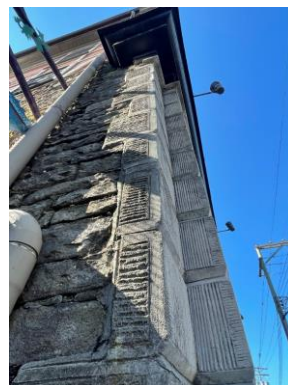
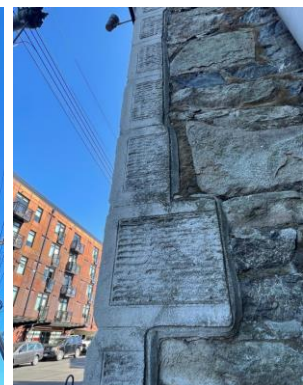
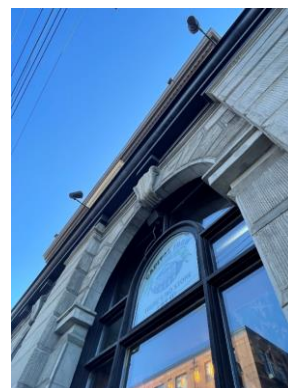
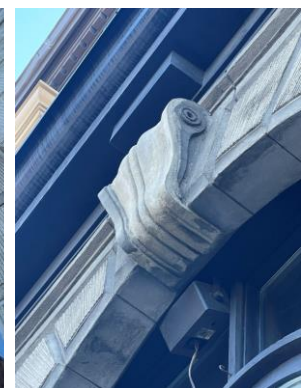
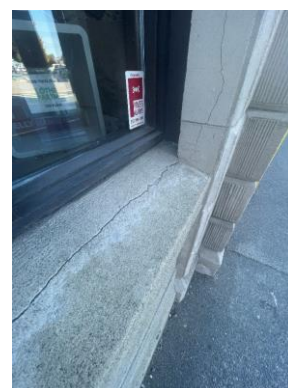
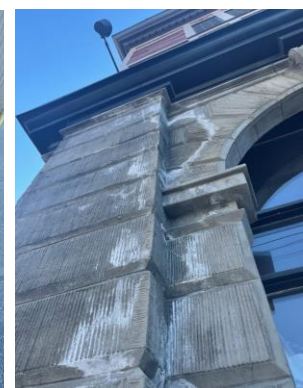
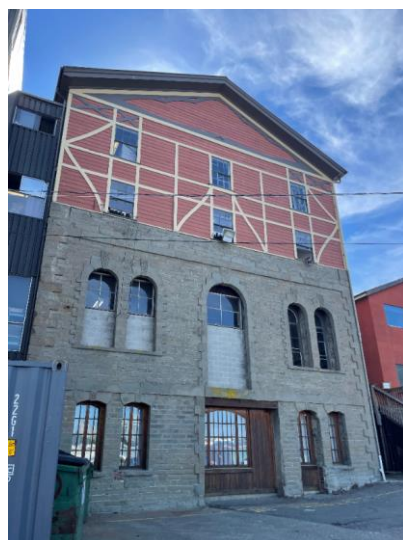
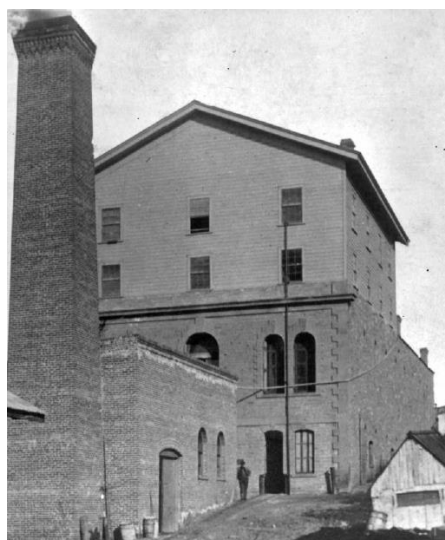
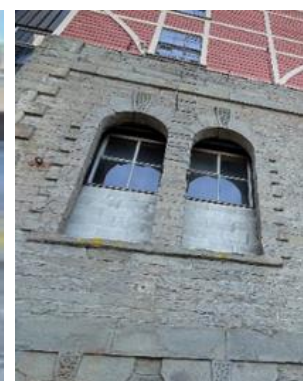
restored street-level façade appears to be parged over what seems to be a mixture of original freestone (sandstone) and replacement sandstone members to replicate the original large, quarried freestone blocks both physically and visually in terms of pattern and scale. Although the restored stonework is tooled with plaster's rake to create a rough surface, it is unclear whether the original stonework would have had the same appearance. The northeast and southeast corners are treated differently from the original in

that the new parged stone blocks are staggered and scratched with a plaster's rake to create a rough surface. The pilasters, arched window and door fenestrations, voussoirs, moulded stringcourse, and keystones restored in 1980 also appear to replicate the original 1862 façade and are well maintained. The parged sills are showing signs of cracking, and hairline cracks and efflorescence are evident throughout the stone façade.

The exterior wall of the first two levels of the west 1862 elevation is also constructed of freestone and is entirely original aside from some windowsill repair using an incompatible material such as brick. Masonry block firewall has also been used to partially infill three windows within the arched fenestration opening on the main floor (street level).

10	All repairs to the exterior walls, including decorative elements, should follow a minimal intervention approach, such as limited replacement in-kind or replacement of an irreparable or missing element using a suitable substitute material. Repairs may also involve the dismantling of a stone or wood-framed wall if a further condition assessment determines that more extensive repair or replacement is required.
11	In the future removal of the 1976 addition, all existing character-defining elements should be preserved, rehabilitated or restored. All character-defining features damaged by the removal should be restored by recreating a missing exterior feature from the 1862 and 1891 period based on physical and documentary evidence.

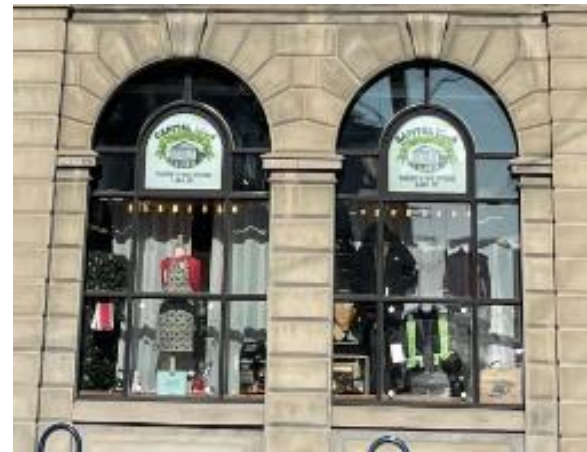
The central window inserts installed during the 1980 restoration of the east façade are similar in design to the original south window on the front façade and appear to be in excellent condition. Although it is recommended these two central windows be removed, they can be retained for potential reuse on the interior of the building.

1	Remove central two windows installed during the 1980 restoration of the east façade and retain for potential reuse within the interior of the building.
2	Remove lower bulkheads and repair stonework. Repair should be limited to replacement in-kind or a compatible substitute material. Ensure the repair matches as close as possible to the physical and visual properties of the existing material.
3	Restore the original single-glazed, double-swing multi-panel wood doors and upper multi-lite shaped transoms to represent the entryways as they appeared in 1862. Ensure door hardware is compatible with the period.

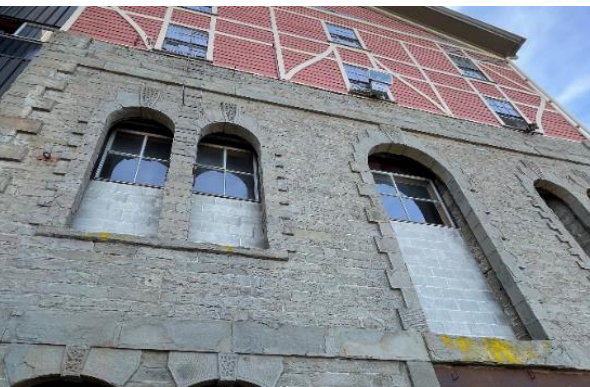
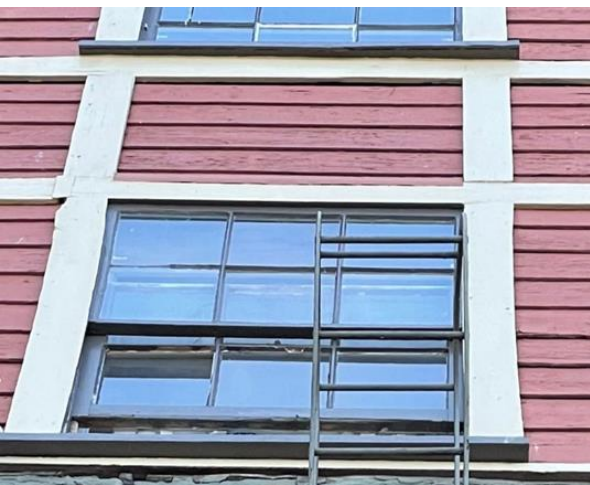
The upper windows, lintels and sills are in fair to good condition due to good maintenance over the years.

Windows in the second west level should be restored to their original 1862 appearance. Evidence is lacking as to the original treatment of the central elongated opening. The upper 1891 west elevation contains original six-over-six single hung windows and are in fair condition with signs of maintenance required on the third and fourth floors.

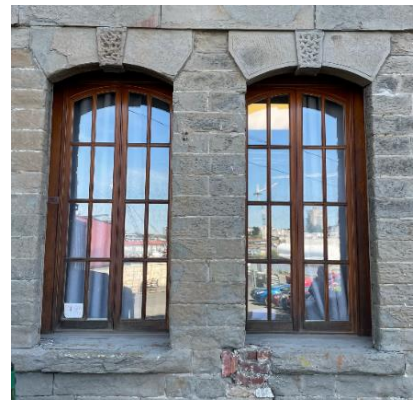
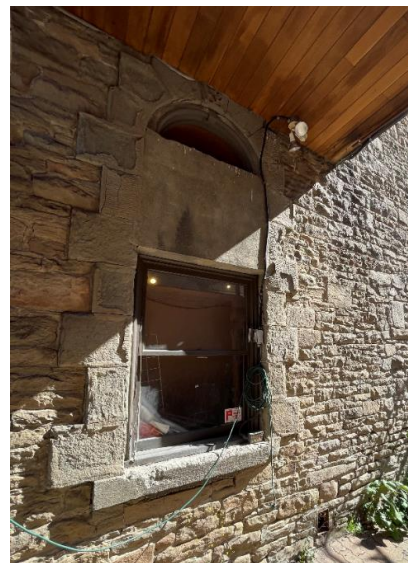
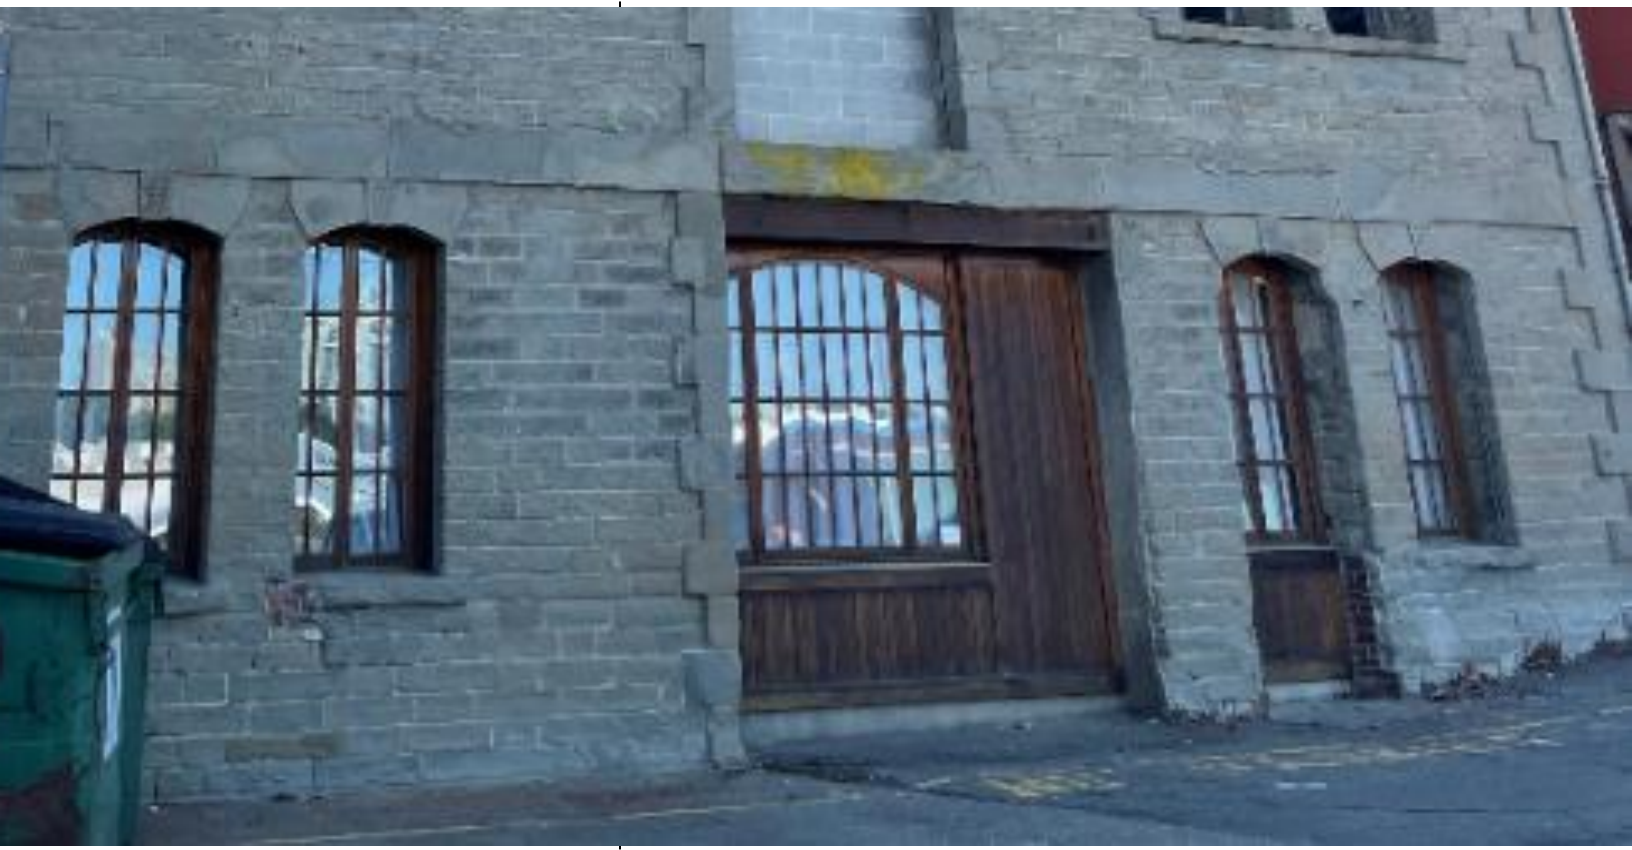
Although the building retains several of its original exterior door openings, the original wood doors no longer exist.
