Re: Wilson Walk Development Proposal

Limited Hazardous Materials Investigation

220 Wilson Street, Victoria, BC

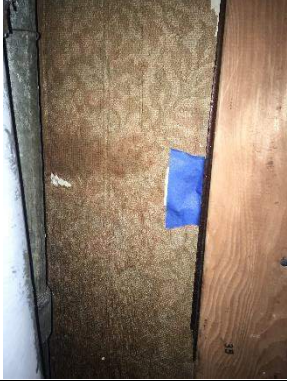
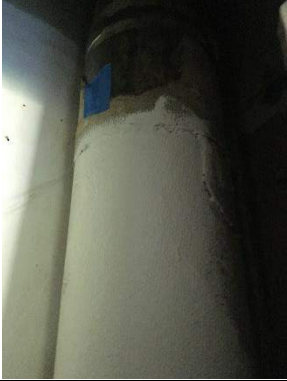
<p>Sample: 18969- 1 Location: Unit 4 - Hall closet - Smooth Description: Plaster Asbestos: None detected</p>	<p>Sample: 18969 – 2 Location: Unit 4 - Hall closet - Duct Description: Duct tape Asbestos: 80% Chrysotile</p>

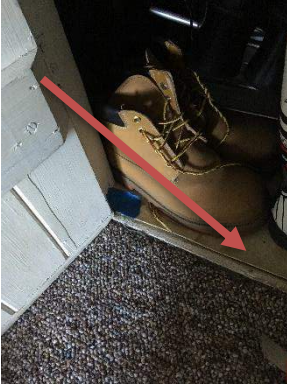
<p>Sample: 18969 - 3 Location: Unit 4 - Hall closet - Top layer Description: Sheet vinyl flooring Asbestos: None detected</p>	<p>Sample: 18969 - 4 Location: Unit 4 - Hall closet - Lower layer Description: Sheet vinyl flooring Asbestos: None detected</p>

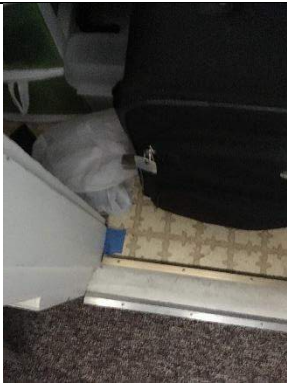
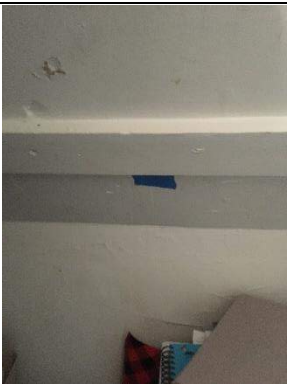
<p>Sample: 18969 - 5 Unit/Location: Unit 4 - Living room closet- 2 layers Description: Sheet vinyl flooring Asbestos: 70% Chrysotile</p>	<p>Sample: 18969 – 6 Unit/Location: Unit 4- Living room closet Description: Plaster Asbestos: None detected</p>

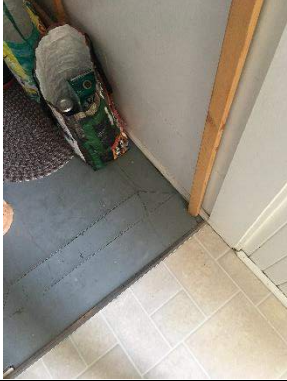
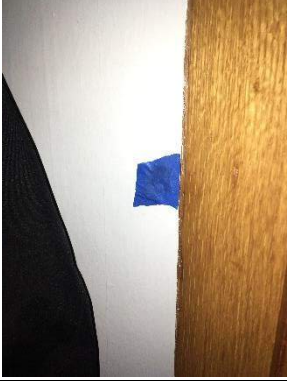
<p>Sample: 18969 - 7 Unit/Location: Unit 4 - Kitchen 2 layers Description: Sheet vinyl flooring Asbestos: None detected</p>	<p>Sample: 18969 – 8 Unit/Location: Unit 4 - Bedroom closet - Smooth Description: Plaster Asbestos: None detected</p>

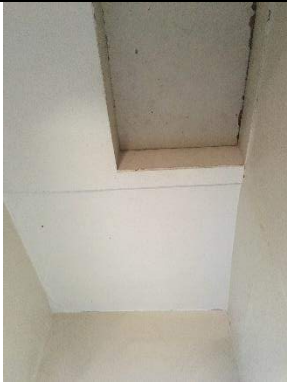
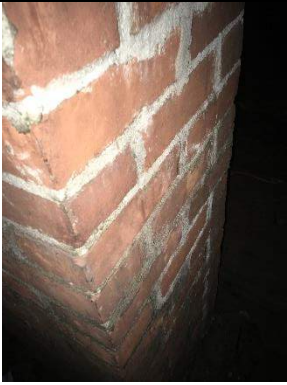
<p>Sample: 18969 - 9 Unit/Location: Unit 4 - Hall ceiling and partition wall Description: Textured ceiling Asbestos: None detected</p>	<p>Sample: 18969 – 10 Unit/Location: Attic - Centre chimney Description: Mortar Asbestos: None detected</p>

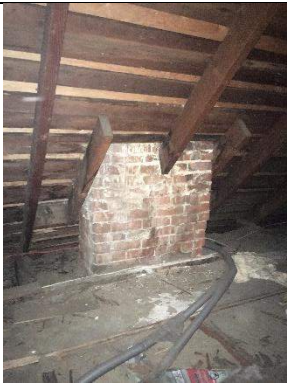
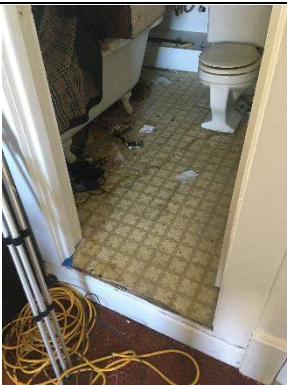
<p>Sample: 18969 - 11 Unit/Location: Attic - South chimney Description: Mortar Asbestos: None detected</p>	<p>Sample: 18969 – 12 Unit/Location: Unit 3 - Bathroom Description: Sheet vinyl flooring Asbestos: 70% Chrysotile</p>

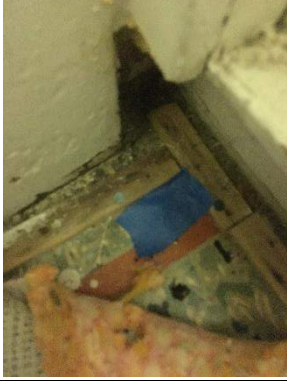
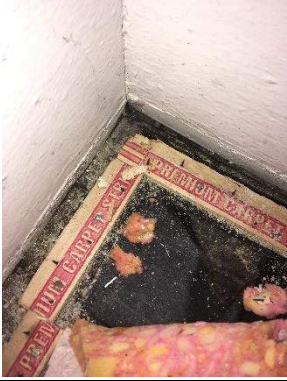
<p>Sample: 18969 - 25 Unit/Location: Unit 2 - Entry under carpet Description: Sheet vinyl flooring Asbestos: None detected</p>	<p>Sample: 18969 – 26 Unit/Location: Unit 2 - Bedroom under carpet Description: Tar paper Asbestos: None detected</p>

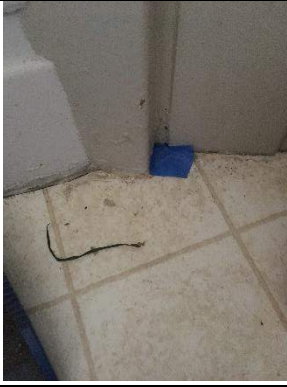
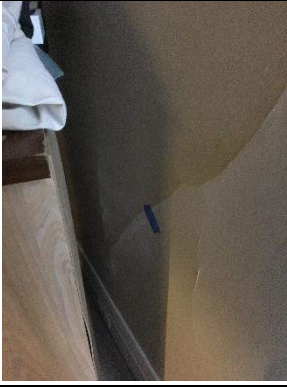
<p>Sample: 18969 - 27 Unit/Location: Unit 2 - Kitchen Description: Sheet vinyl flooring Asbestos: None detected</p>	<p>Sample: 18969 – 28 Unit/Location: Unit 2 - Bedroom wall Description: Plaster Asbestos: None detected</p>

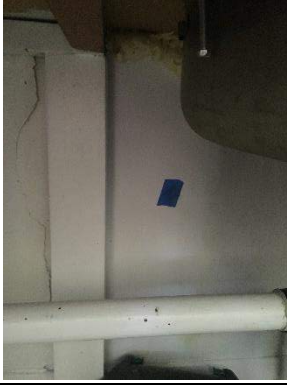
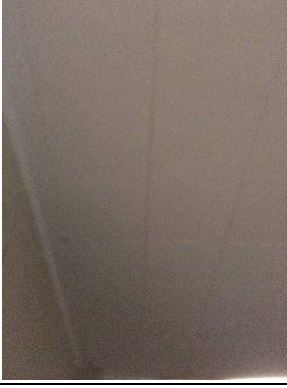
<p>Sample: 18969 - 29 Unit/Location: Unit 2 - Kitchen wall Description: Plaster Asbestos: None detected</p>	<p>Sample: 18969 – 30 Unit/Location: Unit 2 - Bedroom/kitchen ceiling Description: Ceiling tile Asbestos: None detected</p>

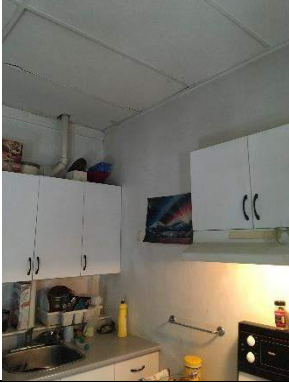
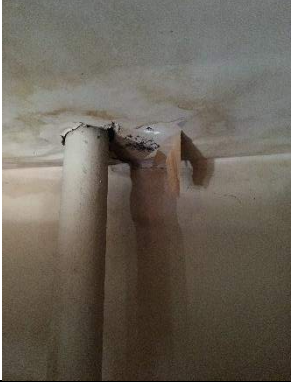
<p>Sample: 18969 - 31 Unit/Location: Unit 1 - Kitchen Description: Ceiling tile Asbestos: None detected</p>	<p>Sample: 18969 - 32 Unit/Location: Unit 1 - Kitchen ceiling above ceiling tile Description: Plaster Asbestos: None detected</p>

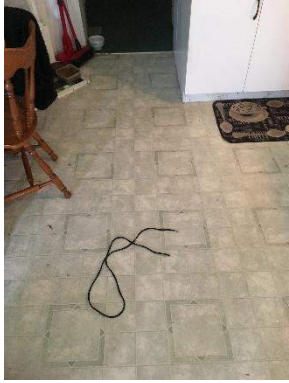
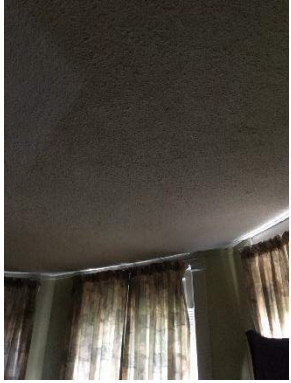
<p>Sample: 18969 - 33 Unit/Location: Unit 1 - Kitchen multiple layers Description: Sheet vinyl flooring Asbestos: 70% Chrysotile</p>	<p>Sample: 18969 - 34 Unit/Location: Unit 1 - Bedroom ceiling Description: Textured ceiling Asbestos: None detected</p>

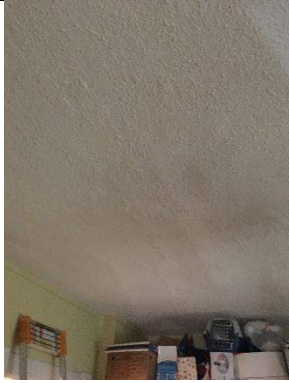
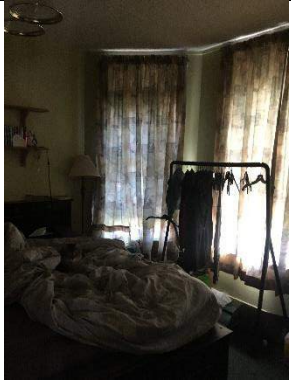
<p>Sample: 18969 - 35 Unit/Location: Unit 1 - Bedroom ceiling Description: Textured ceiling Asbestos: None detected</p>	<p>Sample: 18969 - 36 Unit/Location: Unit 1 - Bedroom wall Description: Plaster Asbestos: None detected</p>

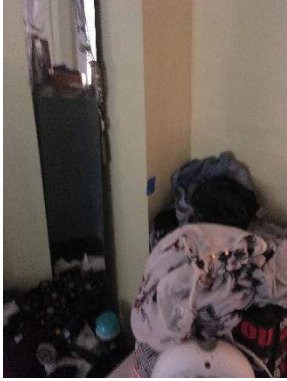
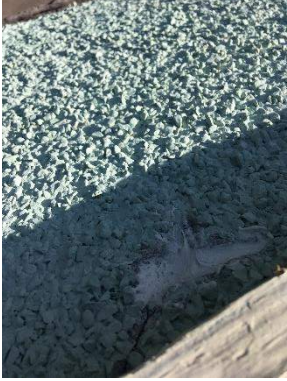
<p>Sample: 18969 - 37 Unit/Location: Unit 1 - Bedroom wall Description: Drywall joint compound Asbestos: None detected</p>	<p>Sample: 18969 – 38 Unit/Location: Exterior - Dormer Unit 3 Description: Stucco Asbestos: None detected</p>

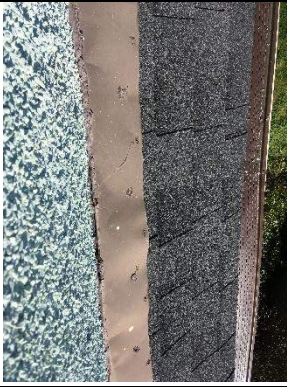
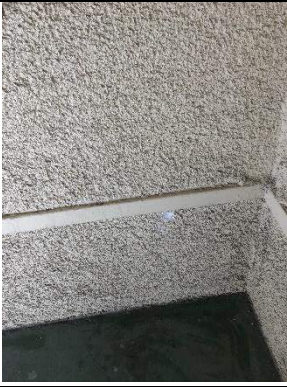
<p>Sample: 18969 - 39 Unit/Location: Roof flashing - Brown Description: Mastic Asbestos: None detected</p>	<p>Sample: 18969 – 40 Unit/Location: Covered front entry Description: Stucco Asbestos: None detected</p>

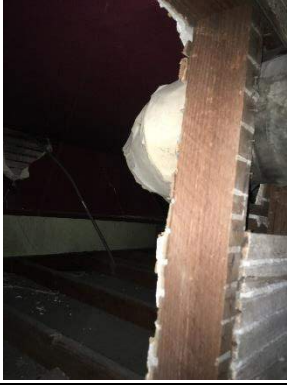
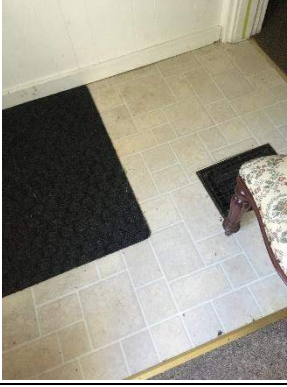
<p>Sample: 18969 - 41 Unit/Location: Unit 5 - Ceiling cavity in closet Description: Plaster Asbestos: None detected</p>	<p>Sample: 18969 – 42 Unit/Location: Unit 5 - Entry Description: Sheet vinyl flooring Asbestos: None detected</p>

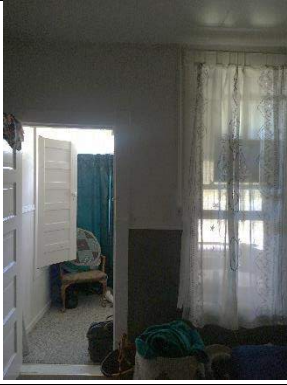
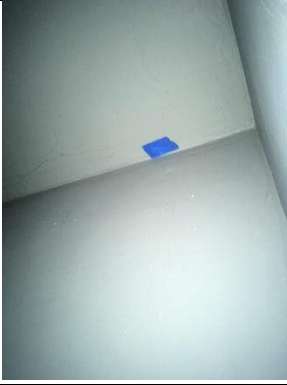
<p>Sample: 18969 - 47 Unit/Location: Living room walls - Textured Description: Plaster Asbestos: None detected</p>	<p>Sample: 18969 - 48 Unit/Location: Living room closet ceiling Description: Drywall joint compound Asbestos: None detected</p>

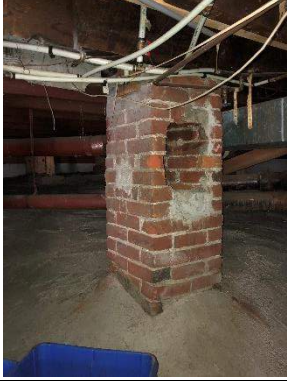
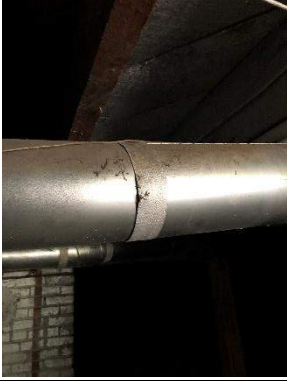
<p>Sample: 18969 - 49 Unit/Location: Crawl space - Chimney Description: Mortar Asbestos: None detected</p>	<p>Sample: 18969 – 50 Unit/Location: Crawl space - Ducting Description: Duct tape Asbestos: 80% Chrysotile</p>

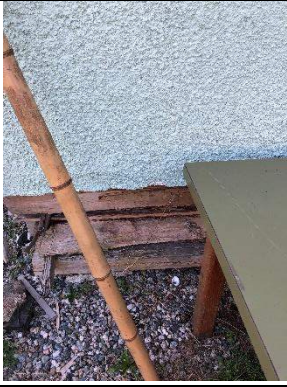
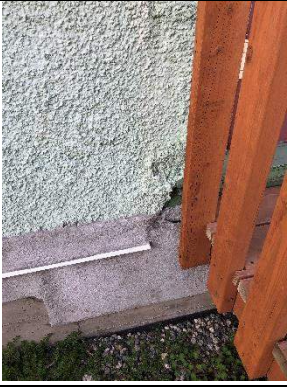
<p>Sample: 18969 - 51 Unit/Location: Exterior - Back Description: Stucco Asbestos: None detected</p>	<p>Sample: 18969 – 52 Unit/Location: Exterior - NE side Description: Stucco Asbestos: None detected</p>

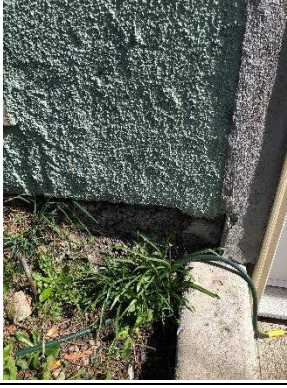
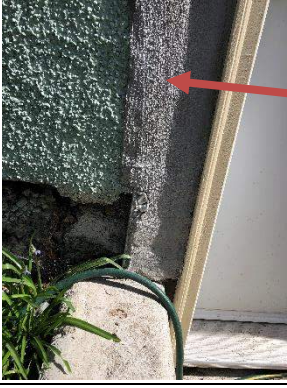
<p>Sample: 18969 - 53 Unit/Location: Exterior - SW side Description: Stucco Asbestos: None detected</p>	<p>Sample: 18969 – 54 Unit/Location: Exterior - Lower entry over stucco Description: Parging Asbestos: None detected</p>

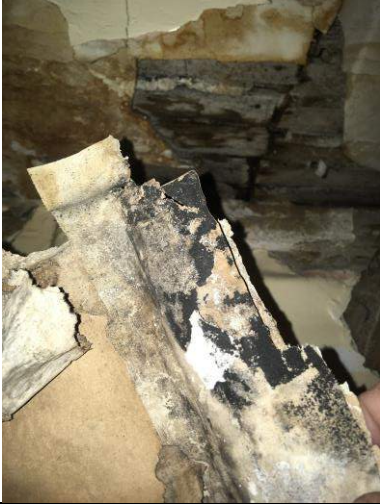
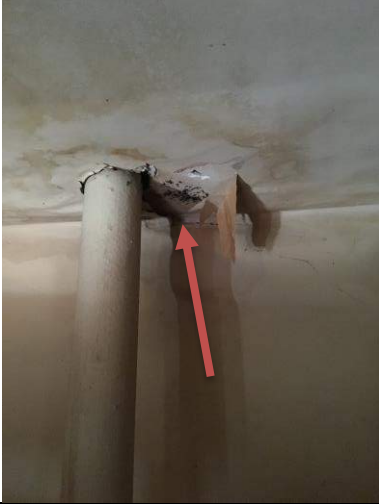
Fungal contamination was identified in Unit 3 and Unit 1. Additional unidentified fungal contamination may be present within other inaccessible/concealed areas throughout the building. It is recommended that a number of steps are followed to prevent workers and occupants from exposure to elevated concentrations of fungal spores and to remediate the identified fungal contamination in Units 3 and 1 at the above referenced site:

<p>Sample: 18969 – M1</p> <p>Unit/Location: Unit 3 – Bathroom above ceiling tiles</p> <p>Description: Fungal growth on plaster and wallpaper</p> <p>Fungal: High levels of <i>Stachybotrys</i> and moderate levels of unidentified brown fungi</p>	<p>Sample: 18969 – M2</p> <p>Unit/Location: Unit 1 – Kitchen above ceiling tiles</p> <p>Description: Fungal growth on plaster and wallpaper</p> <p>Fungal: High levels of <i>Aspergillus</i>/<i>Penicillium</i> growth</p>

- 3) Wood framing or sheathing that is rotten or in poor condition should be removed and disposed of. Any fungal stained wood framing or sheathing that is still in good condition can be scrubbed with an abrasive pad or sanded in conjunction with HEPA vacuuming;
- 4) following the completion of remediation work, all exposed surfaces within the work area should be thoroughly cleaned with a diluted hydrogen peroxide and cleaned with a HEPA filter equipped vacuum;
- 5) The above remediation work should be conducted by an experienced and reputable remediation contractor following appropriate work procedures. These procedures should include worker use of personal protective equipment such as PAPR respirators equipped with P100/chemical cartridges, disposable coveralls with integral head and foot coverings, and work gloves.
