PROPOSED RESIDENTIAL DEVELOPMENT

1908 FOUL BAY ROAD DEVELOPMENT PERMIT APPLICATION 2025-04-28 VICTORIA, B.C.

83 MULTI FAMILY UNITS SITE ADRESS: 1908 FOUL BAY ROAD LEGAL: LOT 1, SECTION 76, VICTORIA DISTRICTPLAN 26773

1908 FOUL BAY Multi-Unit Residential

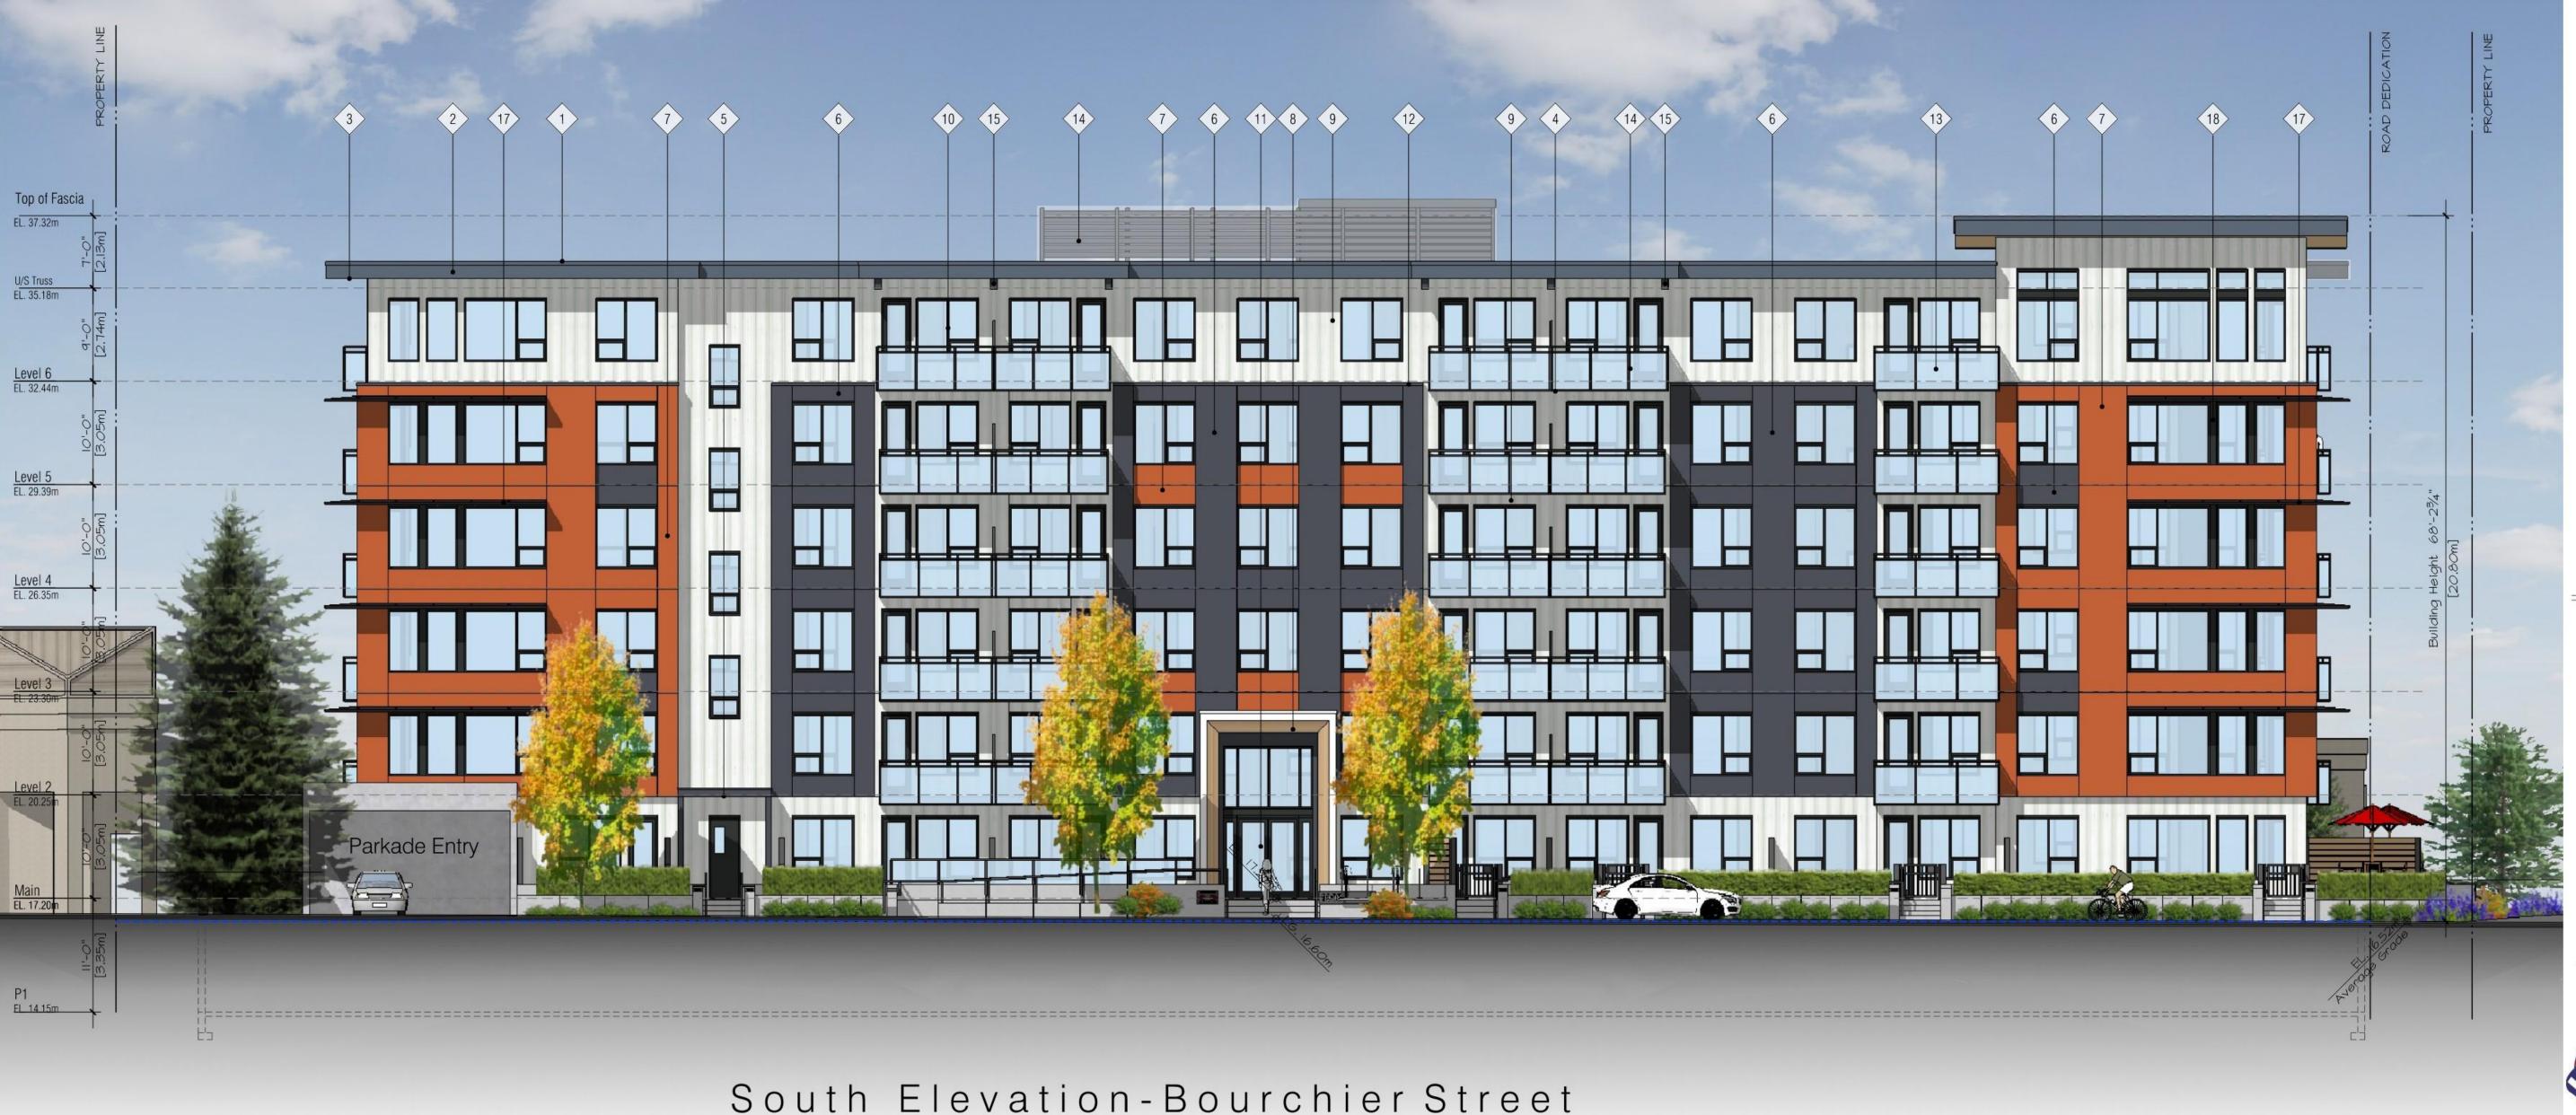
Elevation

- 1 Roofing
 2- PLY SBS Roofing, Light Grey
- Fibre Cement B.C. HC-154 - Hale Navy
- Soffit: Feature Wood
 Fibre Cement, Wood-like Colour
- Soffit: Typical Light Grey Fibre Cement B.M. HC-169 - Conventry Grey

- Soffit: Typical Dark Grey Fibre Cement B.M. 2128-20 - Abyss
- Panels: Dark Grey Fibre Cement Panels B.M. 2128-20 - Abyss
- Panels: Rust Red Fibre Cement Panels B.M. 2175-30 - Rust

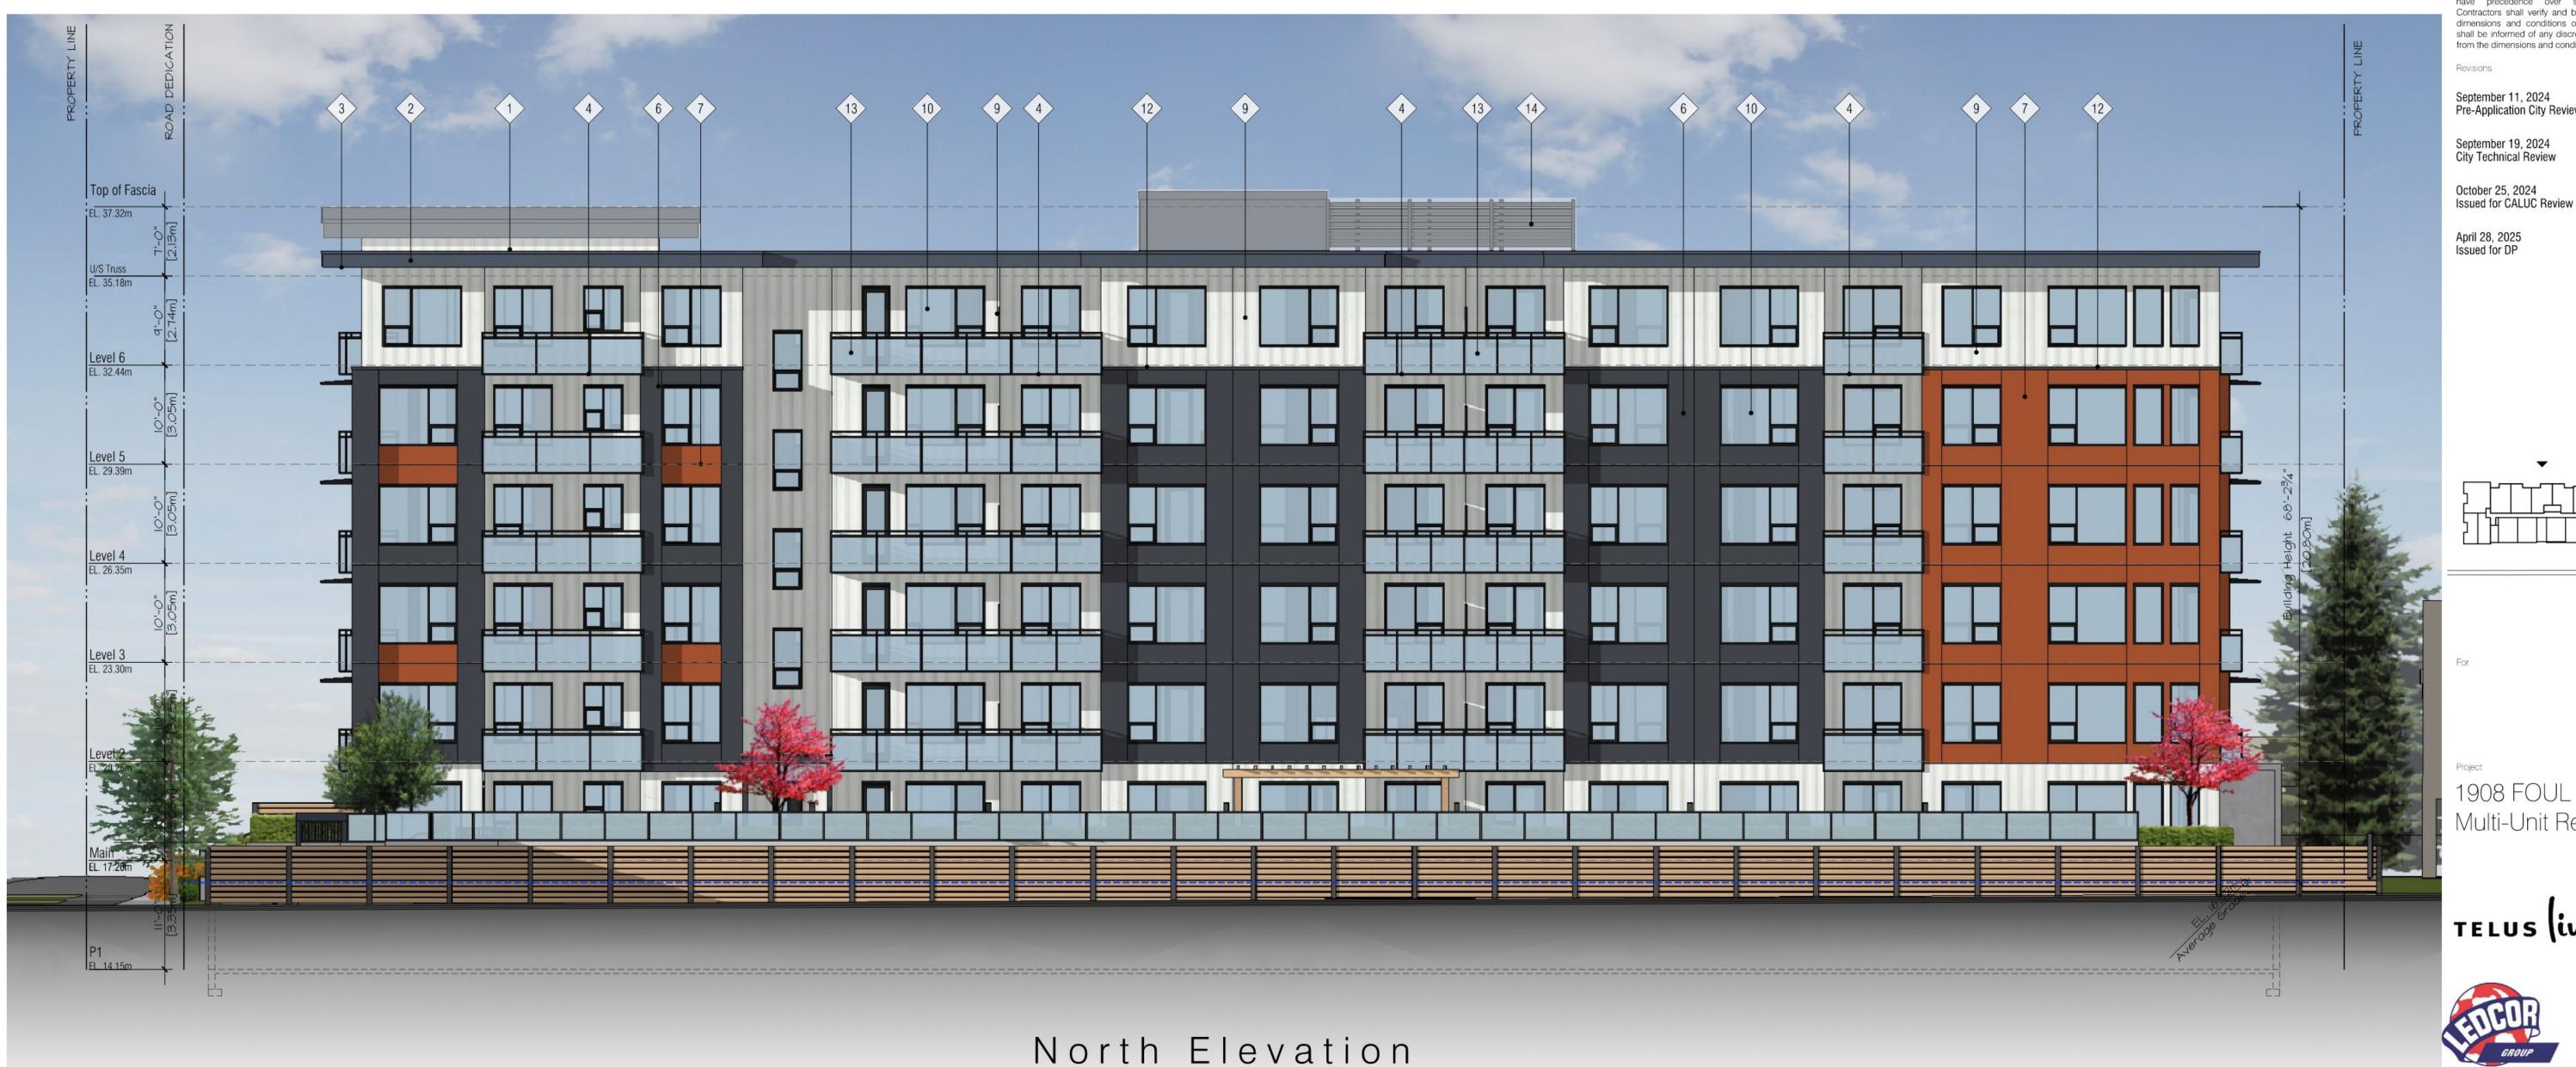
Elevations

- 1 Roofing
 2- PLY SBS Roofing, Light Grey
- Pascia: Dark
 Fibre Cement
 B.C. HC-154 Hale Navy
- 3 Soffit: Feature Wood
 Fibre Cement, Wood-like Colour
- Soffit: Typical Light Grey
 Fibre Cement
 B.M. HC-169 Conventry Grey
- Soffit: Typical Dark Grey Fibre Cement B.M. 2128-20 - Abyss
- 6 Panels: Dark Grey
 Fibre Cement Panels
 B.M. 2128-20 Abyss
- Panels: Rust Red
 Fibre Cement Panels
 B.M. 2175-30 Rust
- 8 Panels: Wooden Look
 Fibre Cement Panels Wood-Like
- 9 Panels: Off White
 Fibre Cement Vertical Board & Batten
 B.M. OC-17 White Dove
- Vinyl Windows: Vinyl Dark
 Vinyl Window Frames, Charcoal Colour
- Windows: Curtain Wall
 Aluminum Frames, Charcoal Colour
- Metal Flashing: Feature

Match Colour to Adjacent Material
- Privacy Screens & Guards
 Aluminum Frame & Glass Panel Guards and
 Privacy Screens, Charcoal Colour
- Metal Guardrails Charcoal Grey
 Aluminum Picket Guards, Charcoal Colour
- Fibre Cement Cladded
 B.M. 2128-20 Abyss
- Architectural Concrete
 Exposed Concrete (Painted At Parts of the Building Envelope)
- Sunshades Charcoal Grey
 Aluminum Frame, Charcoal Colour
- Trims:Dark Grey
 B.M. HC-178 Charcoal Slate

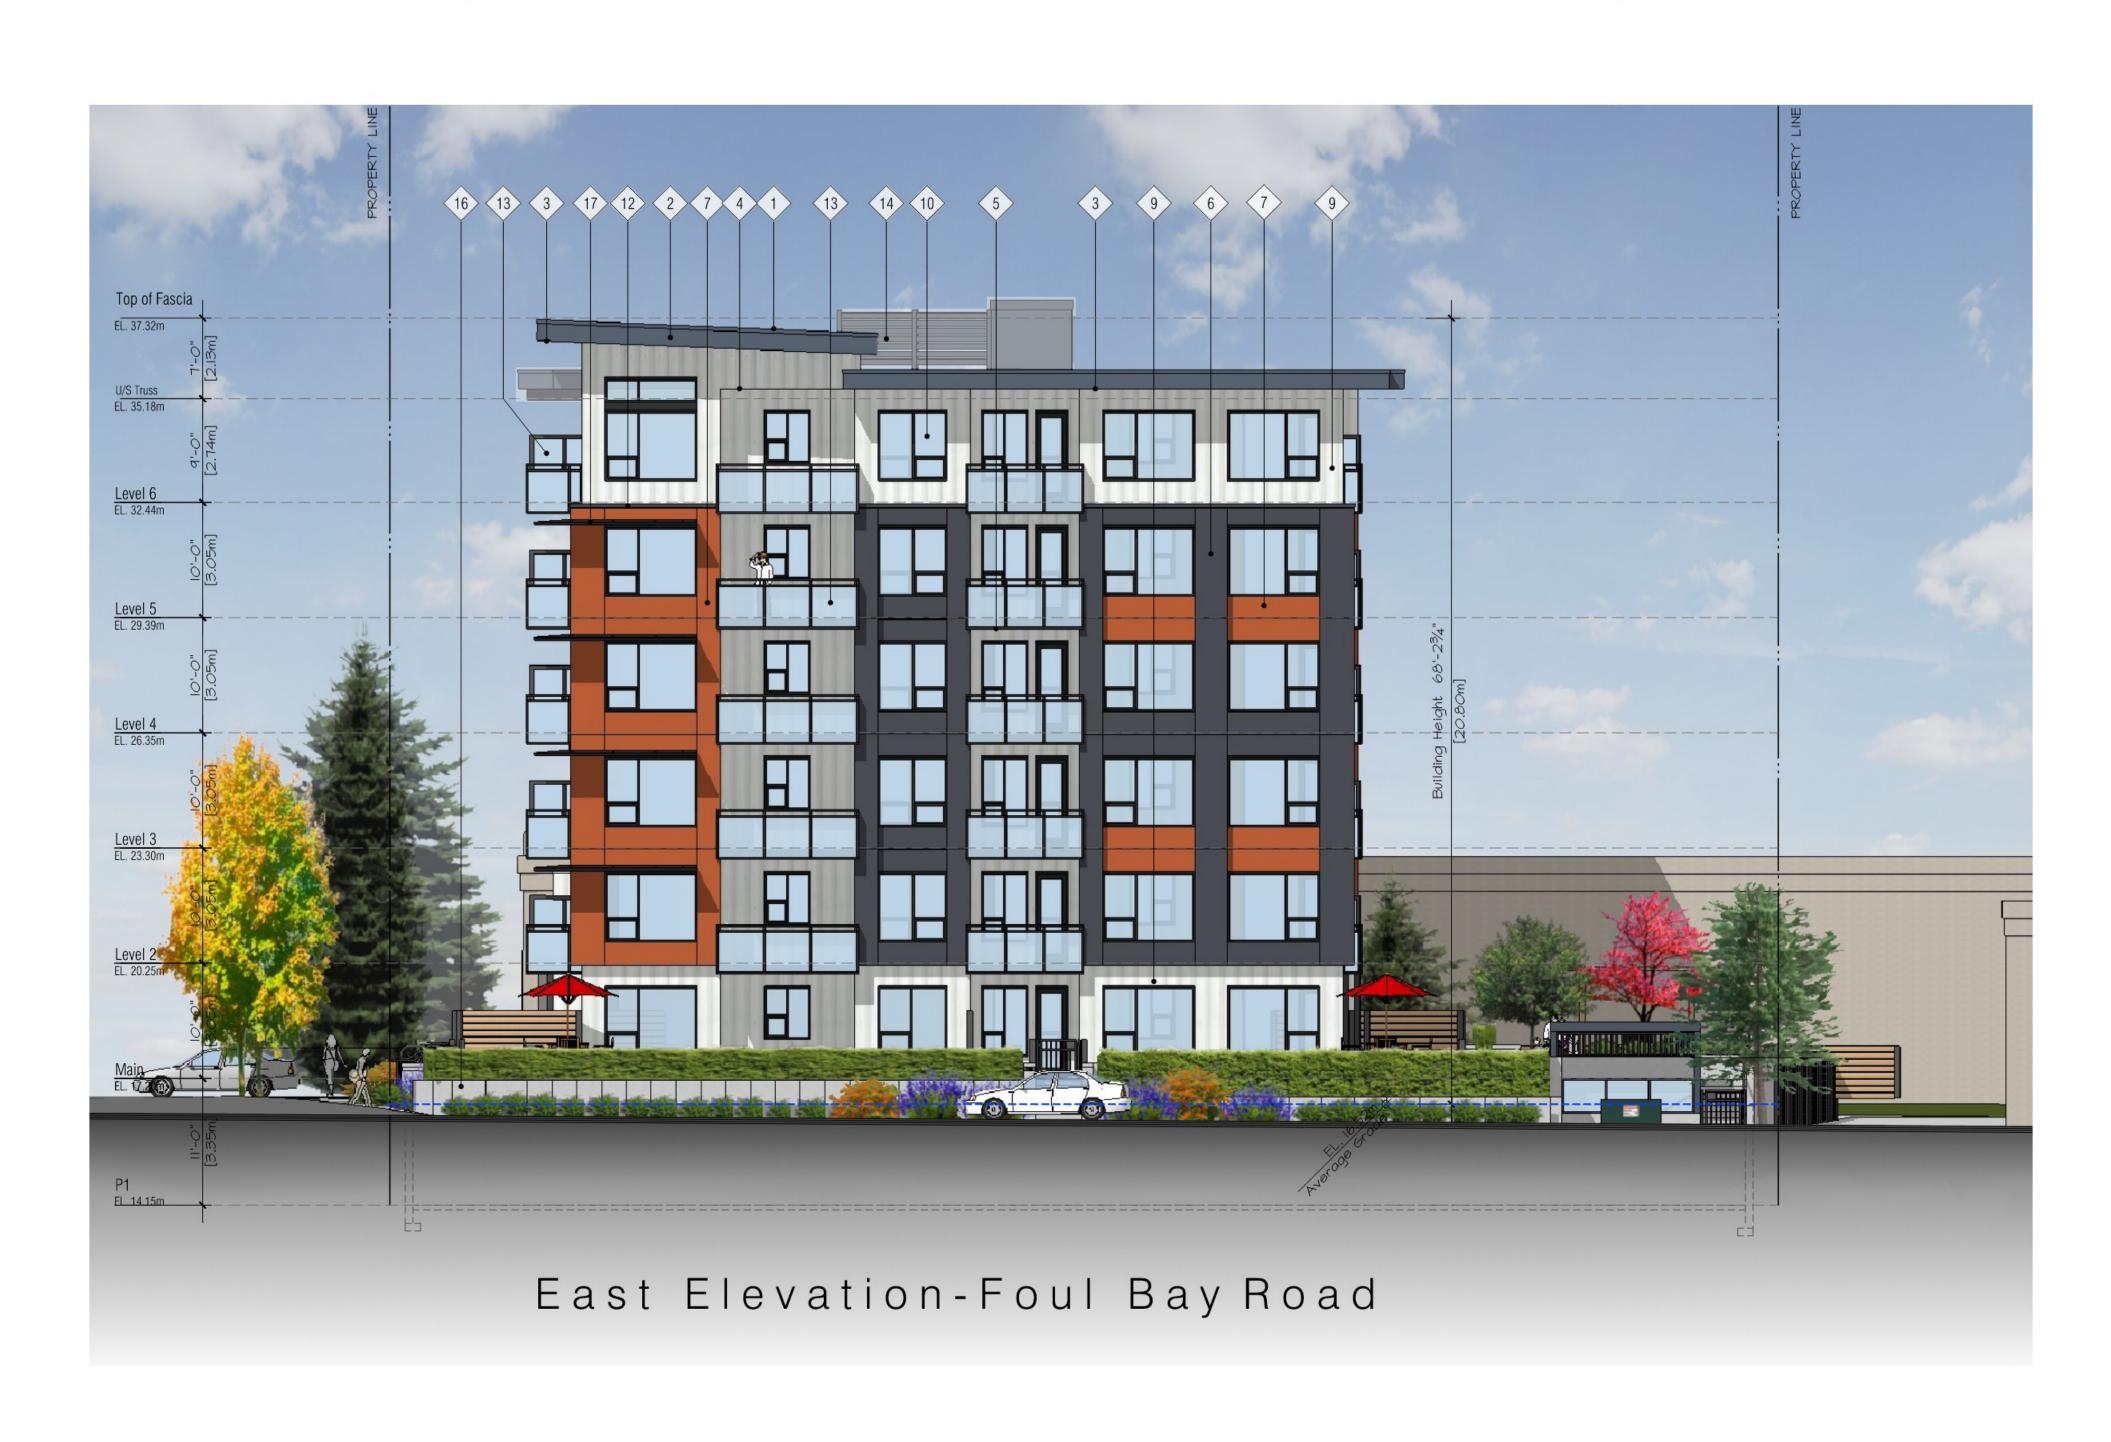
Elevations

- 1 Roofing
 2- PLY SBS Roofing, Light Grey
- Fascia: Dark
 Fibre Cement
 B.C. HC-154 Hale Navy
- 3 Soffit: Feature Wood
 Fibre Cement, Wood-like Colour
- Soffit: Typical Light Grey
 Fibre Cement
 B.M. HC-169 Conventry Grey

- 5 Soffit: Typical Dark Grey Fibre Cement B.M. 2128-20 - Abyss
- 6 Panels: Dark Grey
 Fibre Cement Panels
 B.M. 2128-20 Abyss
- Panels: Rust Red
 Fibre Cement Panels
 B.M. 2175-30 Rust

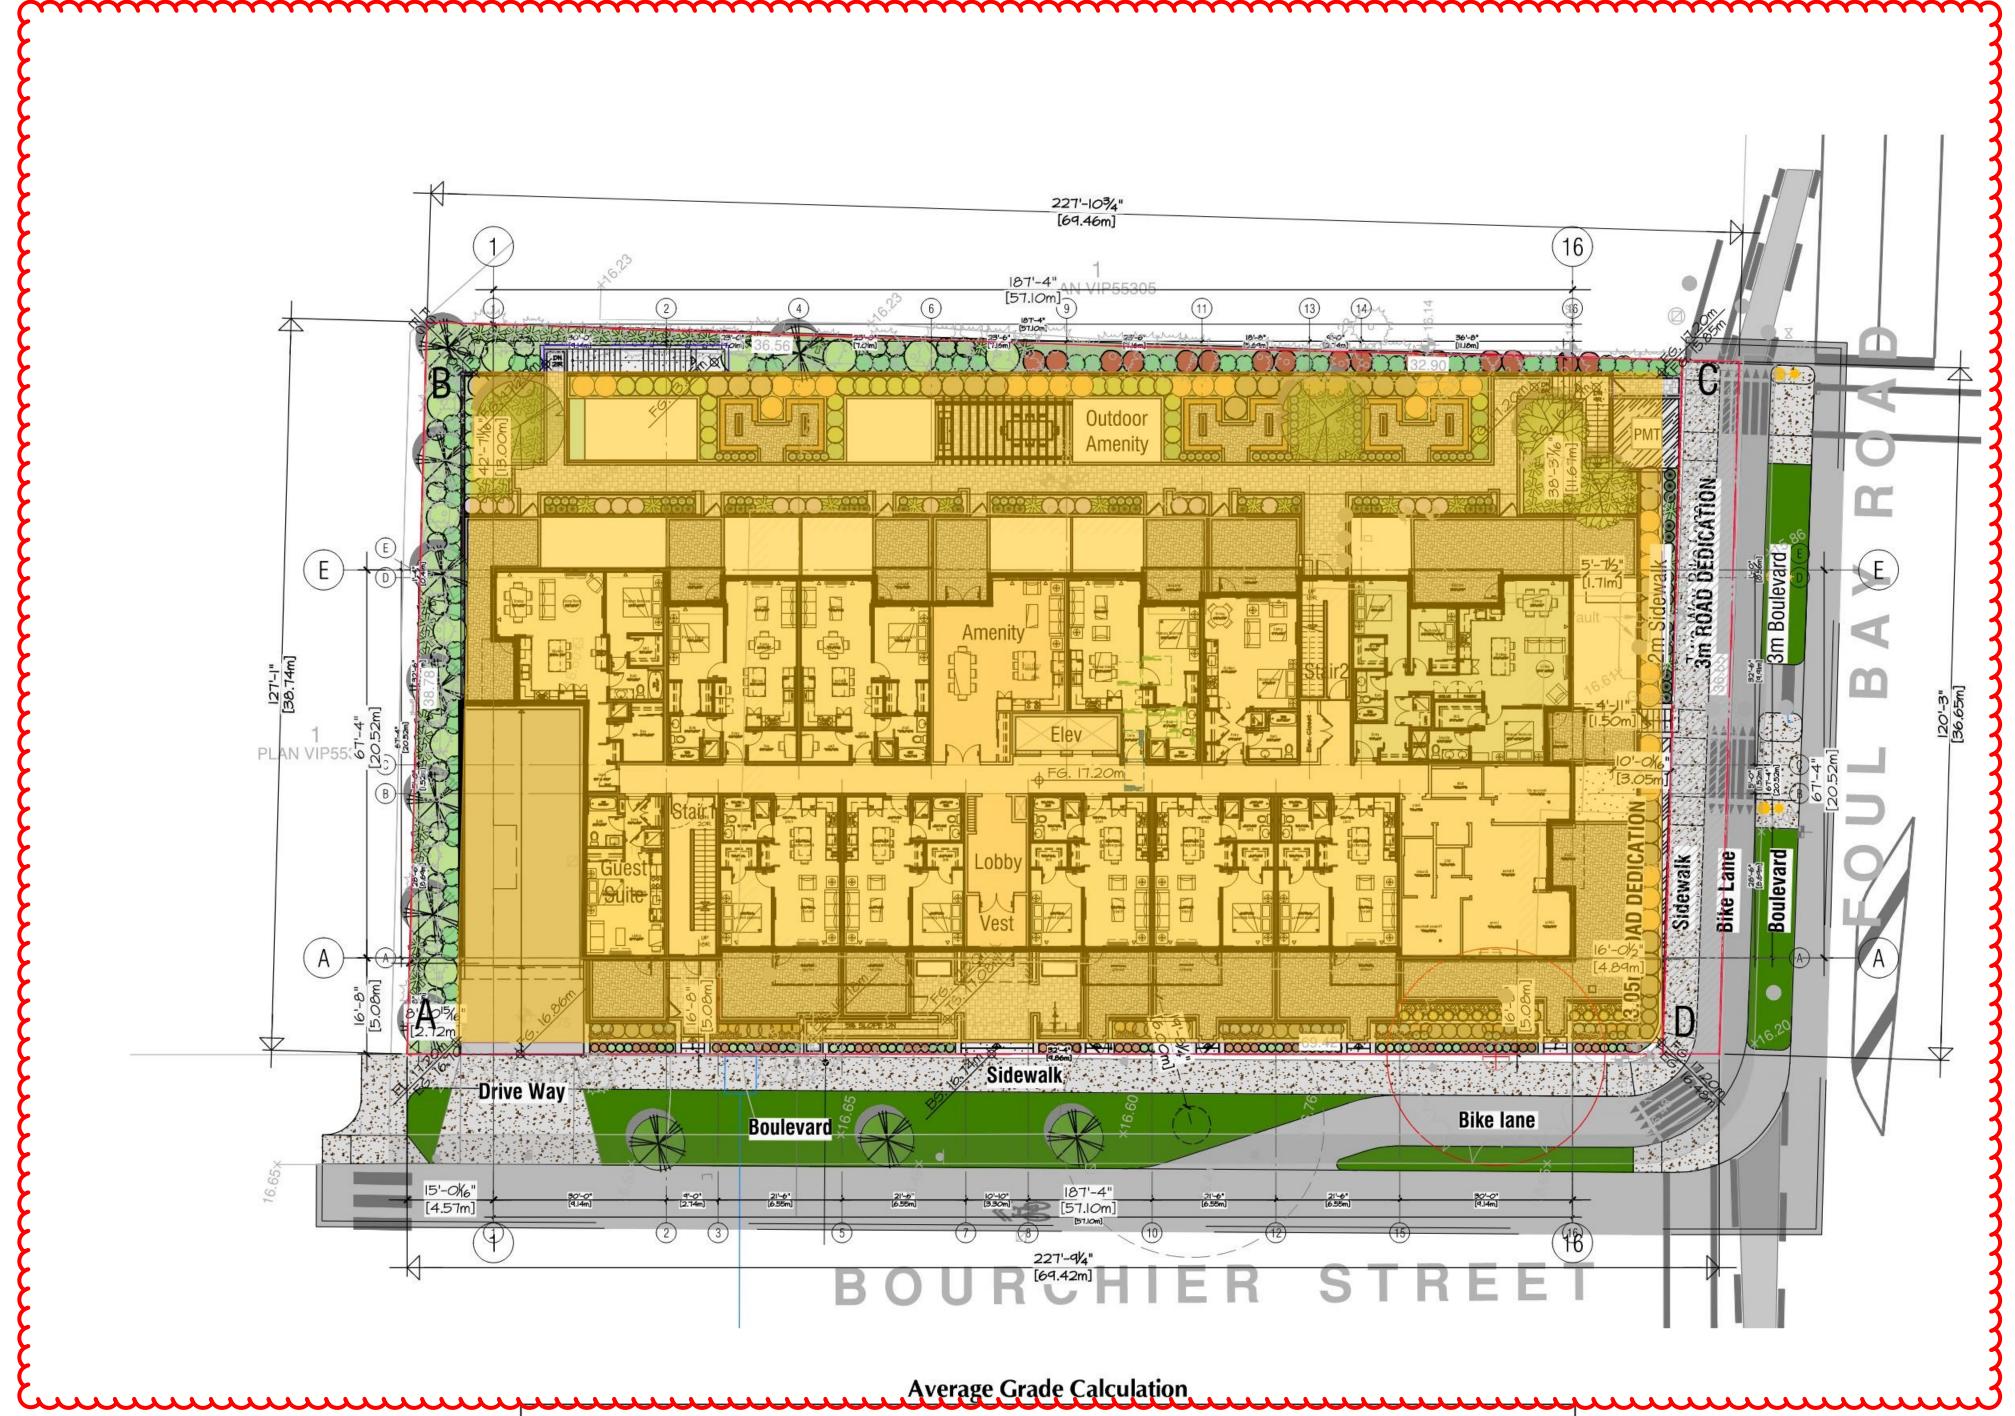
Wall Section	Average G	rade		Length								
A-B	(16.70 + 16.70)/2	16.70	X	38.74	m =	647						
B-C	(16.70 + 15.85)/2	16.28	X	69.46	m =	1,131						
C-D	(15.85 + 16.48)/2	16.67	x	36.65	m =	611						
D-A	(16.48 + 16.70)/2	16.59	х	69.42	m =	1,152						
Total				214.27	m	3,540						
Average Grade	Total height / Total	Perimeter le	ngth									
	3540 / 214.27		=	16.52	m
