FRASER WAREHOUSE

1316-18 WHARF STREET, VICTORIA, BC

CONSERVATION PLAN

AUGUST 2019

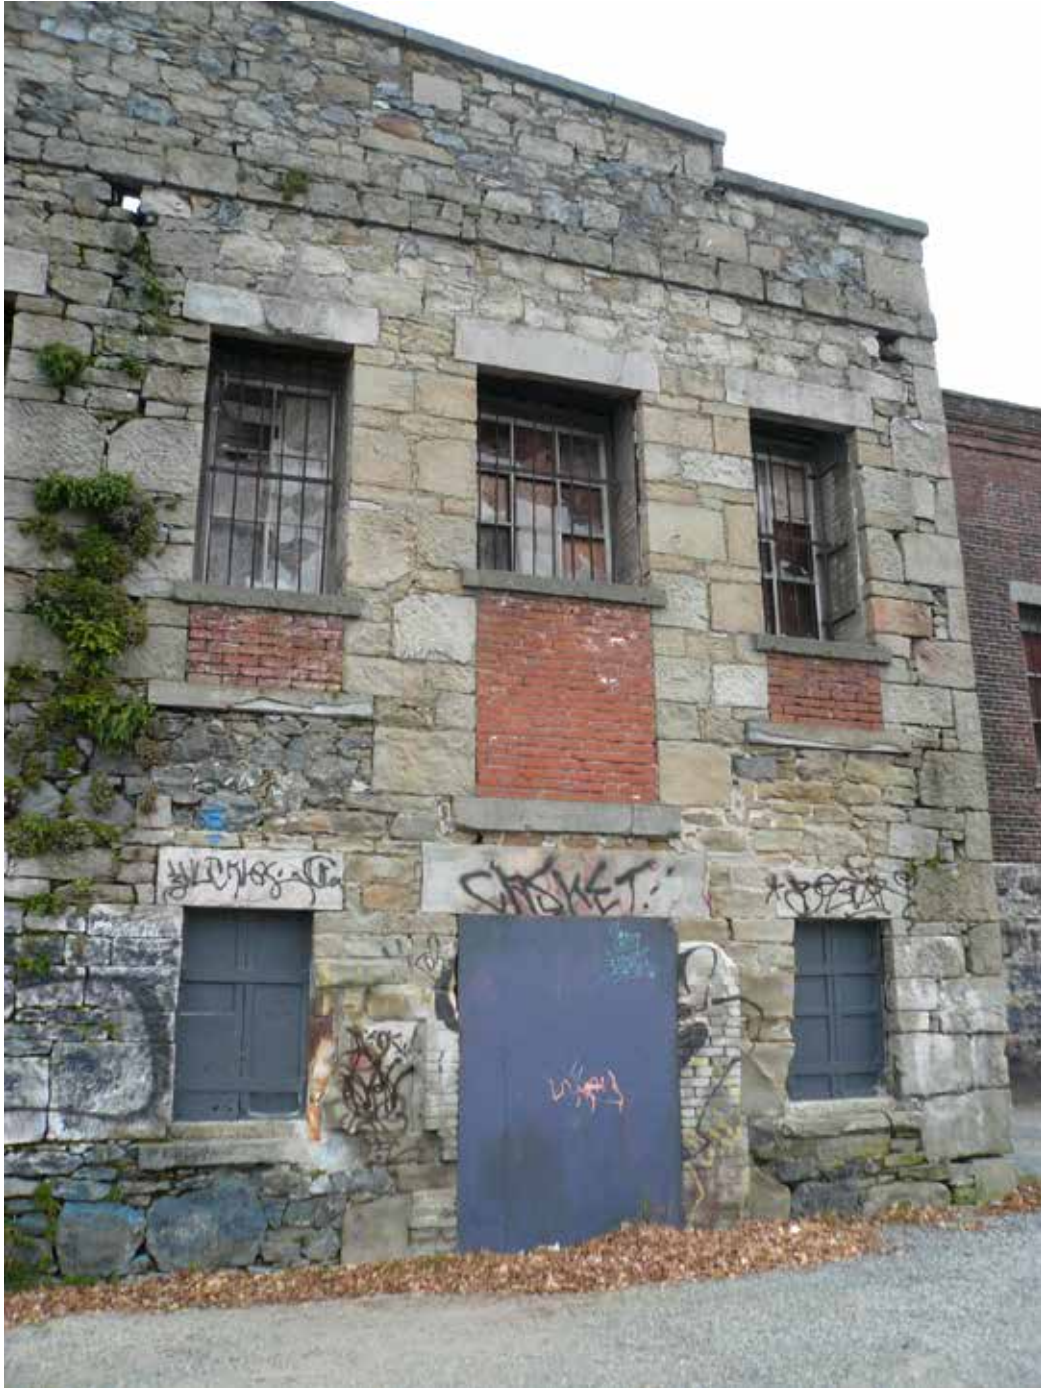
Rear elevation of the Fraser Warehouse showing openings altered using brick, changes to window assemblies, and general condition of masonry.

The existing window openings on the rear façade should be reinstated to their original size through the removal of the later added brick removed. Archival photographs of the façade can be used as guides for replacement wood assembly windows. At the front façade, recent interventions will need to be investigated and the later applied stucco removed to clarify what the original design of the front façade was. Contextual photographs of comparable buildings and façades should be used to develop a sympathetic and reasonable front façade that would be in keeping with the historic aesthetic of the building.

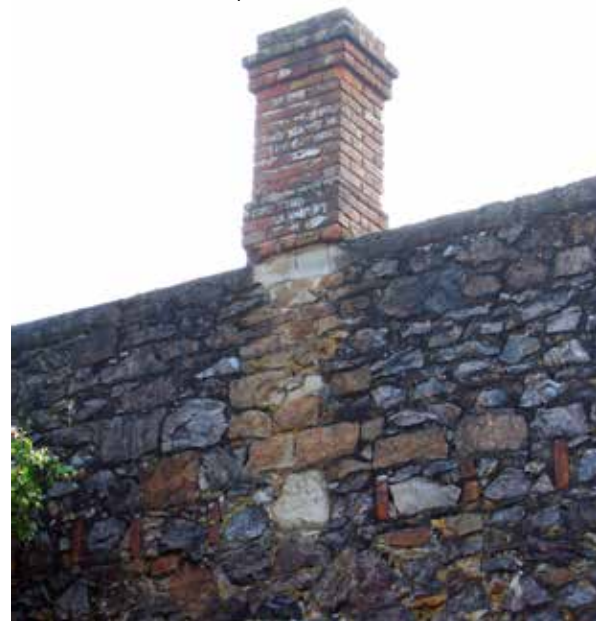
The roof, parapet, and chimneys were not safely accessible for close review and were evaluated from the ground. Those parapet cap flashings visible from ground level on the Fraser Warehouse were limited in their coverage. Absence of flashings to shed water and protect the masonry walls or interface with the roof assembly has contributed to deterioration, organic buildup, mortar loss, and staining. Two brick chimneys are present, as part of the overall redevelopment, these chimneys will not be preserved, but should be documented prior to their demolition.

Parapet and chimney at rear of building - no flashings present.

- Evaluate the overall condition of parapet and any intact cap flashing to determine whether more protection is required, or replacement in-kind is required.
- Repair or replace deteriorated flashing, as required. Repairs should be physically and visually compatible.
- If new flashings are installed, ensure that their design and colour is compatible with the historic masonry façades.
