# CAIRE & GRANCINI WAREHOUSE

1314 WHARF STREET, VICTORIA, BC

## CONSERVATION PLAN

AUGUST 2019

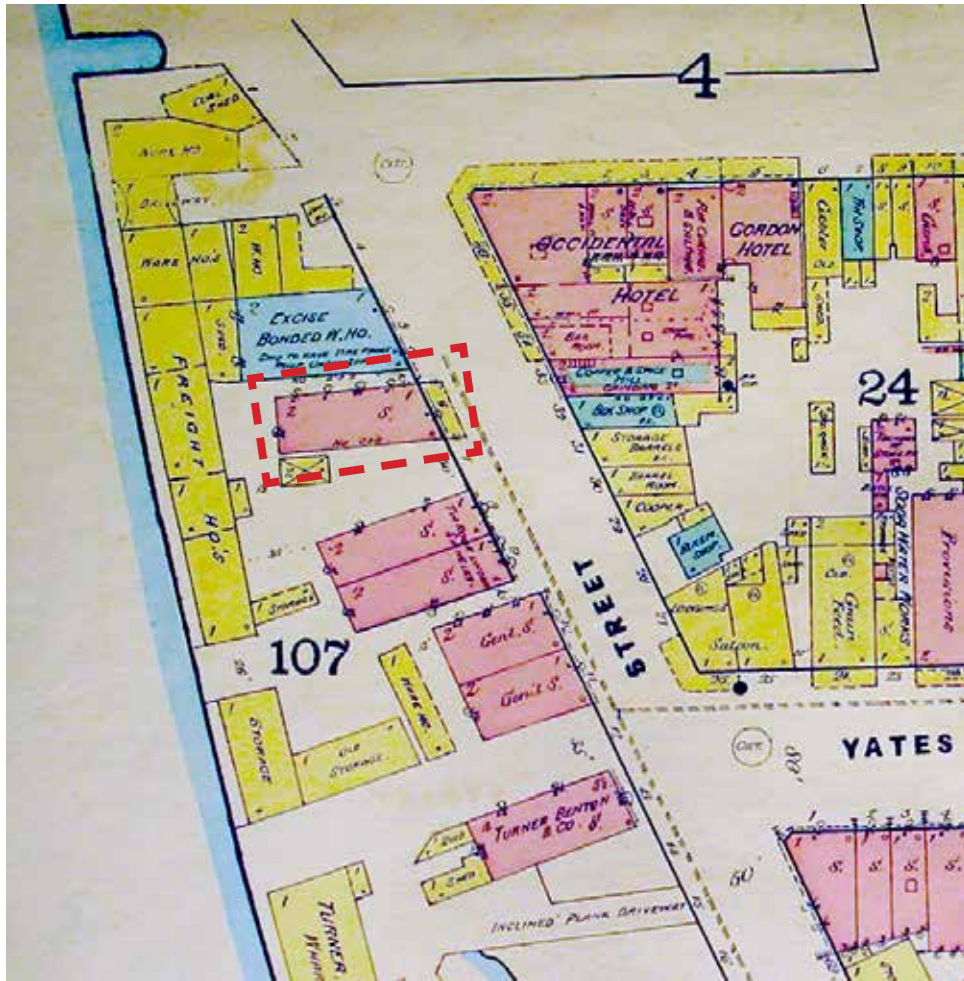
1885 Sandborn Fire Insurance Map - Yates and Wharf Street intersection and site context of the Caire & Grancini Warehouse

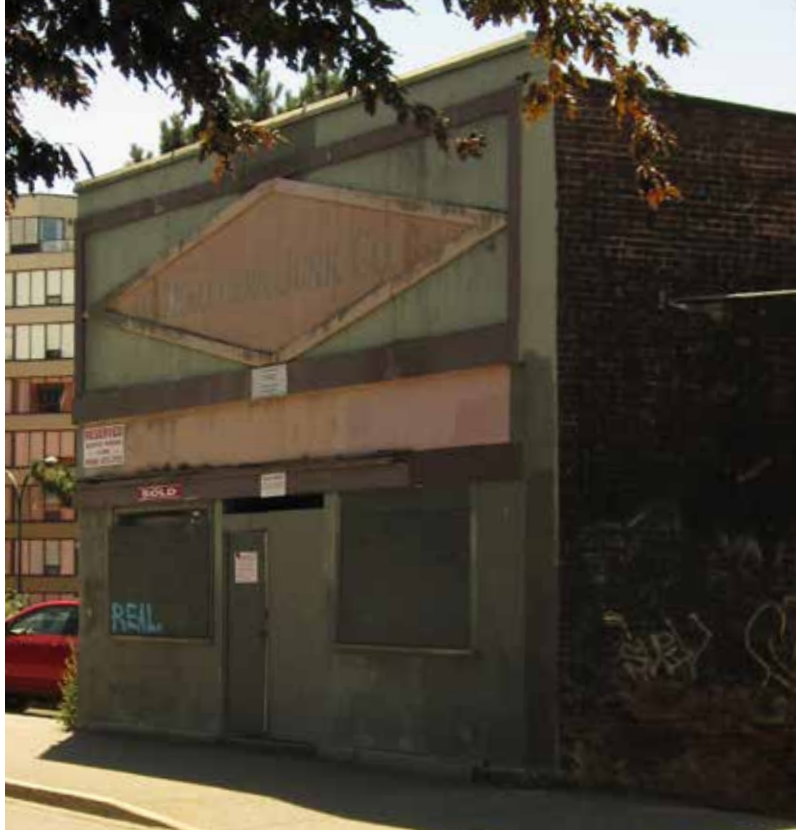
*Current front elevation of the Caire & Grancini Warehouse*

The exterior walls are a mixture of rubble stone, found at the base on the bottom storey at the rear of the building, and red brick on the main floor of the building. The window and door openings are framed by inset sandstone headers and sills. In some locations the openings were bricked in during later interventions to the building.

A later unsympathetic stucco render was installed on the front of the building. The stucco should be removed. The removal of the unsympathetic stucco may provide further information as to the original cladding and finishes and potentially the original design of the front façade and aid in its rehabilitation. Testing will be required to determine the most appropriate method to remove the stucco, as well any paint applied to the brick and stone, to see if removal can be carried out without causing significant damage to the masonry behind. Intact elements hidden behind later interventions to the front façade should be retained and repaired in-kind. Although the original design of the front façade is unknown and is only visible in one oblique photograph, similar frontage designs of buildings of the same period can be used to produce an appropriate and sympathetic design.

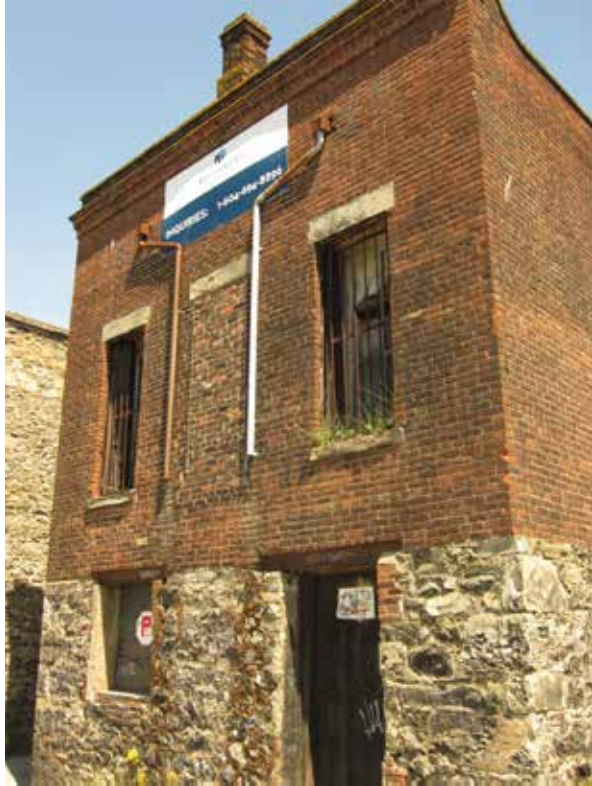
*Current rear elevation of the Caire & Grancini Warehouse.*

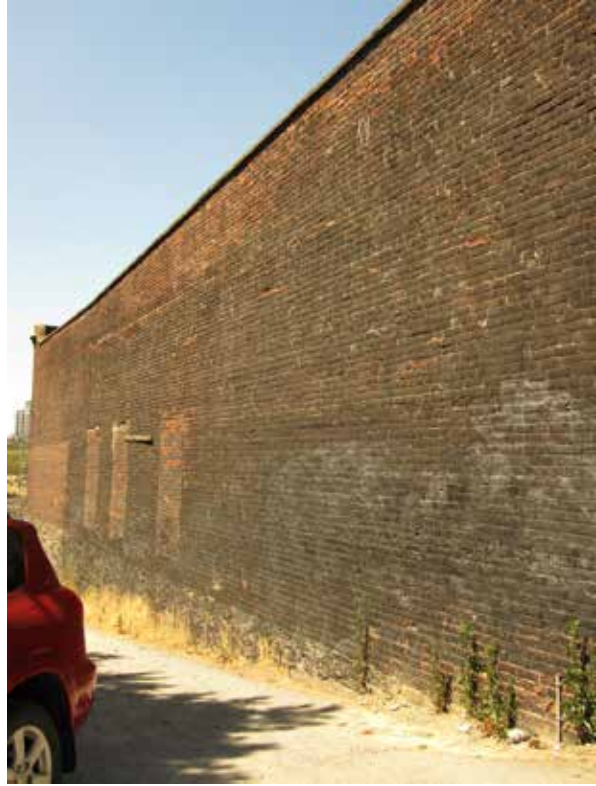
*Current south Elevation of the Caire & Grancini Warehouse*

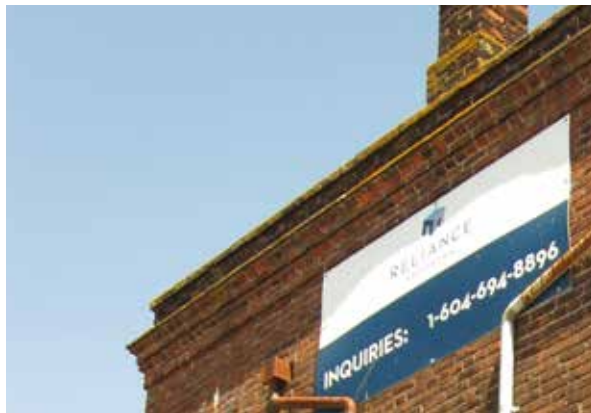
Above: Corbelled brick cornice on rear façade.

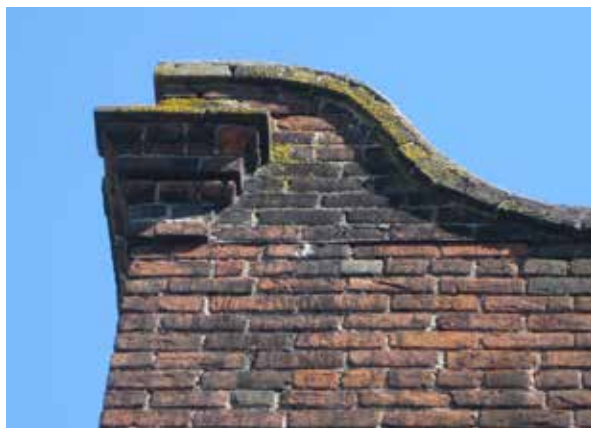
Below: Parapet at rear of Building - no cap flashing noted

The roof and parapet were not safely accessible for close review and were evaluated from the ground. Those parapet cap flashings visible from ground level on the Caire & Grancini Warehouse are limited and only noted on the front façade. Other sections of the parapet and the chimney do not appear to have flashings installed. The existing cap flashings on the front elevation are oversized, not sympathetic to the existing building, are in a significant state of decay, and should be replaced.

- Evaluate the overall condition of the parapet cap flashing to determine whether more protection is required, or replacement in kind is required.
- Replace deteriorated flashing, as required. Repairs should be physically and visually compatible.
- If new flashings are installed, ensure that the colour is compatible with the overall colour scheme.
