FRASER WAREHOUSE

1316-18 WHARF STREET, VICTORIA, BC

CONSERVATION PLAN

MAY 2019

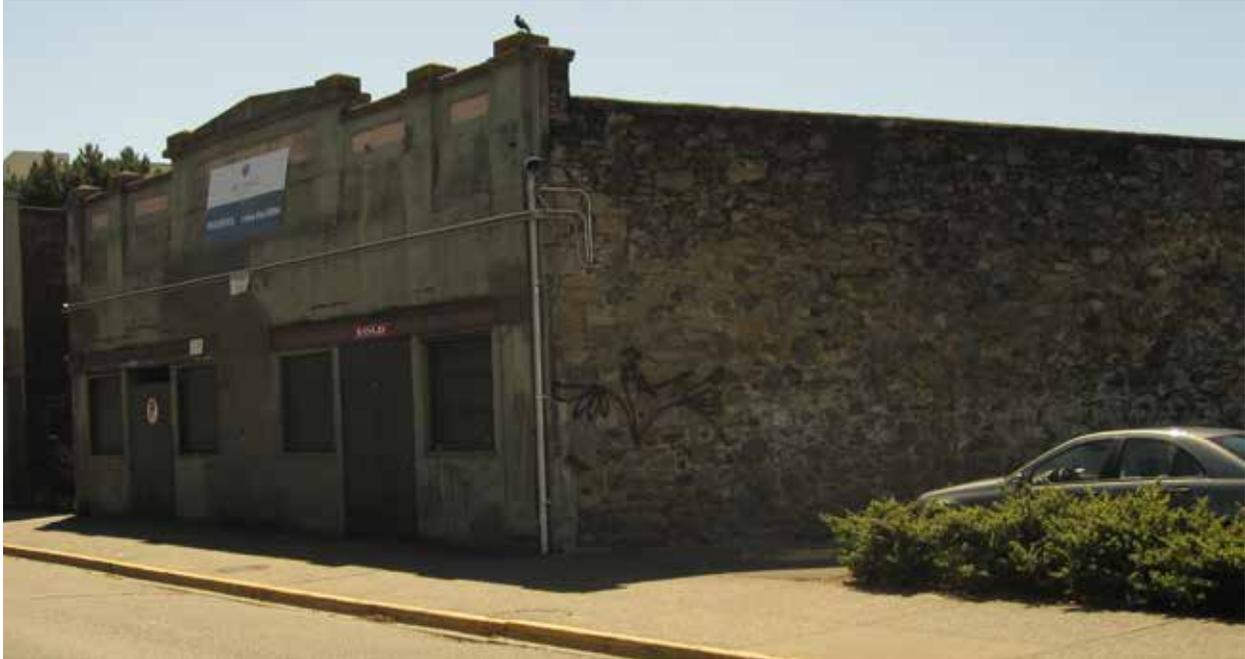
Current front elevation with late applied stucco of the Fraser Warehouse.

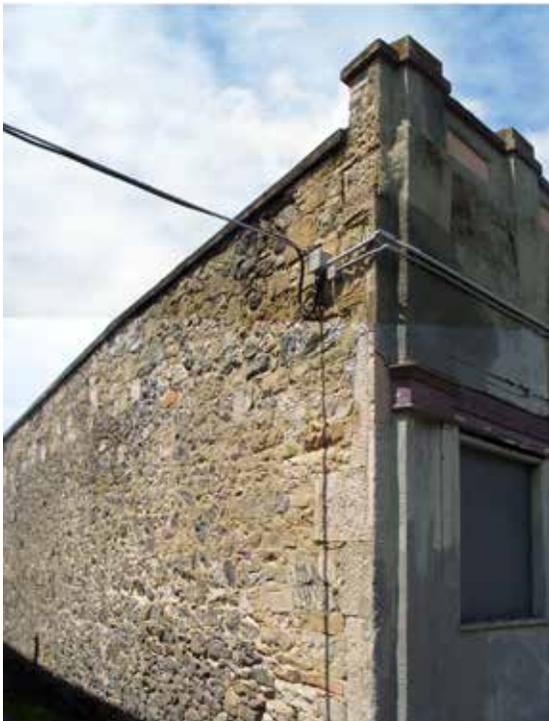
Current side and front elevations showing the stone construction with quoining on the corner Fraser Warehouse

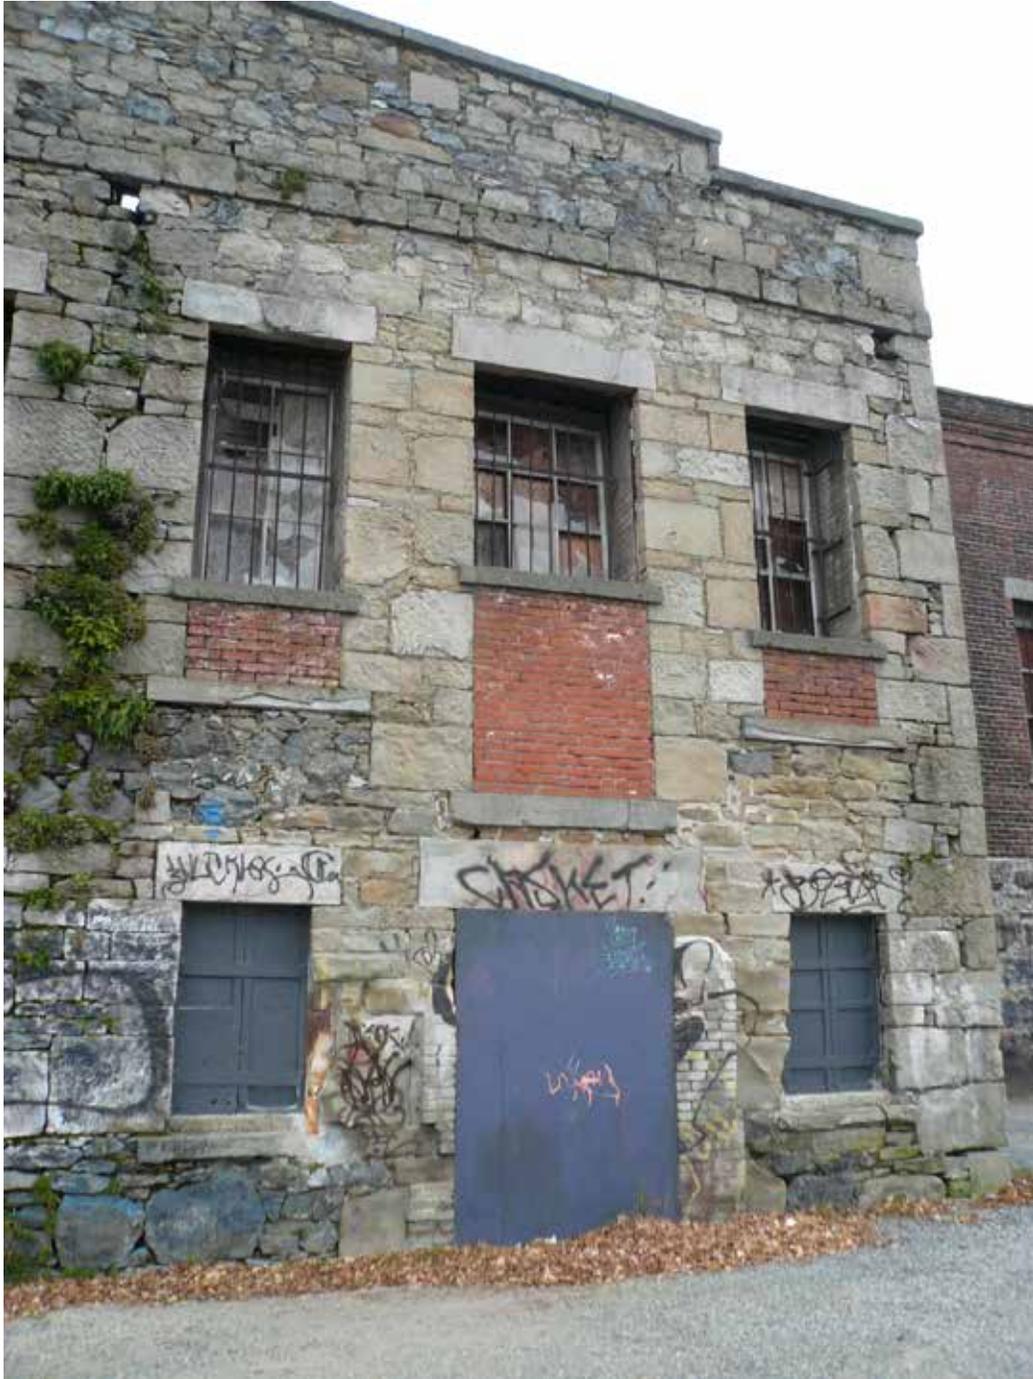
Rear elevation of the Fraser Warehouse showing openings altered using brick, changes to window assemblies, and general condition of masonry.

The existing window openings on the rear façade show be preserved and the later added brick removed. Archival photographs of the façade can be used as guides for the replacement windows. For the front façade, the infills and other alterations made will need to be investigated and later stucco removed to clarify what the original design was. Contextual photographs of comparable buildings and façades should be used to develop a sympathetic and reasonable front façade that would be in keeping with the historic aesthetic of the building.

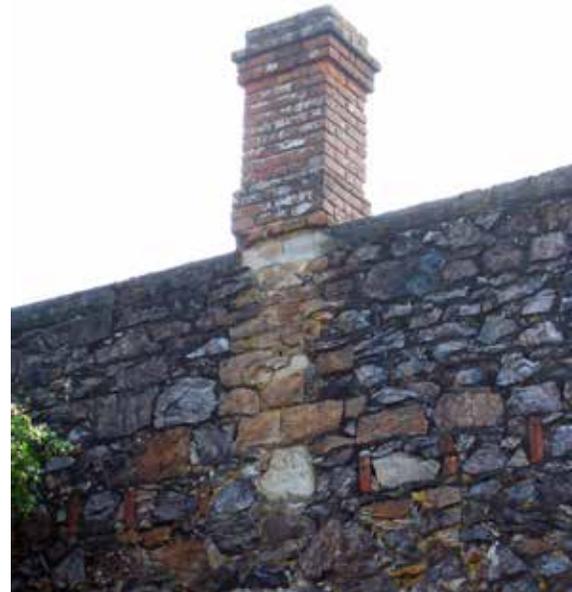
Parapet And Chimney at Rear of Building - No Cap Flashing Noted

The cap flashings on the Fraser Warehouse are limited in their coverage. Absence of flashing to shed water and protect the masonry façade or interface with the roof assembly has contributed to deterioration, organic buildups, mortar loss, and staining. Locations where flashings are absent, new

- Evaluate the overall condition of any intact parapet cap flashing to determine whether more protection is required, or replacement in kind is required.
- Repair or replace deteriorated flashing, as required. Repairs should be physically and visually compatible.
- If new flashings are installed, ensure that their design and colour is compatible with the historic masonry façades.
