VICTORIA RICE AND FLOURING MILLS

1824 STORE STREET, VICTORIA, BC

CONSERVATION PLAN
JANUARY 2022

A condition assessment of 1824 Store Street was undertaken in June and July of 2021 by Geoff Purdon of NorthStar General Contracting Ltd. The assessment reviewed the exterior and interior of the building. Conditions were observed and photographed and at no time were materials or elements removed or damaged.

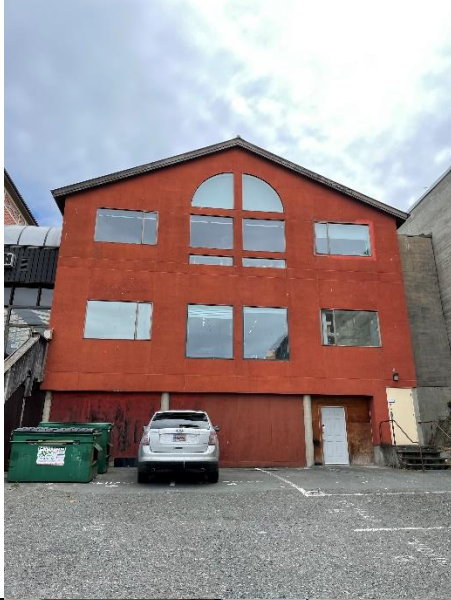
1b)

Item #	Existing conditions/elements:	1824/Victopia/Valhalla Pure/Crawlspace:	Corresponding Appendix:
Item 1	The site reviews would describe the materials and physical condition of exterior walls, including foundation walls, structural masonry, and wood or concrete with an exterior cladding.	<p>Victopia (second floor main entrance to the South of Valhalla)</p> <p>a) 1824 entrance new storefront glass doors, fir soffit cladding, w sheet metal capping, w stucco exterior wall finish, masonry firewall separating 1824 from Value Village, rubble rock foundation, post and beam timber frame construction, masonry fire separations</p> <p>West Elevation</p> <p>b) West elevation newly stuccoed in recent years, likely at the same time as Victopia entrance</p> <p>*West addition begins in crawlspace and extends to exterior wall, glue lam beams on sonotube piles (sprinklered), w concrete ground seal</p> <p>c) Structural masonry block fire separation on South demising wall, prominent masonry pilasters, w footings on northeast and southeast corners of façade, parged lintels and archways front façade</p> <p>*Heritage restoration completed 1980, heritage fabric appears to be in excellent condition on east elevation</p> <p>East store frontage façade/entrance</p> <p>d) Original heritage baker brick, w black herringbone details, ornamental dentil molding, heritage arch windows, w footings and foundation wall, exposed aggregate sidewalk, tiled entrance (tile is non-original), w ornamental security gate, accent lighting parged archway, w 1824 address marker, power service overhead fed to southeast corner of second floor, ornamental metalwork in lower windows (metalwork non-original), w venting below sills, hopper windows on second floor, gable vents</p> <p>Main Floor/ Interior Valhalla Pure</p> <p>e) Finish drywall space VCT tile exposed sprinklers and HVAC ducting, minimal character defining elements remaining after previous TI aside from exposed heritage posts and timbers</p>	<p>1a)</p> <p>1b)</p> <p>1c)</p> <p>1d)</p> <p>1e)</p>

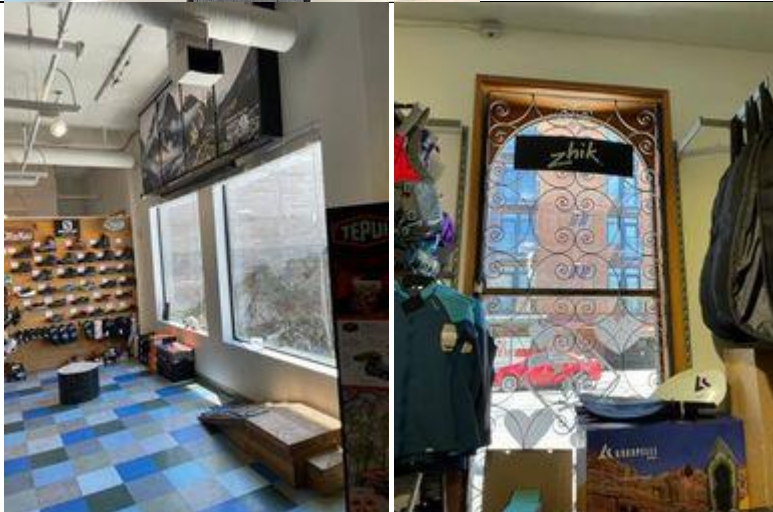
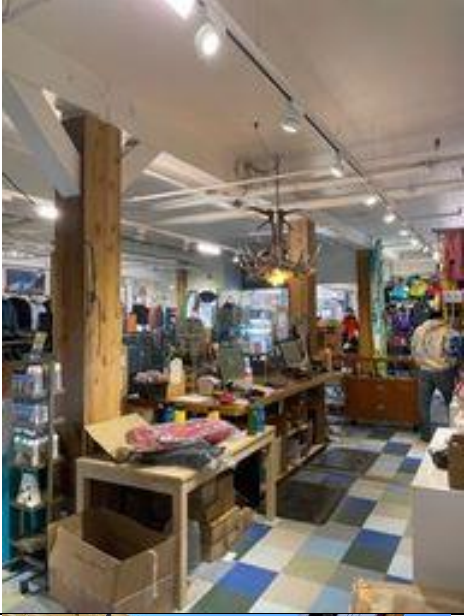
2b)

Item 2	Their construction, and any character-defining detailing.	<p>Second floor</p> <p>a) Heritage post and beam construction exposed elements such as collar ties, *are now stained black and left exposed</p> <p>Main Floor</p>	2a) , a1) , a2)

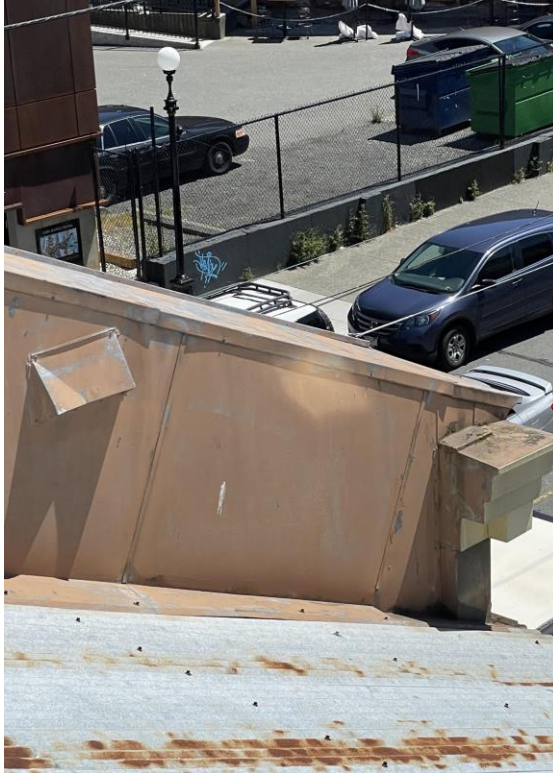
7a)

Item 7	Identify the condition of parapet walls if possible and whether appropriate cap and	<p>a) Parapet flashing is intact, parapet flashing has previously been painted and is currently in need of paint/maintenance</p>	<p>7a)</p>

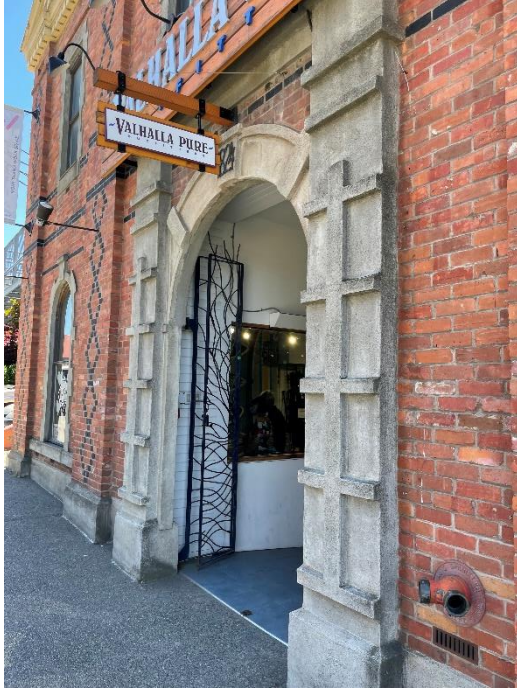
Item 23	Masonry - Assess the current condition of masonry features, such as natural stone, brick, cast stone, terra cotta and concrete block. Identify the finish dressing, texture and colour of the stone, brick or mortar, the coursing pattern, and the joint width and profile, along with any decorative sculptural and functional elements, such as band courses, lintels, water tables, cornices, scuppers and carvings.	a) East elevation brick façade: fair condition, brick jointing: fair condition, North elevation masonry painted appears to be elastomeric paint b) Original exposed footings, lintels, archways, corbels, appear to be in fair condition * Jointing appears to be of newer structural masonry cement carried out in recent years. No evidence of limestone-based mortar	23a) 23b)

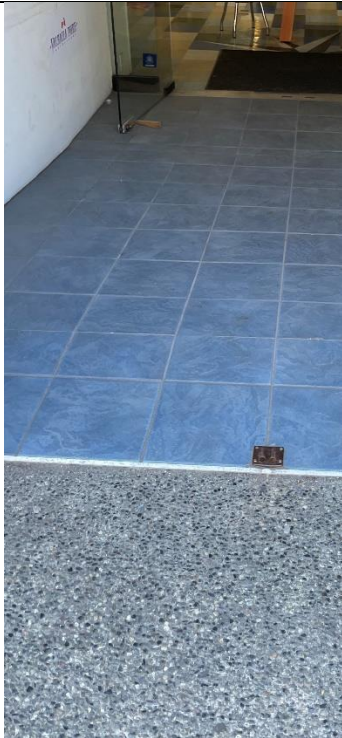
Item 24	Concrete - Identify concrete features used for exterior cladding, flooring and paving. Identify any texture created by formwork, the colour and finish, such as exposed aggregate or terrazzo.	a) Concrete lintels archways and footings for pilasters, concrete sills and window headers/cast in place architectural details b) Exposed aggregate city sidewalks, likely original, 8 inch concrete foundation wall on additions, concrete sonotube foundation piles, concrete foundation wall with masonry block firewalls between 1820 and Value Village	24a) refer to Appendix 23b) 24b)
