# SPRATT BUILDING

1910 STORE STREET, VICTORIA, BC

## CONSERVATION PLAN

JANUARY 2022

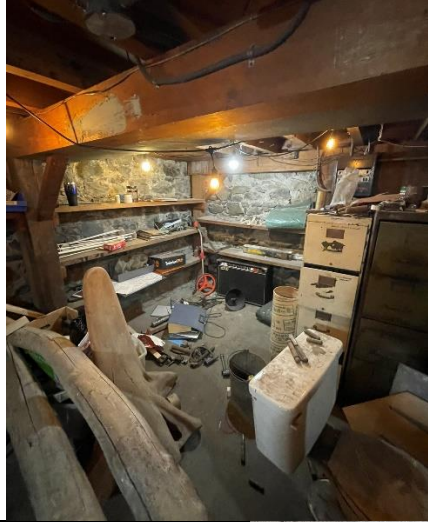
| | | b) Post and beam, rubble rock foundation | 20b) |

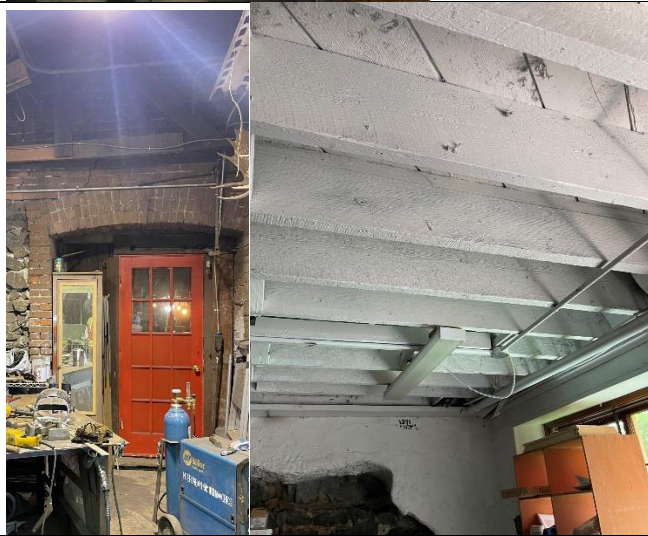
| Item 21 | Identify structural material such as stone, brick, steel, wood or concrete. | a) Rubble rock foundation, fir floor joists, brick archway in basement, second floor masonry | 21a) |

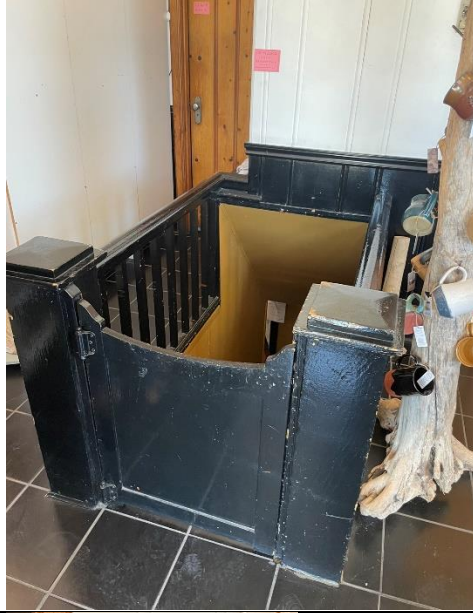
| Item 22 | <b>Wood</b> - Identify any wood features and existing condition on exterior facades, roofs, cladding, structure, windows and doors, interior finishes, and carvings. Determine the condition of finishes or coatings applied to the wood features. | a) Wood guardrail and swing-gate around main floor stairwell | 22a) |

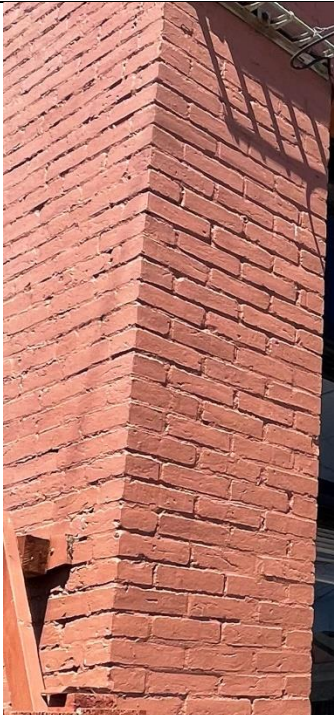
| 23a) | |

| Item 23 | <b>Masonry</b> - Assess the current condition of masonry features, such as natural stone, brick, cast stone, terra cotta and concrete block. Identify the finish dressing, texture and colour of the stone, brick or mortar, the coursing pattern, and the joint width and profile, along with any decorative sculptural and functional elements, such as band courses, lintels, water tables, cornices, scuppers and carvings. | a) Like the other buildings, the brick seems to be in excellent condition and likely restored all at the same time on the exterior. There seems to be no evidence of major peeling of the paint. | 23a) |
