BRITISH COLUMBIA POWER COMMISSION BUILDING

780 BLANSHARD STREET, VICTORIA, BC

CONSERVATION PLAN
REVISED OCTOBER 2022

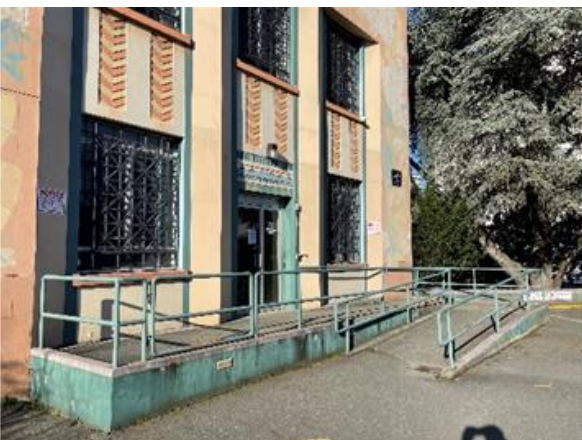
View of the handicap ramp installed in front of the north entrance in 1992.

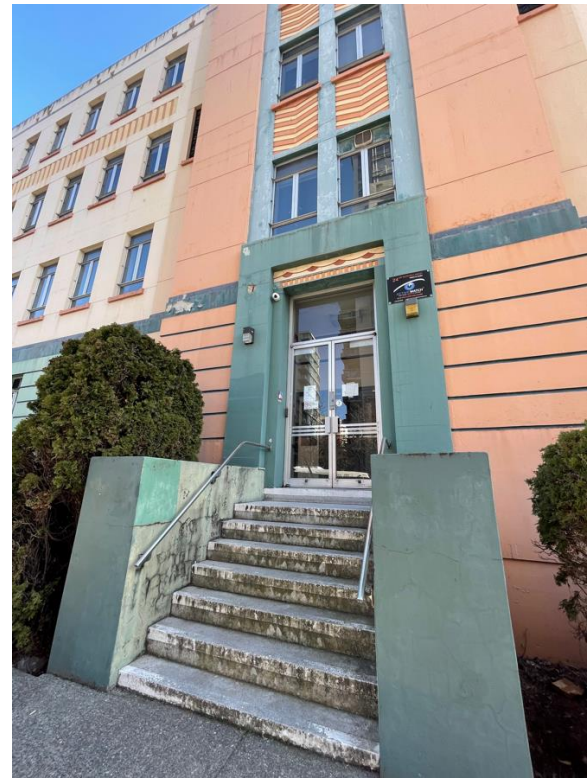
Although the exterior is prominently a stucco finish, the south entrance surround and closed stair rail was originally a dark marble. The vertical pilasters at the west entrance were also clad with marble and the side closed stair was likely marble as well, similar to the treatment of the south entrance. The marble at both entrances was removed and replaced with stucco in 1971, as detailed on the City's building card.

View of south entrance.

9	Restore the original appearance of the south entrance by facing the surround around the entrance and closed stair retaining walls with marble as shown on the original 1949 architectural drawings.
10	Restore the original appearance of the west entrance by facing the full height of the four vertical pilasters and closed stair retaining walls with marble as shown on the original 1949 architectural drawings.
11	Inspect lower and upper projecting concrete canopies over west elevation entrance doors to determine condition and extent of repair to preserve the integrity of each canopy and ensure their

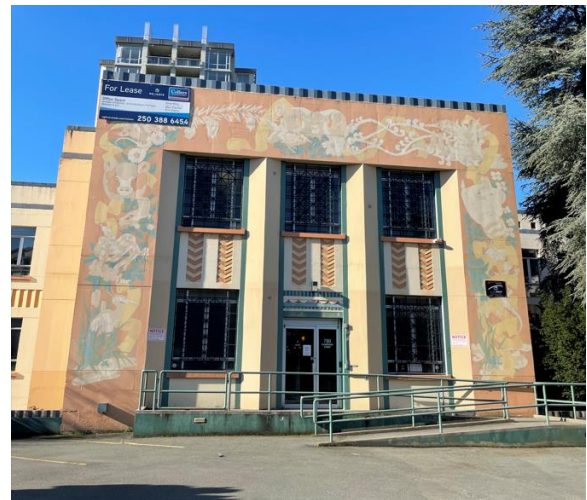
The exterior multi-coloured palette applied in 1994 is not original to the building, nor is the Wildlife Diversity Mural on the north entrance painted in the same year by Rick Thomas, a Victoria artist and employee of BC's Ministry of Environment at the time. The mural was funded by the Ministry, and Thomas was assisted by other employees to complete the mural over a two-week period. Likely, the incised letters "British Columbia Power Commission" were filled in at that time and painted over. The multi-coloured palette was meant to complement the building's Art Deco style. However, the mural does not represent the state of the building as it appeared in 1950 and is not considered a character-defining element with heritage value. With no indication of a maintenance agreement and considering a mural's normal life span is usually ten to twenty years, restoring the architectural aesthetic of the 72-year-old building without retaining the mural would respect Henry Whittaker's original design intent. The intent of the preserving the building is to restore the exterior to its original colour palette identified in a paint analysis study completed in August 2020.

View of north entrance with ramp and Wildlife Diversity Mural.

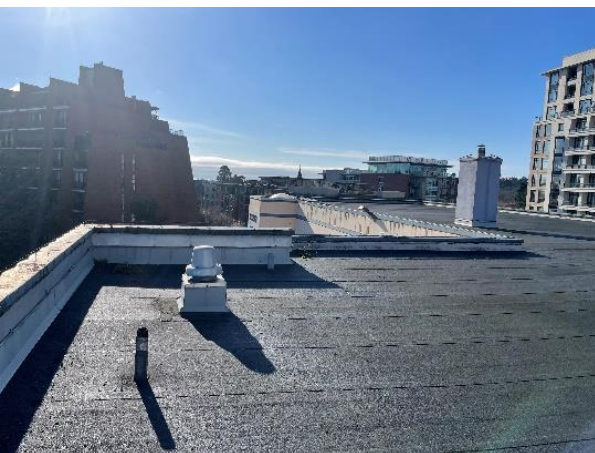
View of flat roof looking east. Note the fluted profile of the parapet that defines the north entrance.

| 2 | Preserve the parapet around the perimeter of the roof and the fluted parapets emphasizing the north, south, and west entrances. Repair where necessary following a minimal intervention approach and include replacement in-kind based on documentary or physical evidence to ensure the repair matches the existing as closely as possible, physically, and visually. Consider protecting the flat horizontal surface of the parapet with a water-based waterproof sealant. Metal cap flashing could potentially cause future rust stains on the vertical face of the building. |

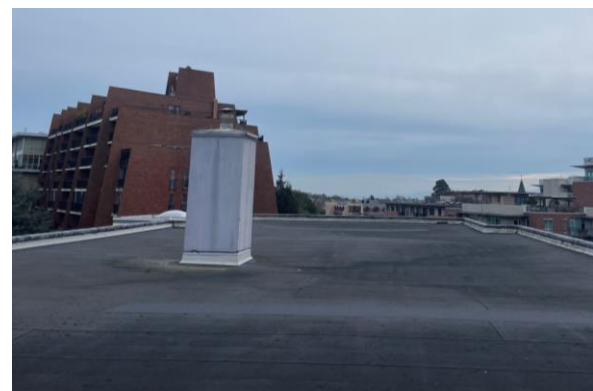
View of flat roof looking east. Note skylight over stair addition in the NE corner.

| 1 | Preserve the original flat roof assembly beyond the footprint of the tower and rehabilitate for adaptive re-use as part of the rooftop landscaping and site planting for hotel and residential use. Rehabilitation will also address roof drainage, flashing replacement. Repairs may also include limited replacement in-kind, or replacement with an appropriate substitute material, of the roof covering, attachments, and penetrations. |

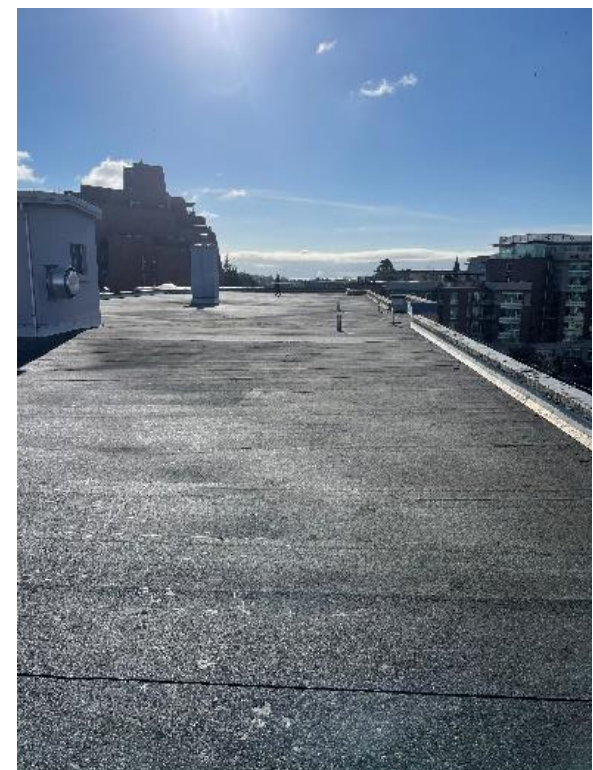
View of flat roof looking east. Note fluted edge defining south entrance.

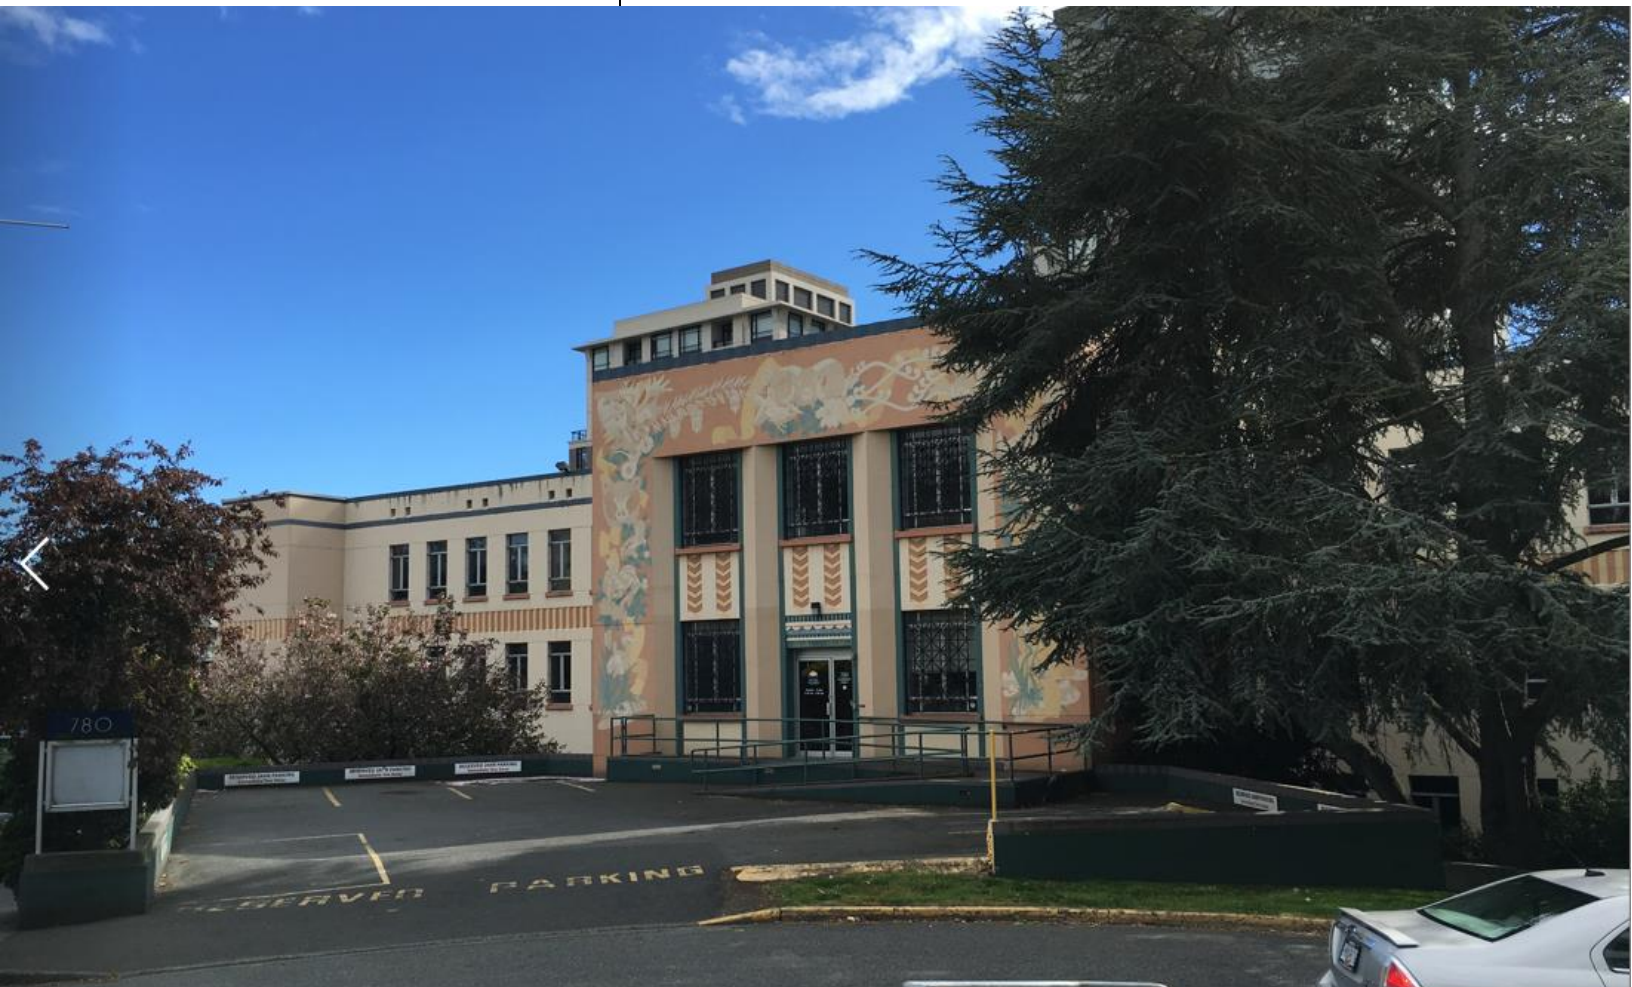
View of north elevation with two-storey entrance with the 1994 Wildlife Diversity Mural. Note the incised 'British Columbia Power Commission' letters are filled in. Existing colour palette is not original to the 1949 building, nor is the mural.

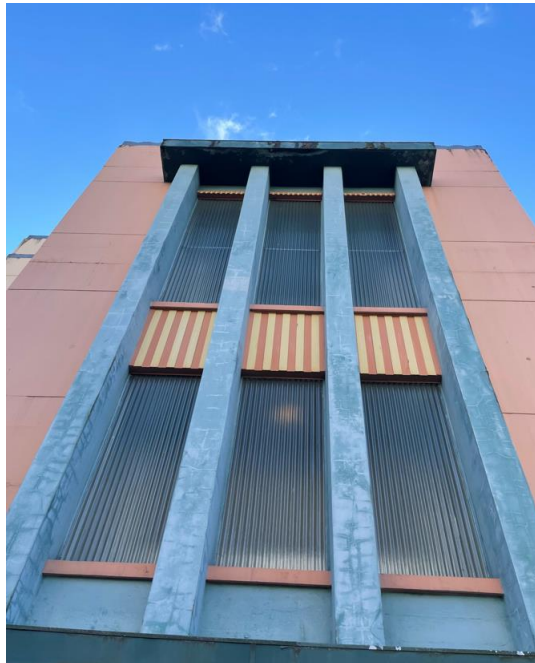
View of vertical pilasters on west façade. Pilasters are to be restored to original appearance clad in marble.

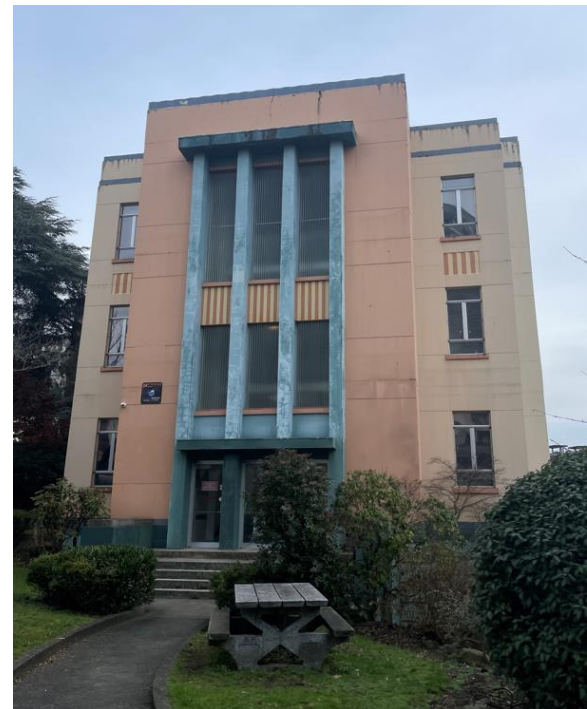
View of west elevation. Vertical pilasters and the closed stair retaining walls to be restored to original appearance clad in marble.

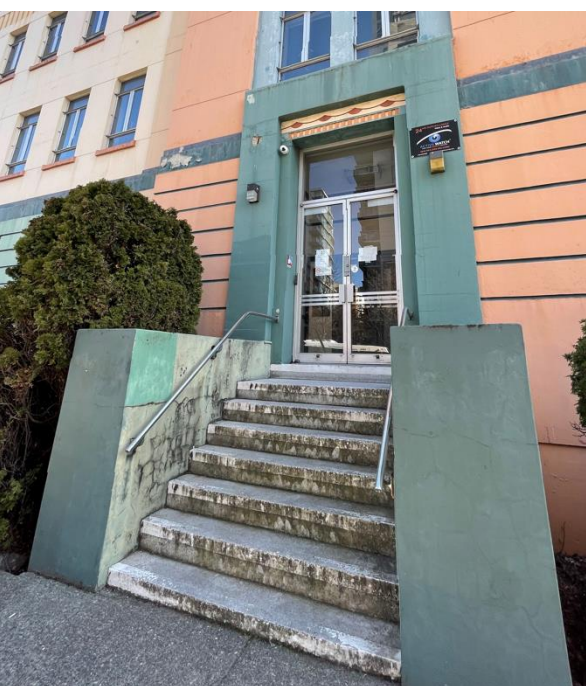
Surround around south entrance and closed stair retaining walls to be restored to their original appearance clad in marble.

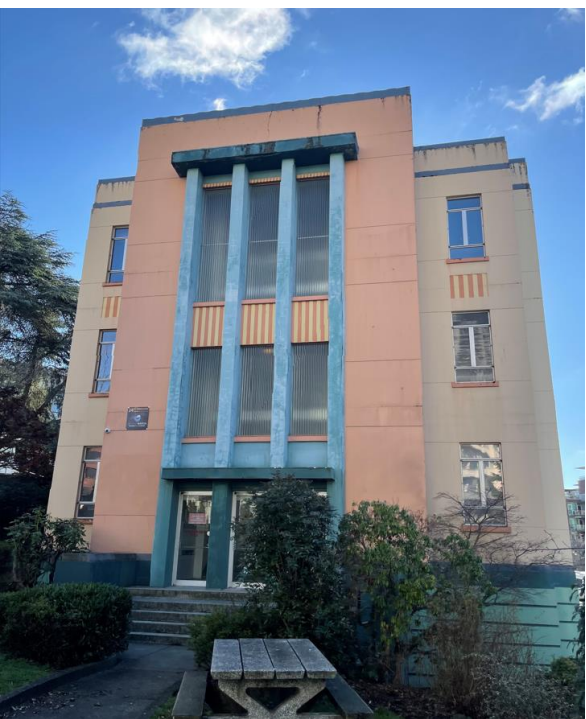
Four pilasters and closed stair retaining walls to be restored to their original appearance clad in marble.

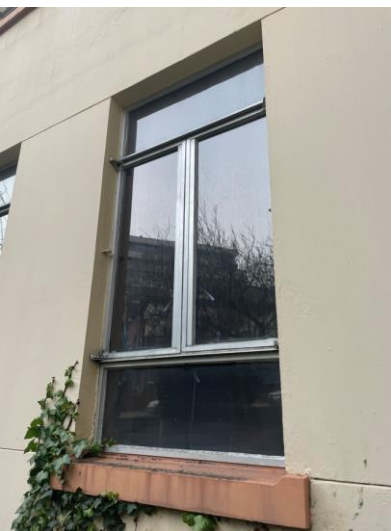
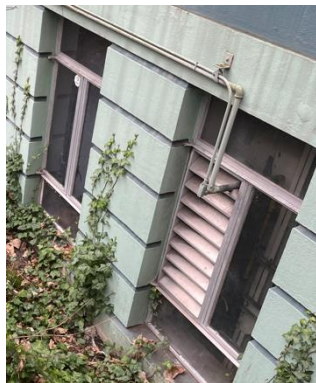
Window modifications to accommodate piping and conduit on lower north elevation.

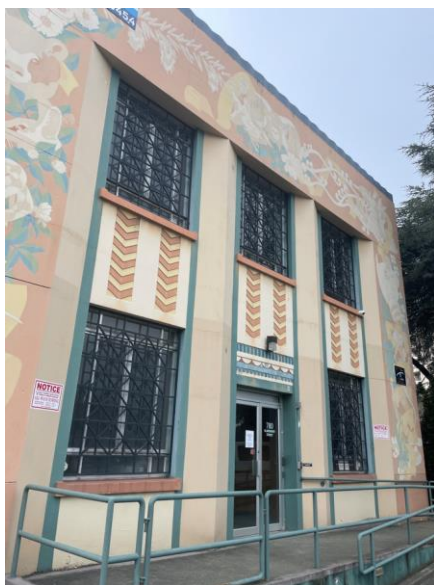
Two-storey north elevation with decorative black metal grilles.

Windows on the north two-storey elevation are screened with decorative black metal grilles that will be preserved.

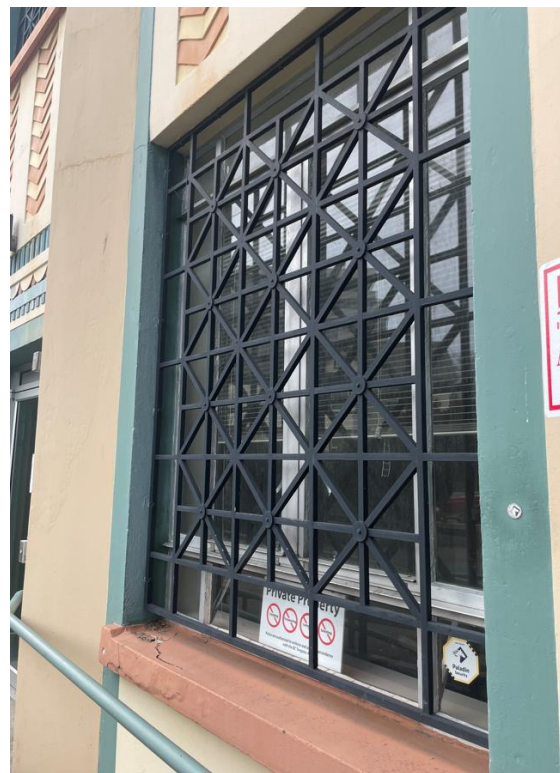
Two-storey north elevation decorative black metal grilles will be preserved in situ.

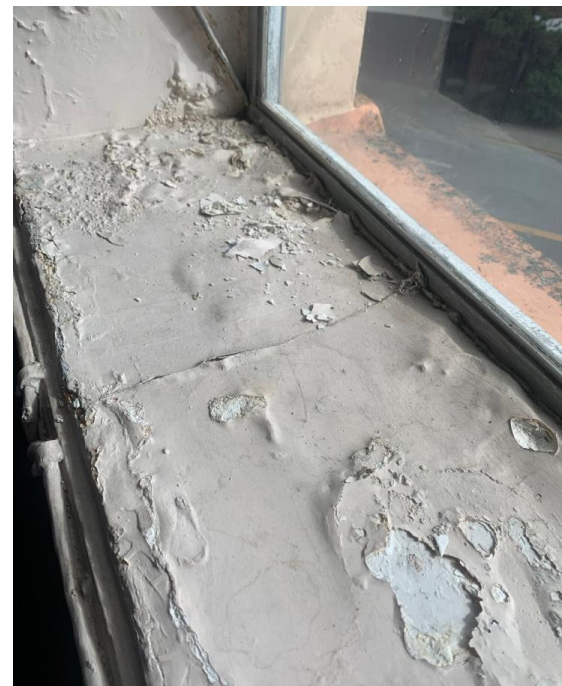
Paint bubbling and lifting from concrete surface. Lack of a waterproof membrane.

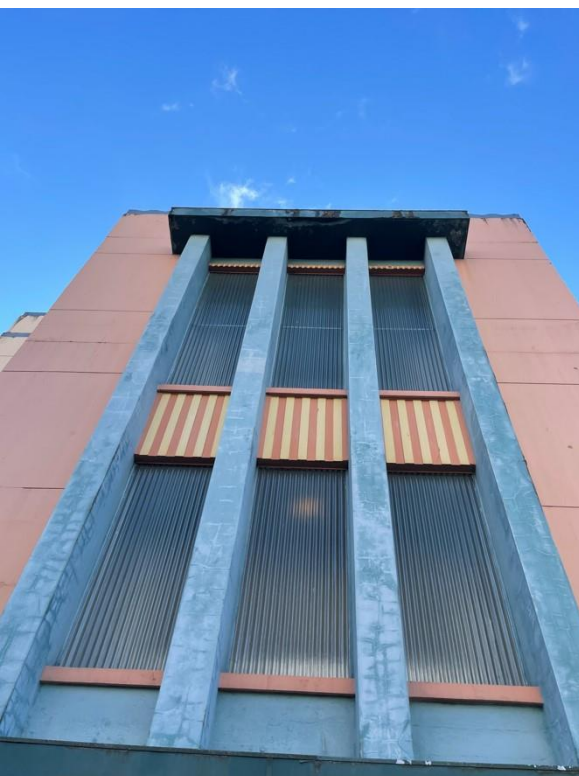
Corrugated glass windows to be preserved in situ.

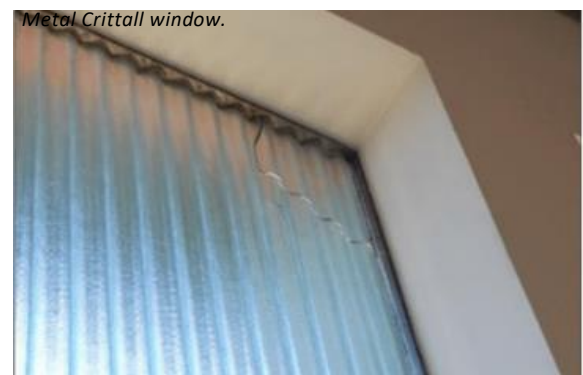
Cracked corrugated glass on west elevation.

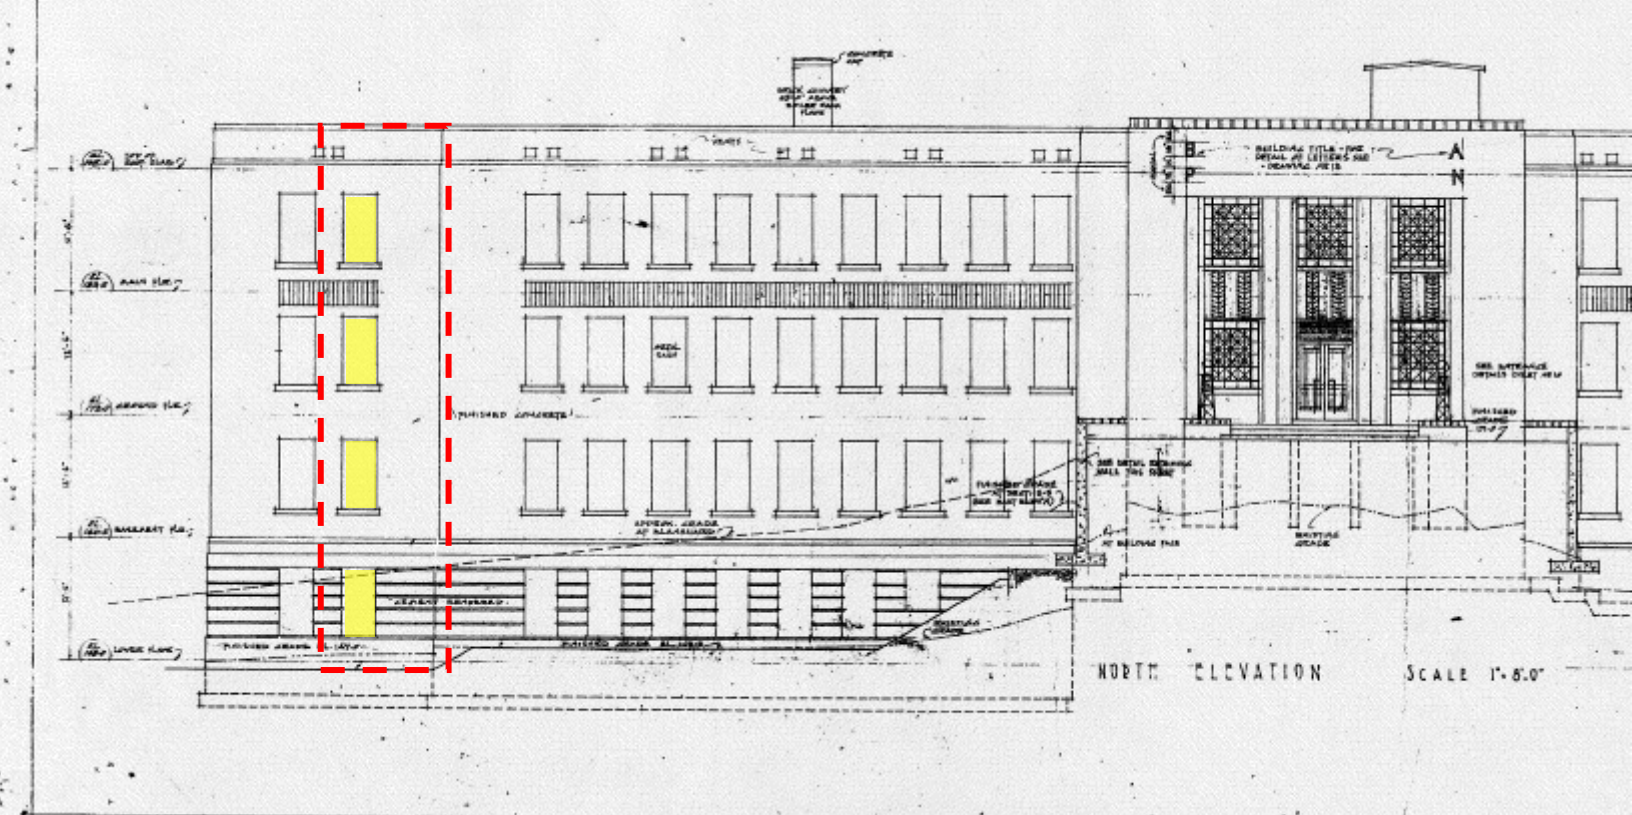
Location of 1979 exterior stair addition caused the removal of four windows that impacted all four levels. The fenestration openings will be restored, along with the slip sills, and all surface detailing.

5	Install four new window assemblies in the fenestration openings that will be restored with the removal of the 1979 exterior four-storey stair addition. Refer to Whittaker's original architectural drawings. The new windows should be based on the original window assembly and should be compatible in size, scale, material, style, and colour. They should also duplicate, as closely as possible, the operability, number and size of panes, the profile and proportion of metal sections, as well as the reflective quality of the glass panes.
6	Restore the original fenestration openings on the east corner of the north façade to accurately represent the state of the building as it appeared in 1950. Refer to Whittaker's original architectural drawings.
