# DICKSON, CAMPBELL & CO. BUILDING

1900 STORE STREET, VICTORIA, BC

## CONSERVATION PLAN

JANUARY 2022

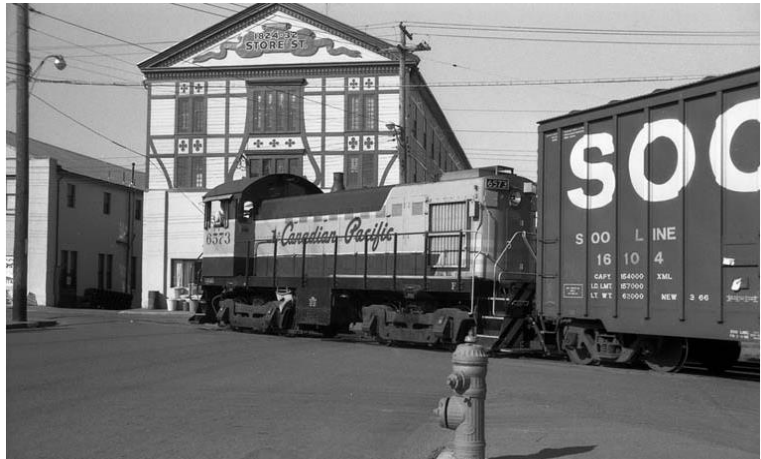
*Partial exterior restoration of Capital Iron, 1900 Store Street, c.1970. TrainWeb.org (train is 1957).*

The large Capital Iron & Metals Ltd. sign was removed in 1969 and the upper two storeys were restored with the return of half-timber detailing with scrolls and quatrefoil panels to match the original 1891 design, as well as repainting the upper two storeys on all sides with a lighter colour to enhance the contrast of detail.

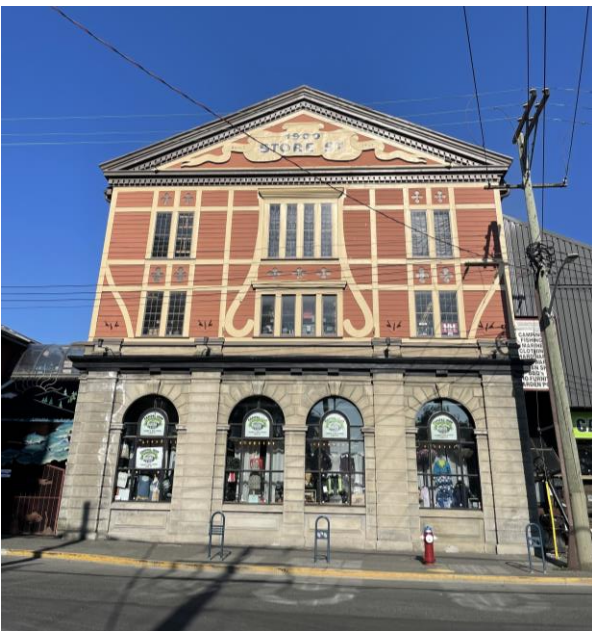
*Capital Iron, 1900 Store Street, July 2021, Photo by Geoff Purdon of NorthStar Contracting Ltd.*

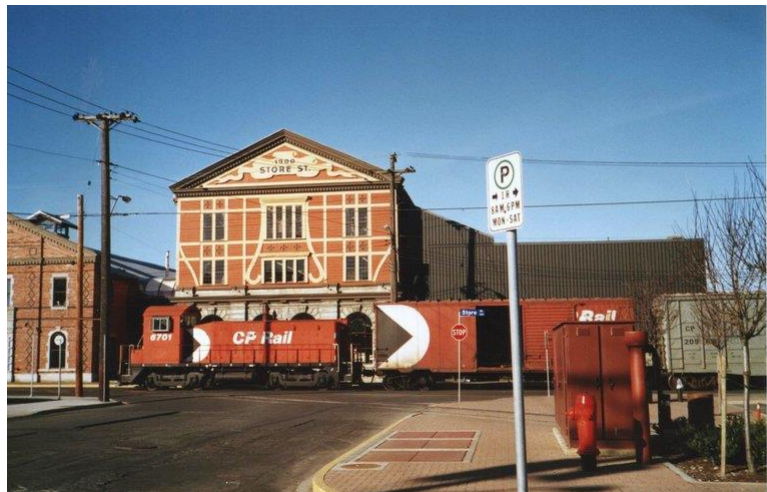
*Complete exterior restoration of Capital Iron, 1900 Store Street, February 29, 1990, TrainWeb.org.*

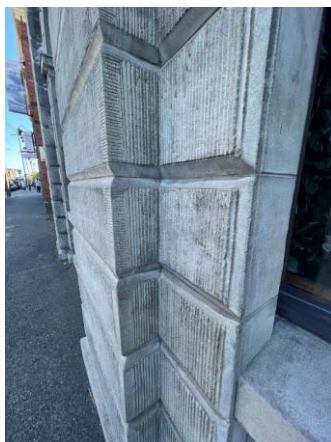
restored street-level façade appears to be parged over what seems to be a mixture of original freestone (sandstone) and replacement sandstone members to replicate the original large, quarried freestone blocks both physically and visually in terms of pattern and scale. Although the restored stonework is tooled with plaster's rake to create a rough surface, it is unclear whether the original stonework would have had the same appearance. The northeast and southeast corners are treated differently from the original in

that the new parged stone blocks are staggered and scratched with a plaster's rake to create a rough surface. The pilasters, arched window and door fenestrations, voussoirs, moulded stringcourse, and keystones restored in 1980 also appear to replicate the original 1862 façade and are well maintained. The parged sills are showing signs of cracking, and hairline cracks and efflorescence are evident throughout the stone façade.

1	Complete a comprehensive survey of all stone surfaces to further document noticeable deterioration, areas requiring immediate protection and repair, and areas that may require monitoring.
2	Preserve the parged stonework of the east façade by repairing cracked parged surfaces, cleaning the surface of efflorescence, and replacing in-kind stonework that may be too deteriorated to retain.
3	Retain all stonework and protect by cleaning and repairing any damaged areas and checking for moisture penetration and infestation. Take corrective action as soon as possible. Clean exterior masonry using the gentlest means possible, such as: water-based methods of soaking; low-pressure water washing; water washing supplemented with non-ionic detergent; and low-pressure hot water washing. A light scrubbing with a natural bristle or a synthetic bristle brush can facilitate cleaning textured surfaces or carved masonry. Always follow with a final water rinse to wash off the loosened soiling material from the surface. If chemical cleaning is required, only use approved chemical restoration cleaners that do not contain acids. Abrasive cleaning methods such as abrasive blasting and the use of grinders and sanding disks is never acceptable and is not permitted for use on heritage buildings.

4	Repoint stonework where necessary to protect from rainwater entering the core of the wall or the inside face of the building through the joints between the stones. The width, profiles and texture of the joints in stonework affect its visual character. In rubble stone walls, the joints would often be filled flush with mortar spreading onto the surface of the stone to give the wall a smoother more even appearance. Using permeable mortar joints allows the moisture to escape back to the outside. Hard cement mortar will increase the chance of frost damage or damage due to crystallization of soluble salts rising to the surface.
5	Repair of stonework should be limited to extensively deteriorated areas or missing parts of an exterior wall and should be limited to replacement in-kind or a compatible substitute material. Ensure

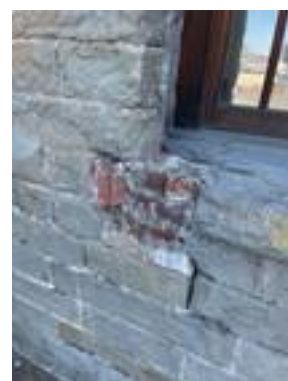
The exterior wall of the first two levels of the west 1862 elevation is also constructed of freestone and is entirely original aside from some windowsill repair using an incompatible material such as brick. Masonry block firewall has also been used to partially infill three windows within the arched fenestration opening on the main floor (street level).

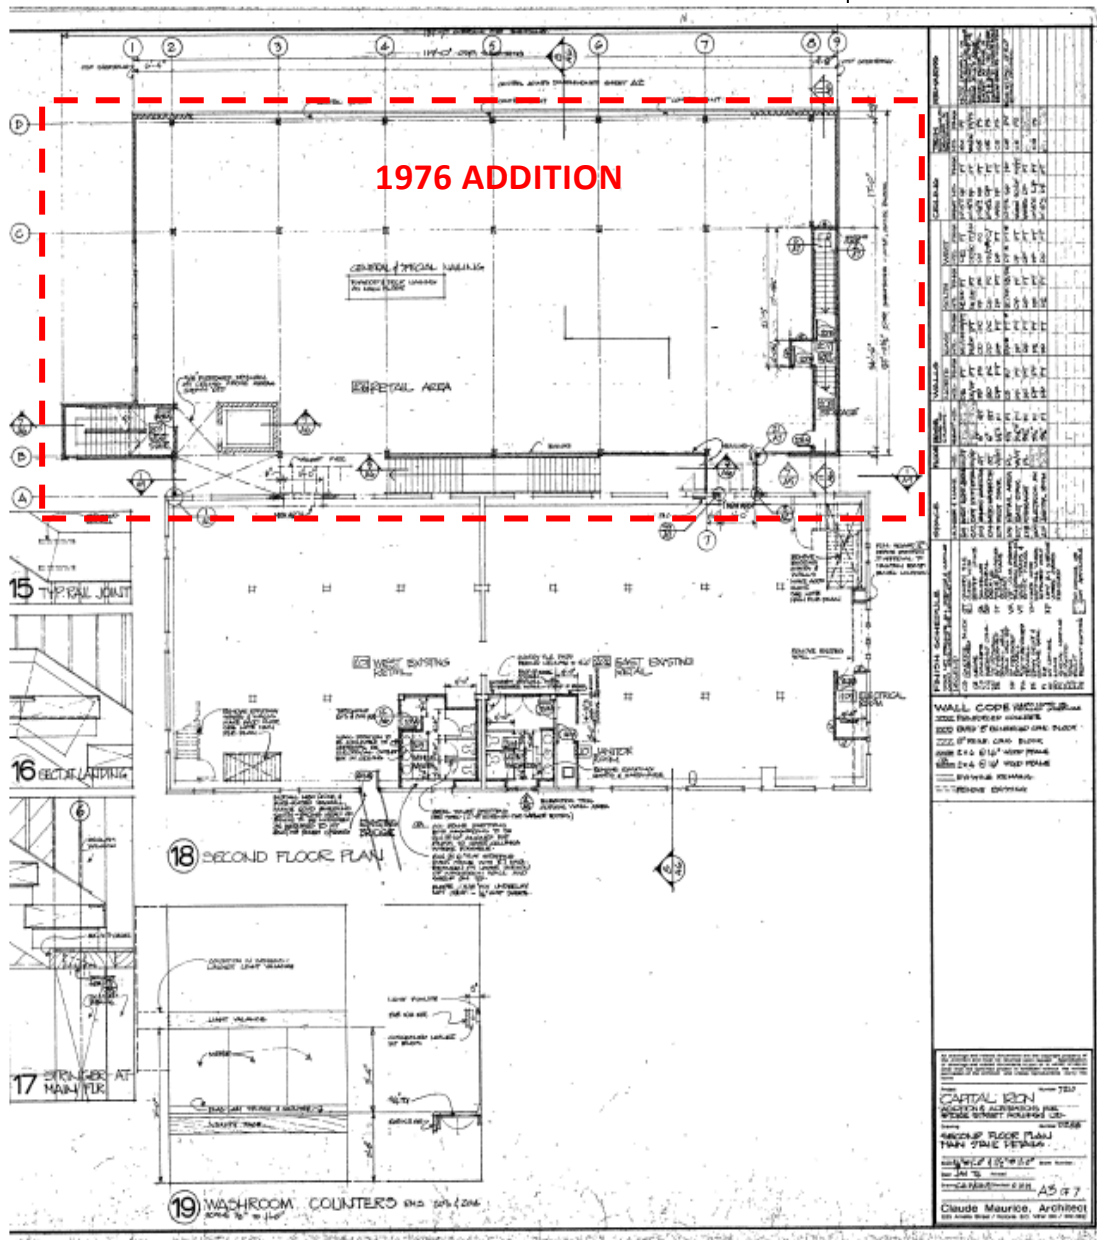
2<sup>nd</sup> Floor Plan, 1976 Capital Iron addition, City of Victoria Permits and Inspections Division.

1976 addition, the focus of the Conservation Plan involves the 1862, 1885 and 1891 construction periods. However, drawings of the addition provided by the City of Victoria show some plans and sections indicating how the 1976 addition impacted the north wall of the original structure. Sections and elevations provide information on the 1976 openings in the north stone rubble and wood frame walls, as well as an existing opening enlarged to accommodate increased circulation. Upon removal of the 1976 addition, all 1976 fenestration openings in the original stone rubble wall should either be repaired with replacement in-kind or compatible substitute material, or continue to function as a fenestration opening. If new openings are considered, utilize removed stone rubble to repair 1976 openings to near original in appearance.

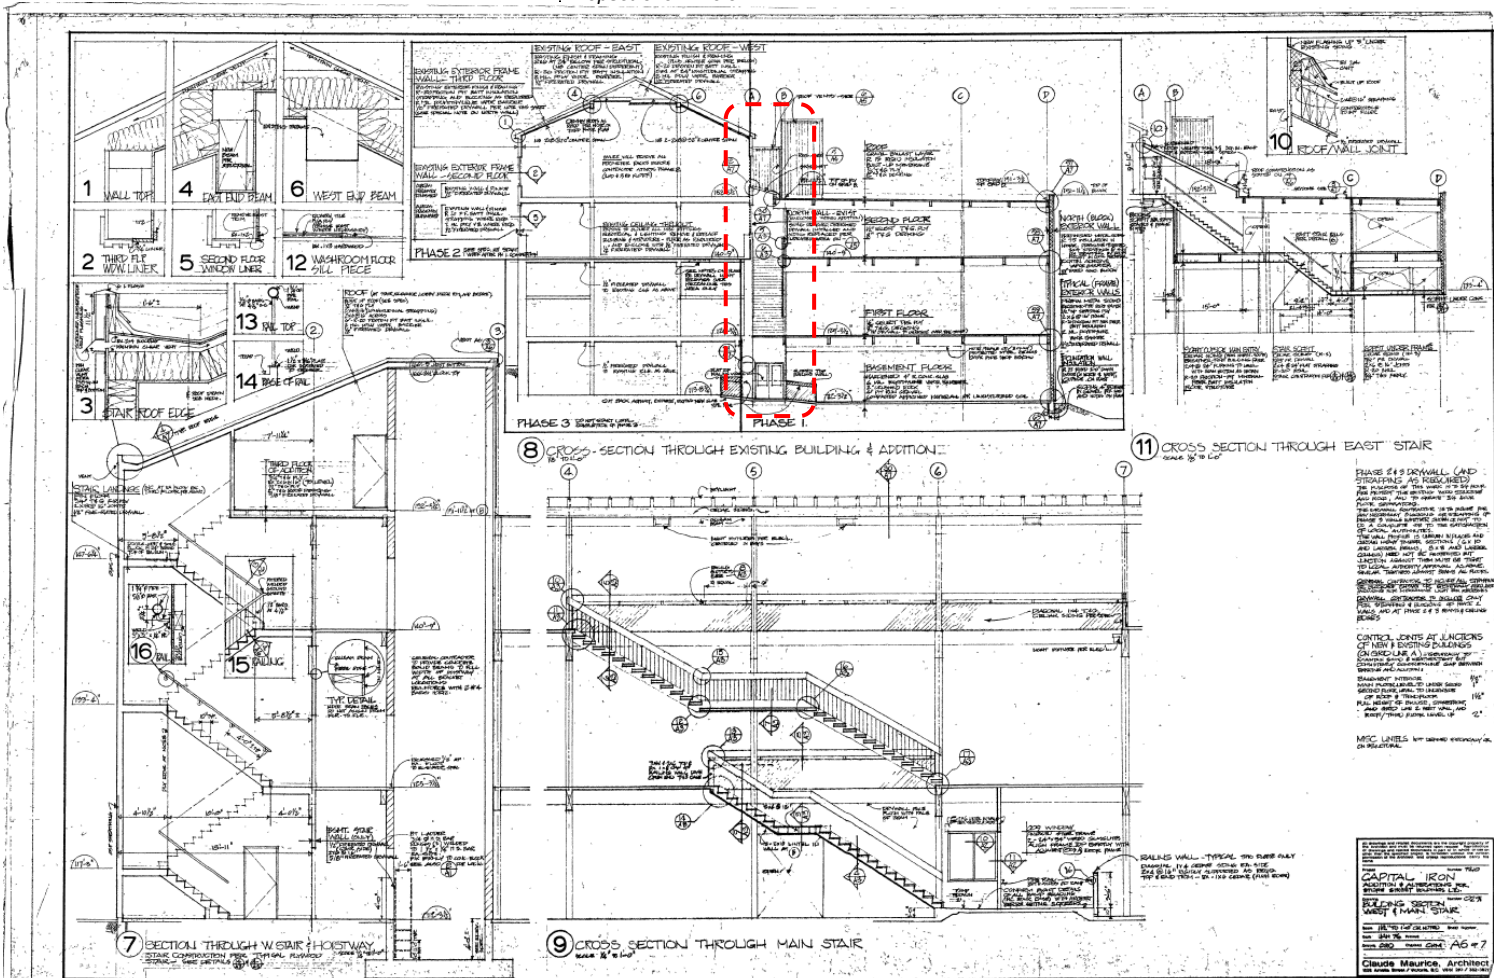
Building Section, West & Main Stair, 1976 Capital Iron addition, City of Victoria Permits and Inspections Division.

The restoration of the front façade did not entail the reinstatement of the two central entrance ways as shown in the following photographs. Instead, new windows replicating the original 1862 lite division were installed in create four equally dimensioned fenestration openings. It is recommended that the two central openings be restored to their original dimension to operate as they were initially intended as entry ways with double-swing doors.

1	Remove central two windows installed during the 1980 restoration of the east façade and retain for potential reuse within the interior of the building.
2	Remove lower bulkheads and repair stonework. Repair should be limited to replacement in-kind or a compatible substitute material. Ensure the repair matches as close as possible to the physical and visual properties of the existing material.
3	Restore the original single-glazed, double-swing multi-panel wood doors and upper multi-lite shaped transoms to represent the entryways as they appeared in 1862. Ensure door hardware is compatible with the period.

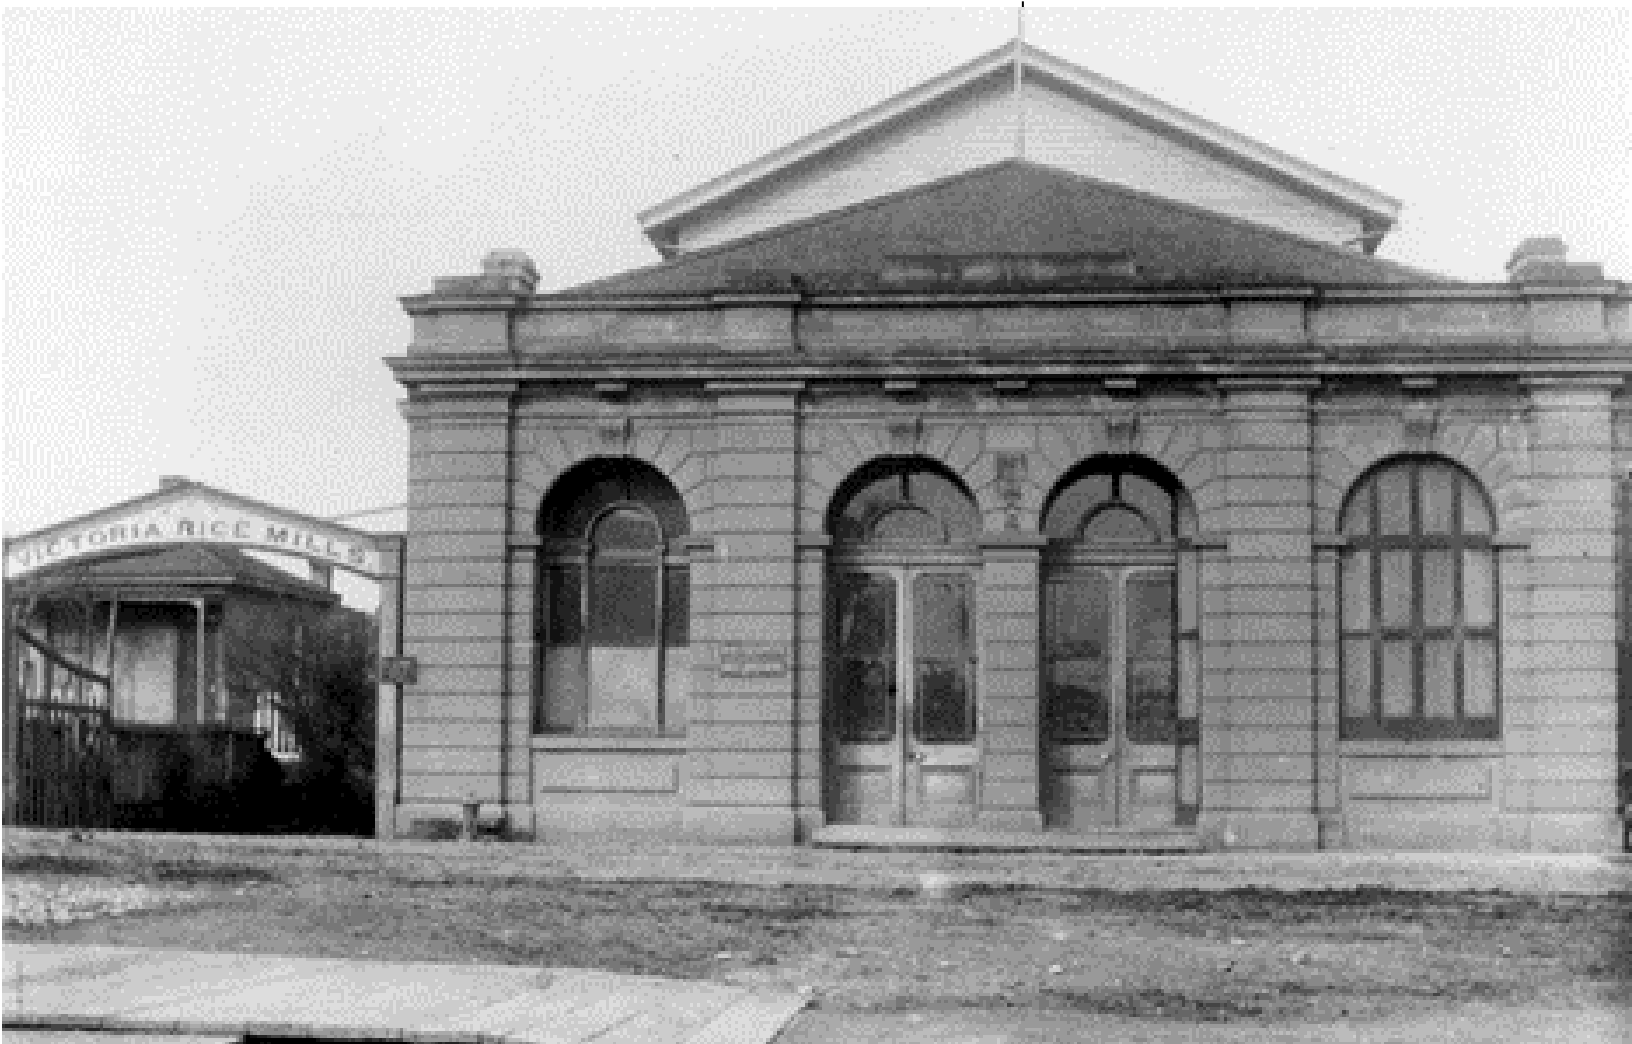
The central window inserts installed during the 1980 restoration of the east façade are similar in design to the original south window on the front façade and appear to be in excellent condition. Although it is recommended these two central windows be removed, they can be retained for potential reuse on the interior of the building.

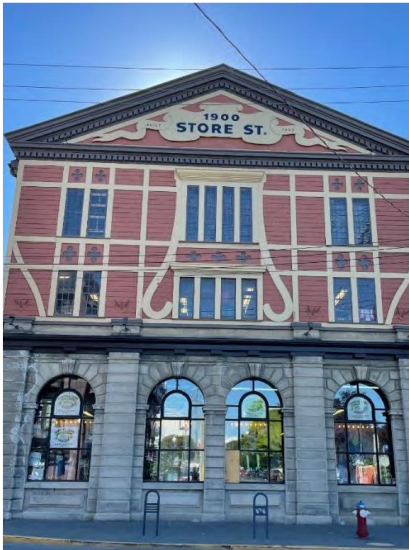
The upper windows, lintels and sills are in fair to good condition due to good maintenance over the years.

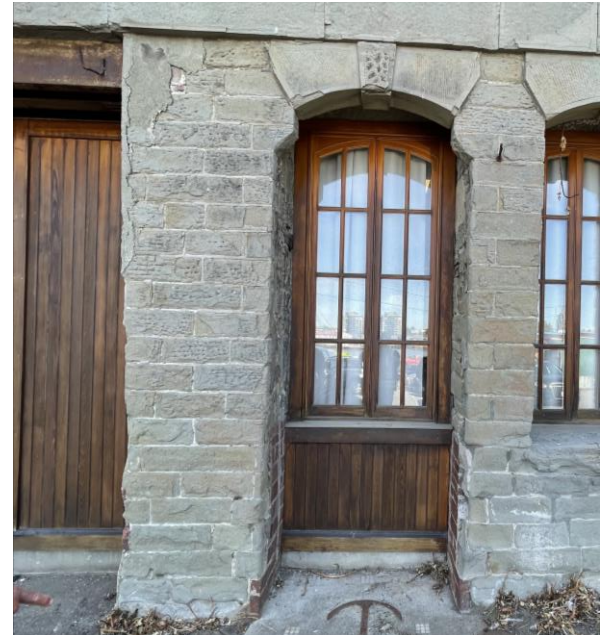
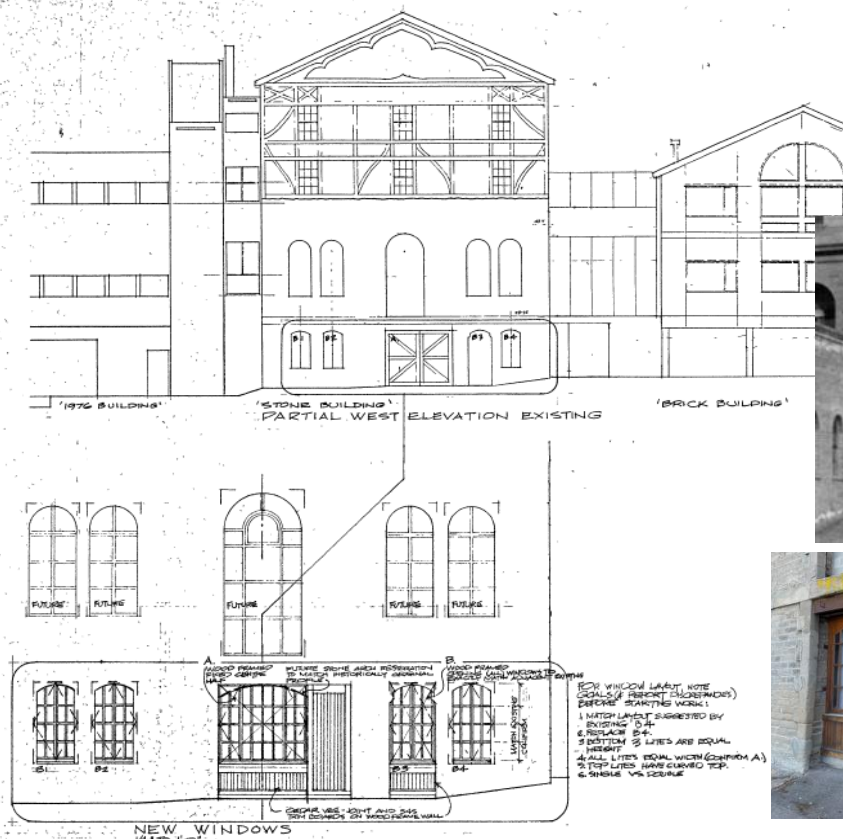
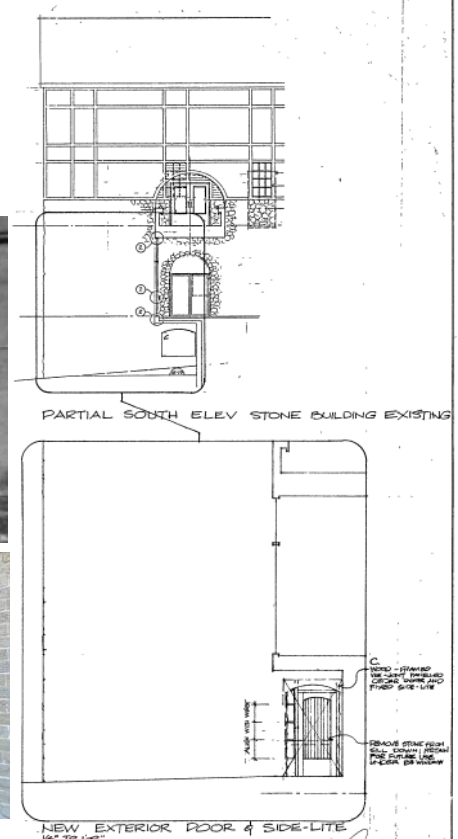
West Elevation and Partial South Elevation, 1994 window and door restoration/rehabilitation, architect Claude Maurice, City of Victoria Permits and Inspections Division.

Based on a 1994 drawing by architect Claude Maurice, the ground-level west windows were restored to their original 1862 appearance. However, it appears the central fenestration originally had wooden swing doors and the fenestration to its right was the original opening where rice was brought in by rail on a small car from the sailing vessels and

placed on an elevator to carry it to the top floor for processing. These two openings have been rehabilitated in a manner that is compatible with the style, era, and character of the historic building. There is also physical evidence of steel shutters at one time as hinge mounts are still intact.

Windows in the second west level should be restored to their original 1862 appearance. Evidence is lacking as to the original treatment of the central elongated opening. The upper 1891 west elevation contains original six-over-six single hung windows and are in fair condition with signs of maintenance required on the third and fourth floors.

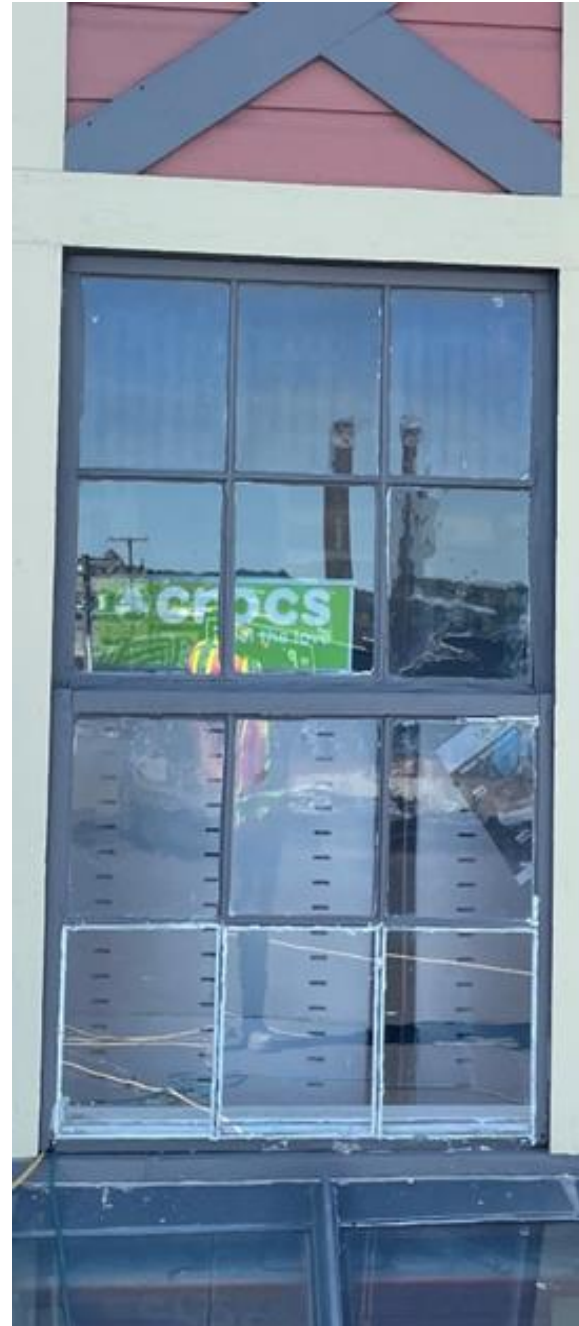
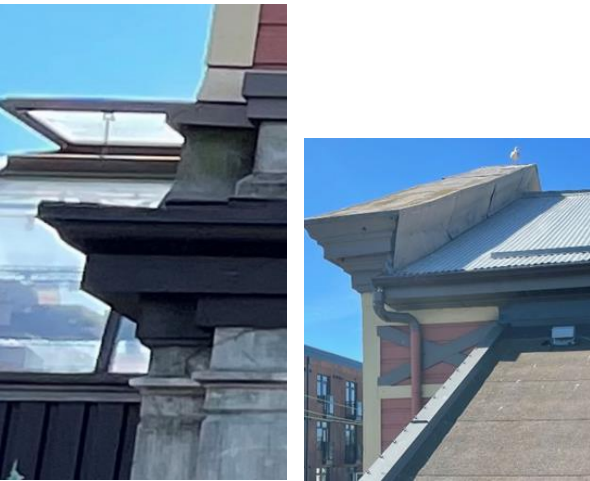
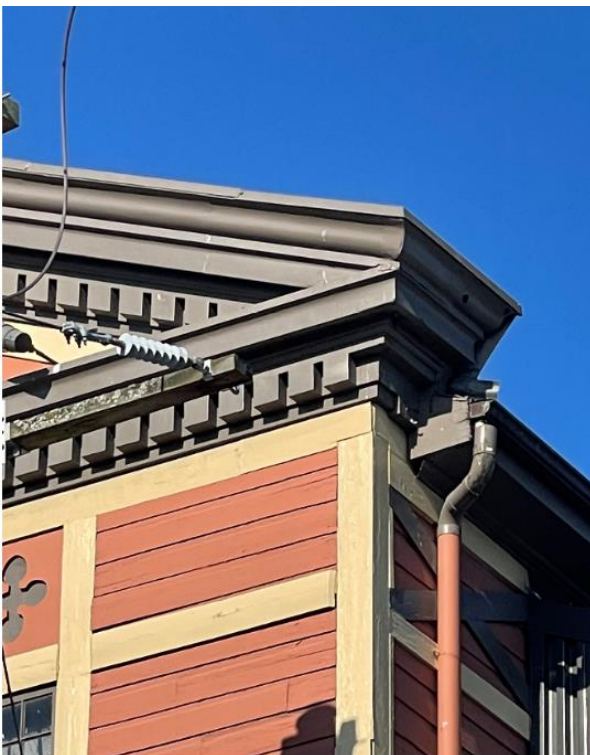
The south and north sides of the 1885 and 1891 addition contain nine equally spaced six-over-six single hung wood windows and appear to be original and in good to fair condition with restorable original wooden sashes.

An arched window fenestration is on the southeast section of the south rubble foundation, with a crenelated or quoined surround, a textured keystone and stone sill. It appears to have been partially filled in with concrete in the early 1960s and contains a single hung window in the lower portion. The upper arched wood transom may be original, and there appears to be a moulded metal arch support, which may also be original to the 1862 structure.

1	Inspect all original window assemblies and determine extent of repair or replacement that may be required.
2	Retain all windows original to 1862, 1885 and 1891 period that are in good condition, as well as windows restored, rehabilitated, or replaced during the 1980 and 1994 restoration work. Protect and maintain windows through cleaning, rust removal, minimal paint removal and reapplication in-kind. Ensure windows are weather. Re-putty, replace or install weatherstripping.
3	Repair intact window assemblies in fair condition using a contractor specializing in heritage restoration using recognized conservation techniques. Ensure windows are repaired to operable condition and weather tight. Repair cable hung counterweights, and inoperable hardware. Re-putty and weatherstrip where necessary. Repairs should be physically and visually compatible and may include limited replacement in-kind, or with a compatible substitute material based on documentary or photographic evidence. Repairs should always follow a minimal intervention approach.

4	Where windows are extensively in disrepair or have irreparable or missing elements, repair may include limited replacement in-kind or replacement with a substitute material. Repairs should physically and visually match existing based on documentary or physical evidence, where feasible. Replacement window frames and sashes for wooden windows should be of wood construction or an approved substitute material. Decorative detailing on the original windows, such as mouldings, lintels, sills and casings, should be accurately duplicated.
5	Any window assemblies or missing elements replaced with new windows should be based on physical and documentary evidence, or be compatible in size, scale, material, style and colour.
6	Retain all original glass in historic window assemblies where possible. All new window assemblies are to be single-pane to ensure consistency of reflectivity with all original single-pane windows that are repaired and remain in place.

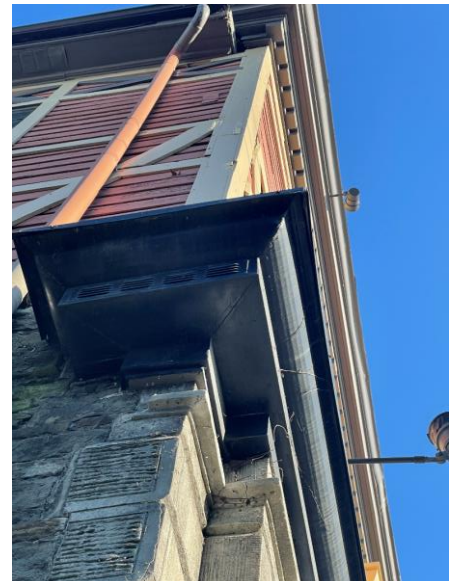
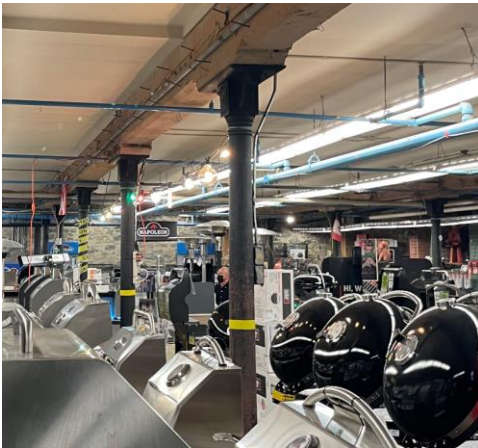
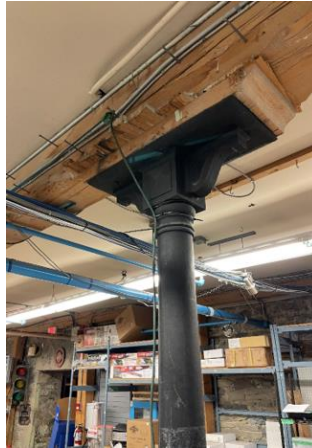
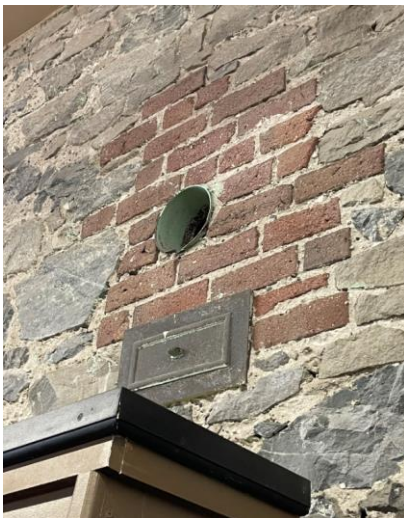
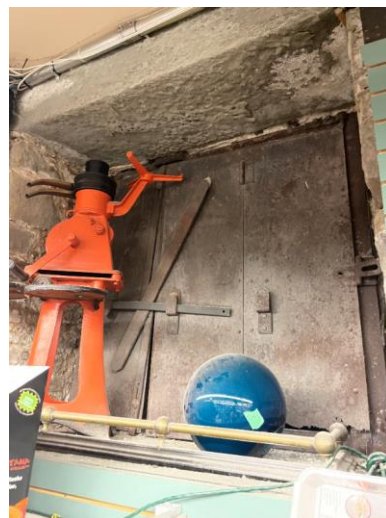
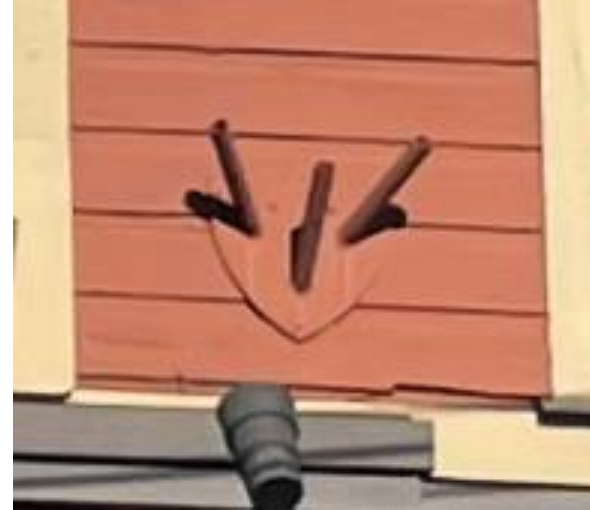
The Dickson, Campbell & Co. building features a variety of architectural metalwork details on the east, south and north façades, as well as on the interior walls. The east façade features a projecting wood-framed cornice clad with sheet metal and tied in with the sheet metal roof. The dentils are also clad with metal, as is a horizontal cornice and brackets on the 1862 façade. The metal cladding appears to be in good condition with some evidence of peeling paint on the dentils. Four metal flag pole supports are located just above the mid-horizontal cornice.

Each south and north rubble stone wall contains eight round decorative metal plates that appear to be rim

board anchors. However, it has been suggested that they may also be associated with rice chutes.

The lower wharf-side ground level contains original round decorative cast iron columns, decorative cast iron column brackets and a cast iron plate. Original metal shutters also exist within the lower-floor side window openings. The north and south wall main street-side floor level contains decorative rectangular metal plates below a round metal opening and appear to have been installed after 1885, as the opening around the elements has been filled in with baker brick. There is no evidence of this on the exterior wall. Those familiar with the building state that the elements were potentially rice chutes.

1	Retain all sound and repairable metals that contribute to the heritage value of the historic place.
2	Assess the overall condition of all metal elements to determine a scope for appropriate cleaning, and the reapplication of suitable paint or coating systems to decrease corrosion.
3	Replace, in-kind, any metal elements that are missing or are too deteriorated to repair, based on physical or documentary evidence.

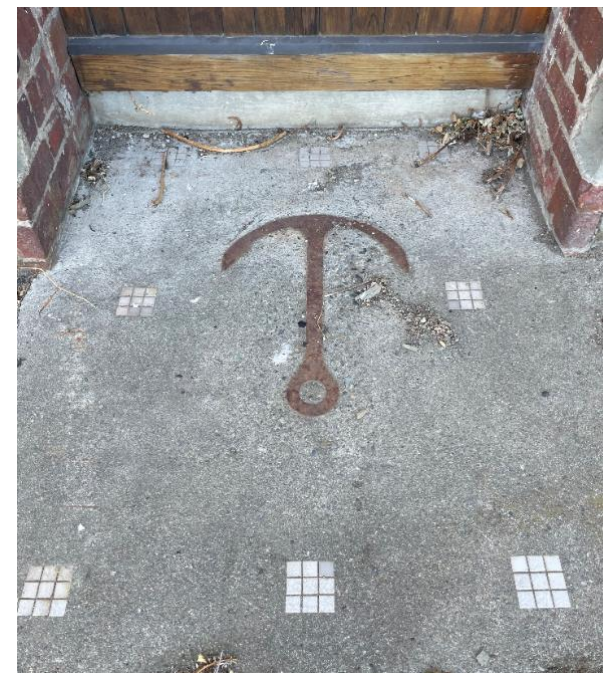
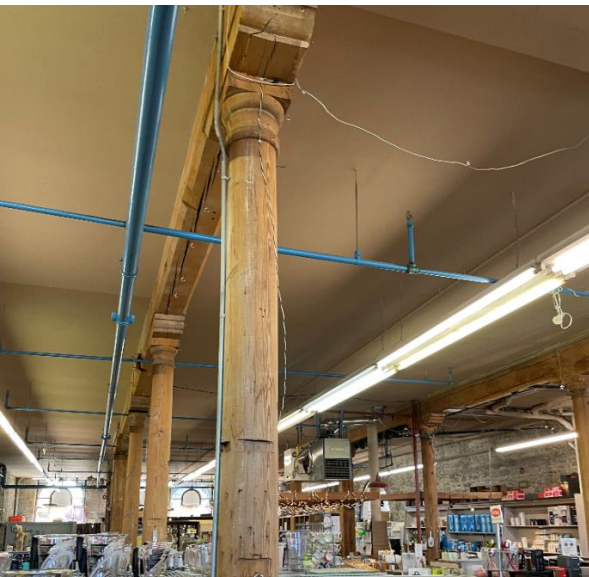
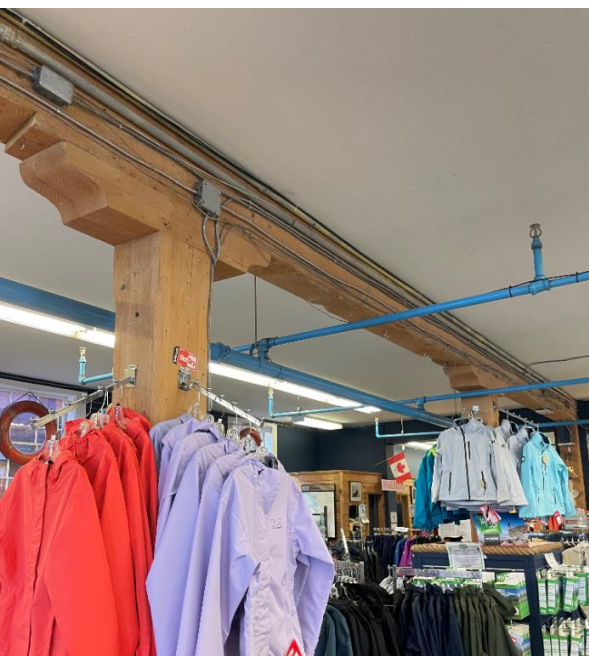
A metal anchor and ceramic tile patterns are embedded in the concrete of the west side ground-level opening that was once used to bring rice in by small train cars where it would then be lifted to the top floor by an elevator. It is unclear when this was placed, but certainly has nautical connections.

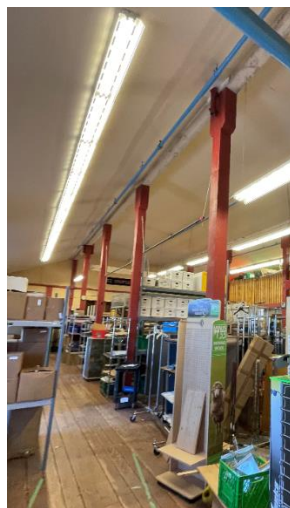
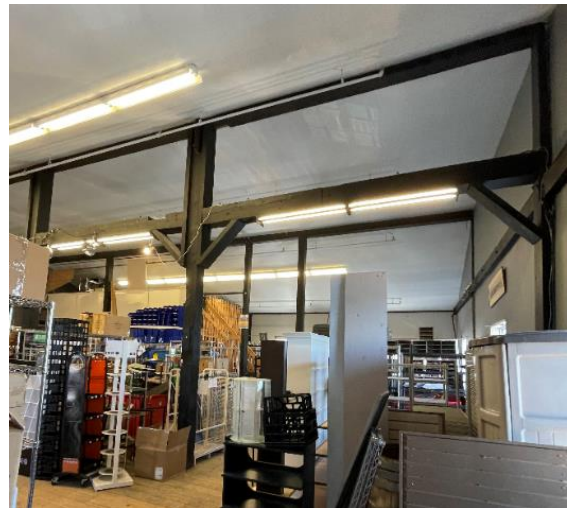
As mentioned in the previous section, the lower ground floor contains decorative round metal columns and steel window shutters. The main street level contains carved round wood columns with a moulded plate supporting 120-foot-long wood beams, decorative rectangular metal rice chute plates, and original west-side wood window frames and sashes. The second street-facing level contains original timber columns and beams and original wood window frames and sashes, and the upper level contains original post and beam construction with connector plates, and original wood window frames and sashes.

1	Retain all sound and repairable wood that contributes to the heritage value of the historic place.
2	Assess the overall condition of all wood window frames and sashes and determine scope of repair.
3	Where windows are extensively in disrepair or there are irreparable or missing elements, repair may include limited replacement in-kind or replacement with a substitute material. Repairs should physically and visually match existing based on documentary or physical evidence, where feasible. Replacement window frames and sashes for wood windows should be of wood construction or an approved substitute material. Decorative detailing on the original windows, such as mouldings, lintels, sills and casings, should be accurately duplicated.
4	Any window assemblies or missing elements replaced with new windows should be based on physical and documentary evidence, or one that is compatible in size, scale, material, style and colour.

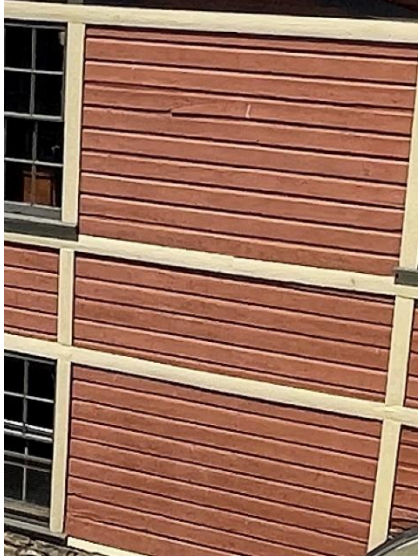
Reference #:	Corresponding Picture:
1a)

Item #	Existing conditions/elements:	1900 Store Street Capital Iron Building:	Corresponding pictures:
Item 1	The site reviews would describe the materials and physical condition of exterior walls, including foundation walls, structural masonry, and wood or concrete with an exterior cladding.	<p>a) Original wood cladding is in good condition, some evidence of peeling and maintenance over the next two years</p> <p>b) Original rubble rock foundation is in fair condition, w no signs of extensive deterioration</p> <p>c) Windows in the East elevation are in excellent condition</p> <p>d) Windows in the West elevation fair condition, w some sings of maintenance required on 3<sup>rd</sup> and attic floor,</p> <p>e) Rear access stairs showing signs of wear/weathering</p> <p>f) Roof condition is fair</p> <p>g) Masonry and parging around lentils</p>	<p>1a)</p> <p>1b)</p> <p>1c)</p> <p>1d)</p> <p>1e)</p> <p>1f)</p> <p>1g)</p>

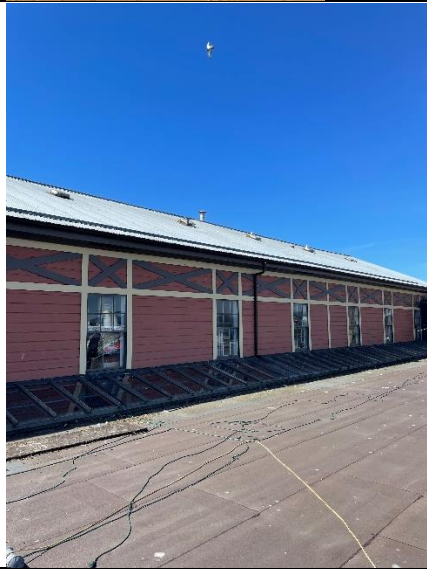
i) Siding around the exterior of the building of the heritage portion	14i)
Item 15	Identify the remains of original staircases and assess their condition. Remember, interior arrangements can have a strong relationship with the exterior form so changes to the interior can impact the exterior...thus we need to consider the interior where necessary.	a) Staircases appear to be not original, likely installed when the addition was added	15a)

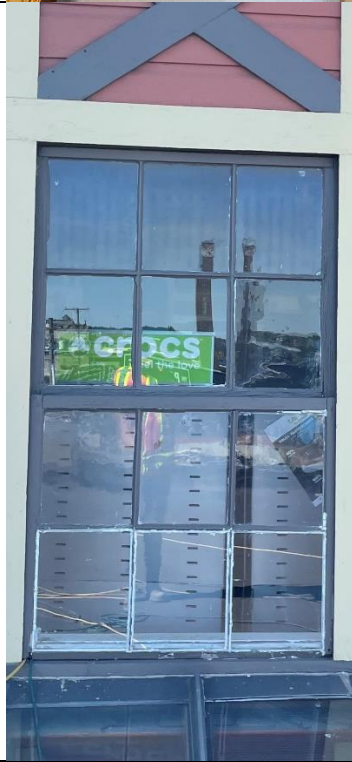
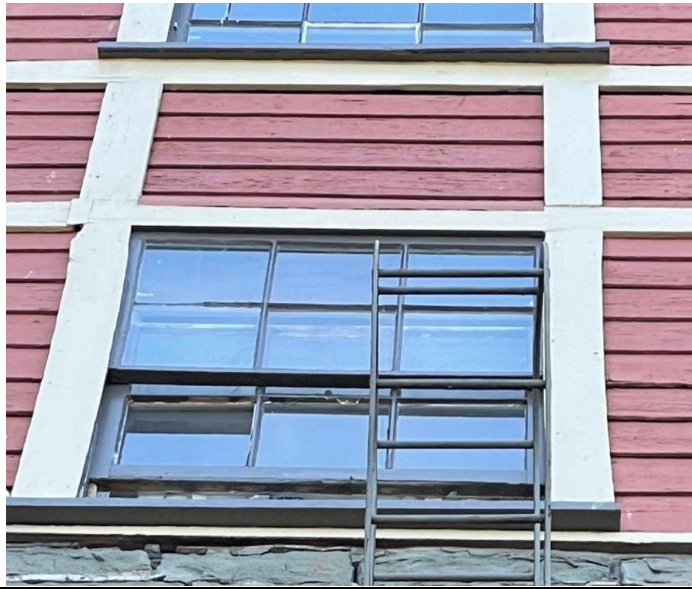
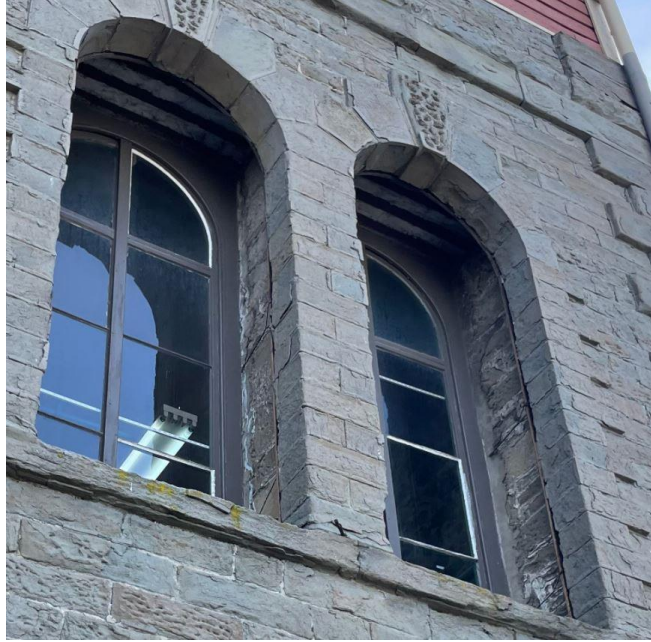
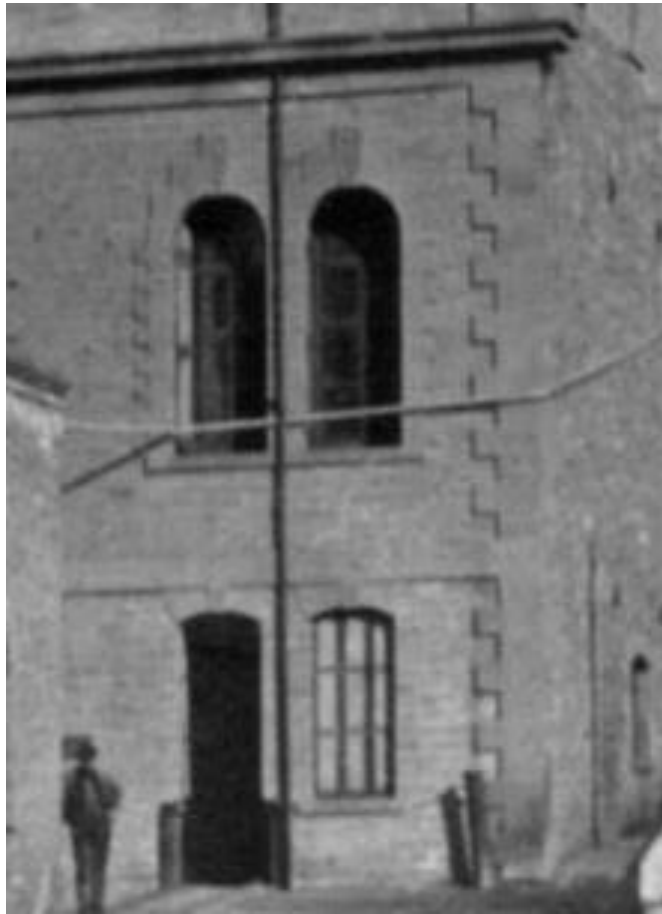
Item 16	Assess condition of windows and doors, are they original wood or metal, or newer replacements? If original, are they repairable? If there are newer replacements, are wood sash assemblies intact?	a) Heritage building – all visible windows on heritage side appear to be in good to fair condition/restorable wooden original sashes, a few are in need of repair (pictures in appendix)	16a)

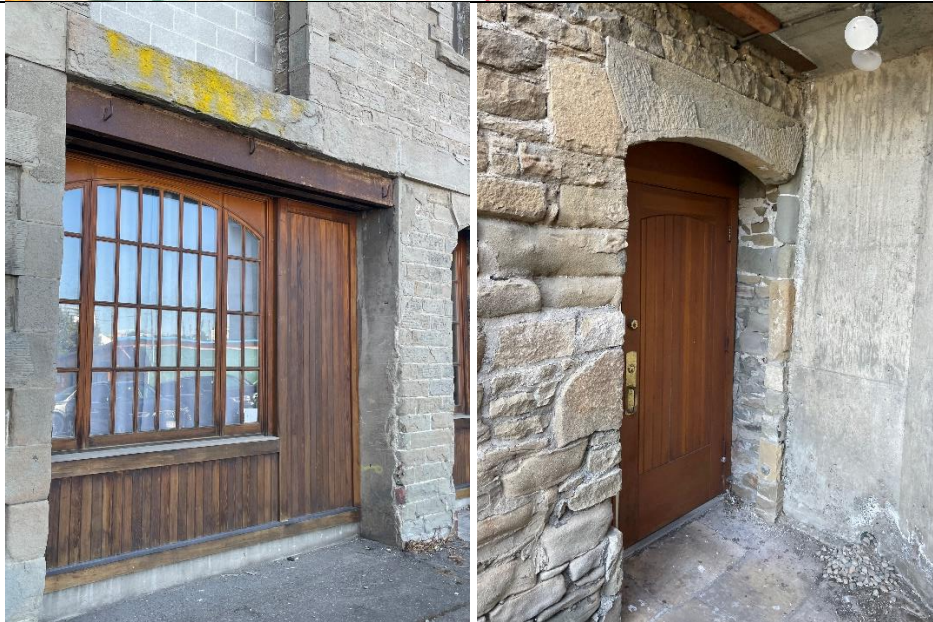
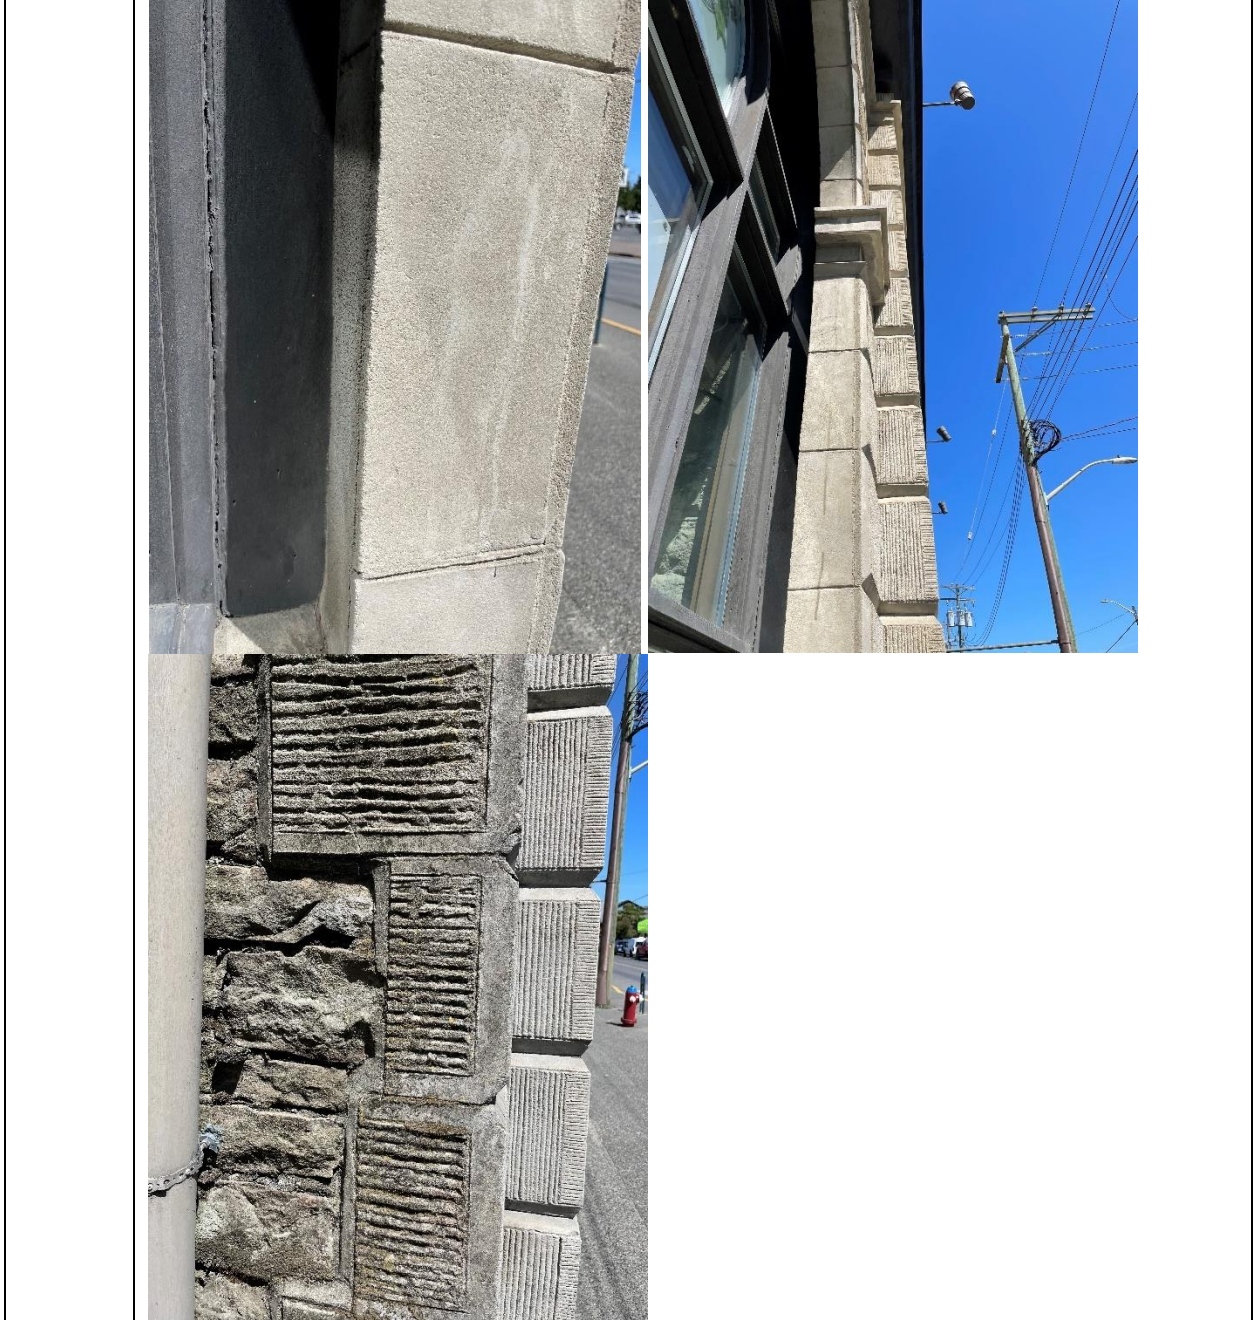
18a)

Item 18	Identify whether the storefront configuration has changed over time. Is the original still evident under the existing layers?	<p><b>East Elevation</b></p> <p>a) Original storefront appears to be original from the 3<sup>rd</sup> floor extending up to the roof, the ground floor appears to have architecturally formed and precast concrete, w parging,</p> <p>b) There is a crack running the length of the sill</p>	<p>18a)</p> <p>18b)</p>

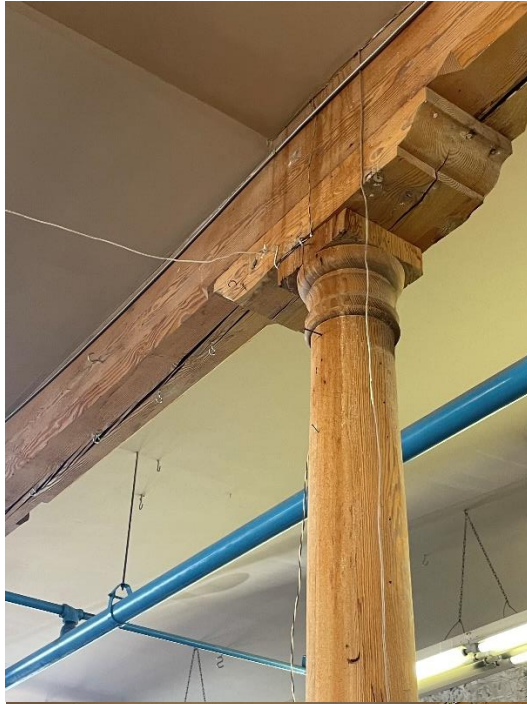
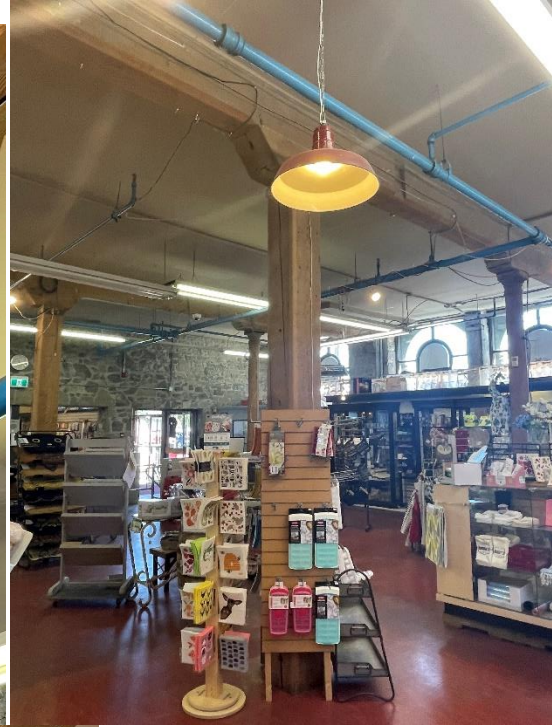
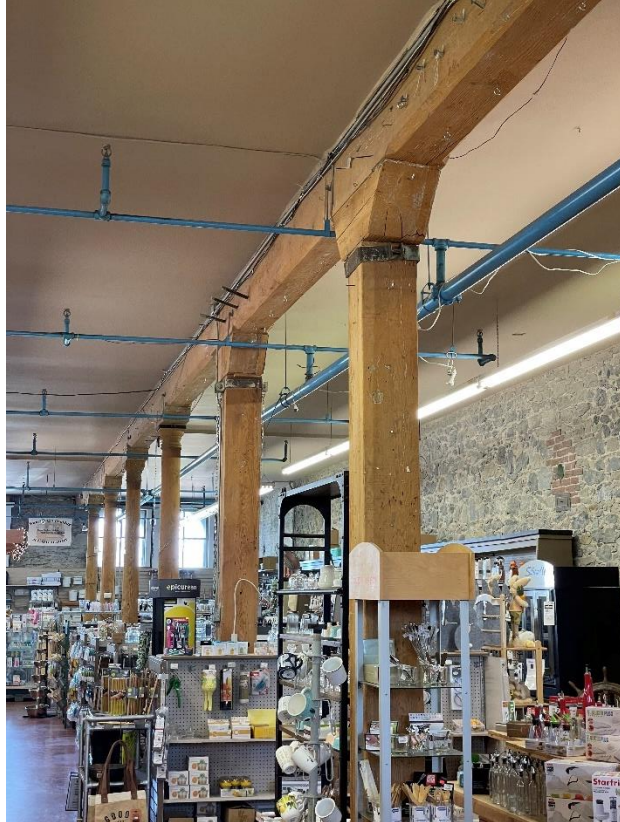
21a)

Item 21	<p><b>Wood</b> - Identify any wood features and existing condition on exterior facades, roofs, cladding, structure, windows and doors, interior finishes, and carvings. Determine the condition of finishes or coatings applied to the wood features.</p>	<p><b>Main Floor</b> – heritage side</p> <p>a) Hand carved columns supporting the beams on the main floor, beams on the main floor and ground floor are said to be made up of 120ft long lengths</p> <p><b>Stairs</b></p> <p>b) Main flight of stairs on the inside of the building appear to be constructed at the time of the addition</p> <p><b>West Elevation</b></p> <p>c) Ground floor stairs appear to be added at time of the addition</p> <p>d) *Original wood siding from the 3<sup>rd</sup> floor up around the whole building</p> <p>e) New addition consists of multiple glue lam beams that appear to be up to 3ft in depth</p> <p><b>Third Floor</b></p> <p>f) Wood shiplap for ceiling finish, original wood carved timber columns and beams</p> <p><b>Attic</b></p> <p>g) Original post and beam construction on 4<sup>th</sup> floor, red painted timbers, fir flooring</p>	<p>21a)</p> <p>21b)</p> <p>21d)</p> <p>21e)</p> <p>21f)</p> <p>21g)</p>
