# DICKSON, CAMPBELL & CO. BUILDING

1900 STORE STREET, VICTORIA, BC

## CONSERVATION PLAN

JANUARY 2022

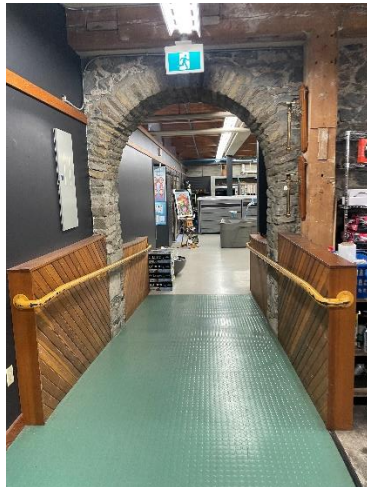
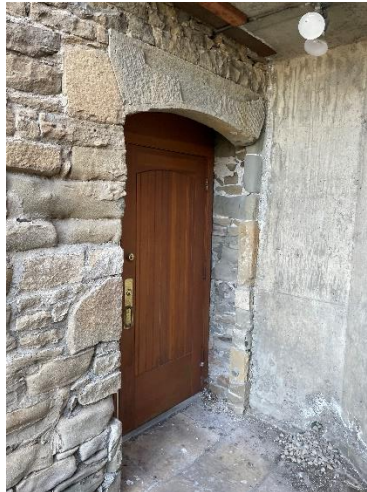
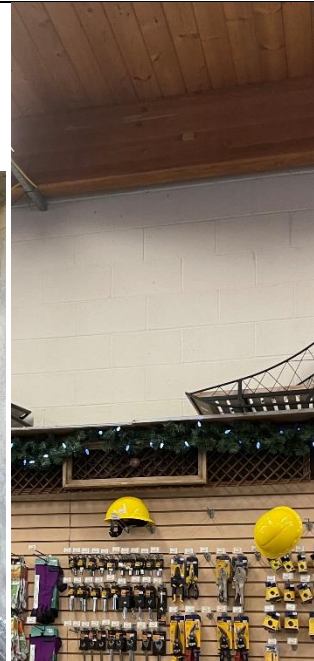
23b)

Item 23	<p><b>Masonry</b> - Assess the current condition of masonry features, such as natural stone, brick, cast stone, terra cotta and concrete block. Identify the finish dressing, texture and colour of the stone, brick or mortar, the coursing pattern, and the joint width and profile, along with any decorative sculptural and functional elements, such as band courses, lintels, water tables, cornices, scuppers and carvings.</p>	<p><b>East Elevation</b></p> <p>a) Rubble rock foundation, demising wall, exterior walls</p> <p><b>Ground Floor</b></p> <p>b) Rubble rock foundation with stone lintels on exterior windows, stone archways connecting the original building to the new addition, masonry block firewalls throughout new addition</p> <p>c) Baker brick masonry pilasters on the ground floor South wall, wall safe on East wall heritage side</p> <p><b>Main Floor</b></p> <p>d) Exterior walls heritage side large stone window archways on South side</p> <p>e) Retrofit window and potential rice chute repairs on demising wall</p> <p>f) baker brick patched in around rubble rock foundation, masonry patch/repair around rice chute, ornate cover plates covering voids in exterior/interior walls (said to be rice chutes at one time),</p>	<p>23b)</p> <p>23c)</p> <p>23d)</p> <p>23e)</p> <p>23f)</p>

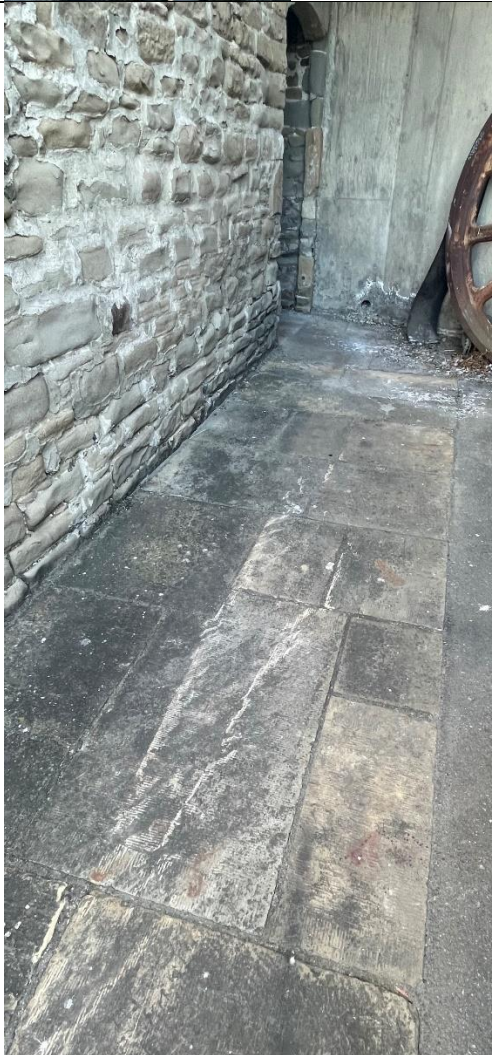
concrete features used for exterior cladding, flooring and paving. Identify any texture created by formwork, the colour and finish, such as exposed aggregate or terrazzo.	<p>a) Concrete slab in breezeway supported by a concrete foundation wall, stamped concrete/cobblestone leading to South entrance on the Westside ground floor, polished concrete slab in the West loading bay in the new building, evidence of architecturally formed concrete façade/parging</p> <p><b>Ground Floor</b></p> <p>b) Exposed concrete footing down demising wall between old section and new section, newer concrete posts and beams formed around electrical room on ground floor of new addition</p> <p>c) Original stone pavers at the southwest entrance</p>	24c)
